VENETIAN CAUSEWAY

Project Development & Environment (PD&E) Study

FROM NORTH BAYSHORE DRIVE TO PURDY AVENUE

Cultural Resources Committee (CRC)

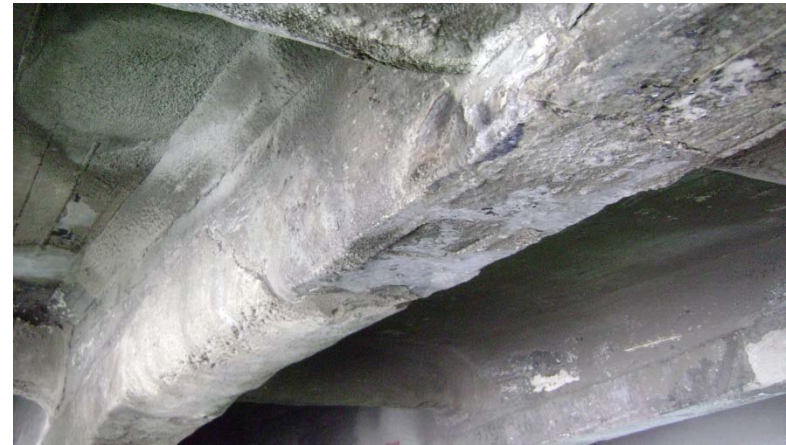
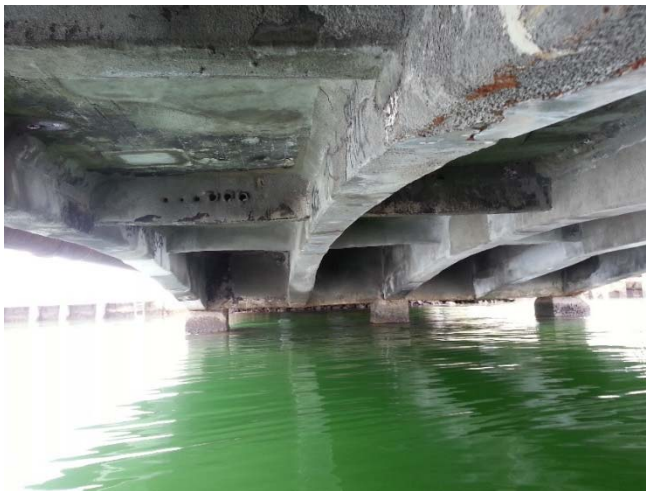
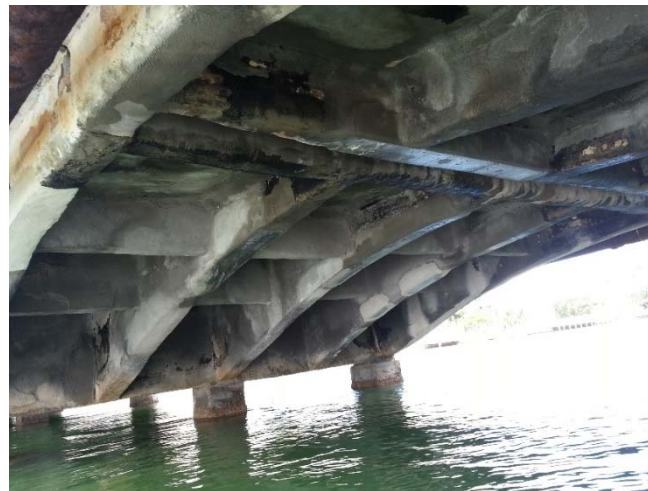
Summary of Typical Deficiencies

- Unsound concrete in Beam & Slabs
- Failed Repairs
- Significant corrosive deterioration

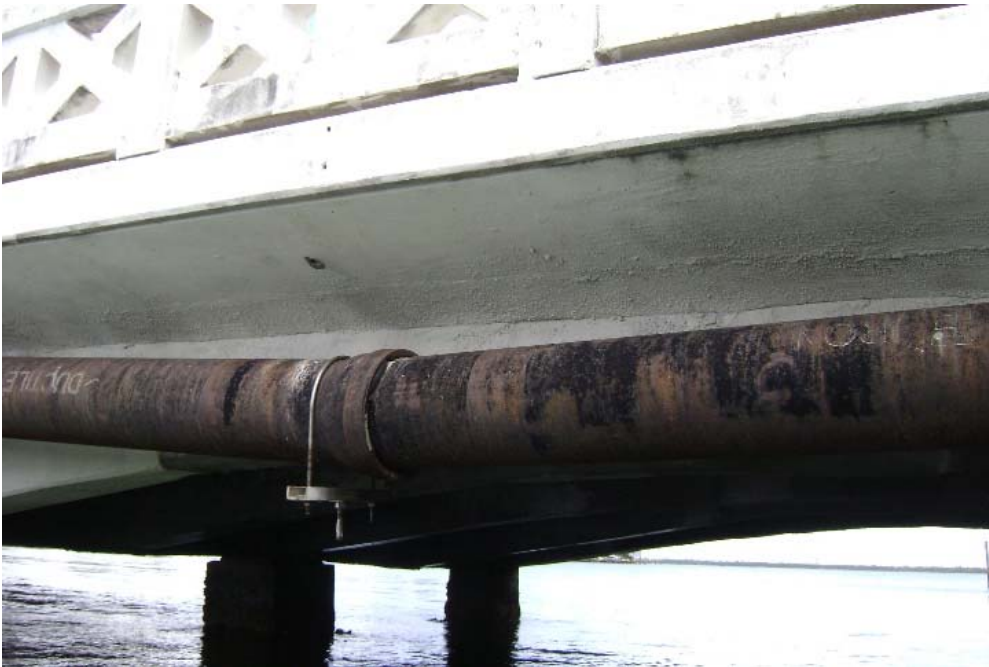
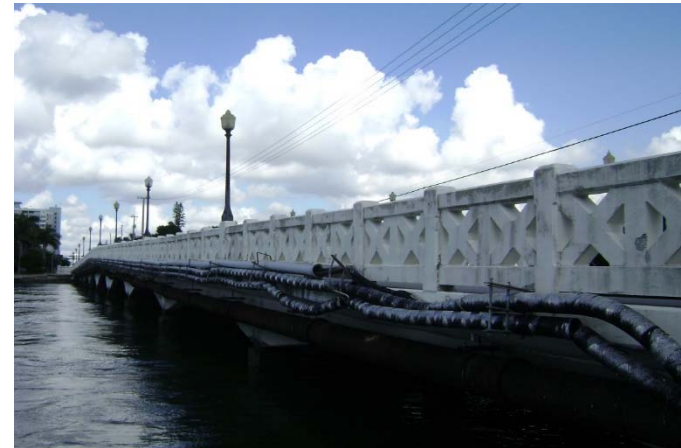
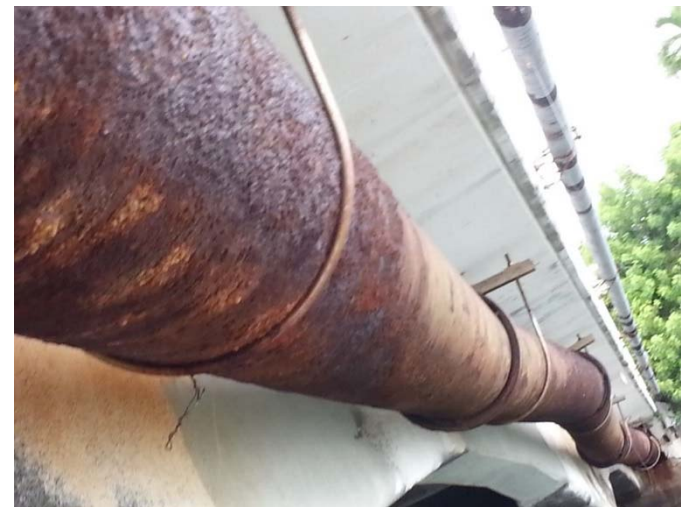
- Utilities- Supporting Hangers broken & hanging loose & uneven pipes

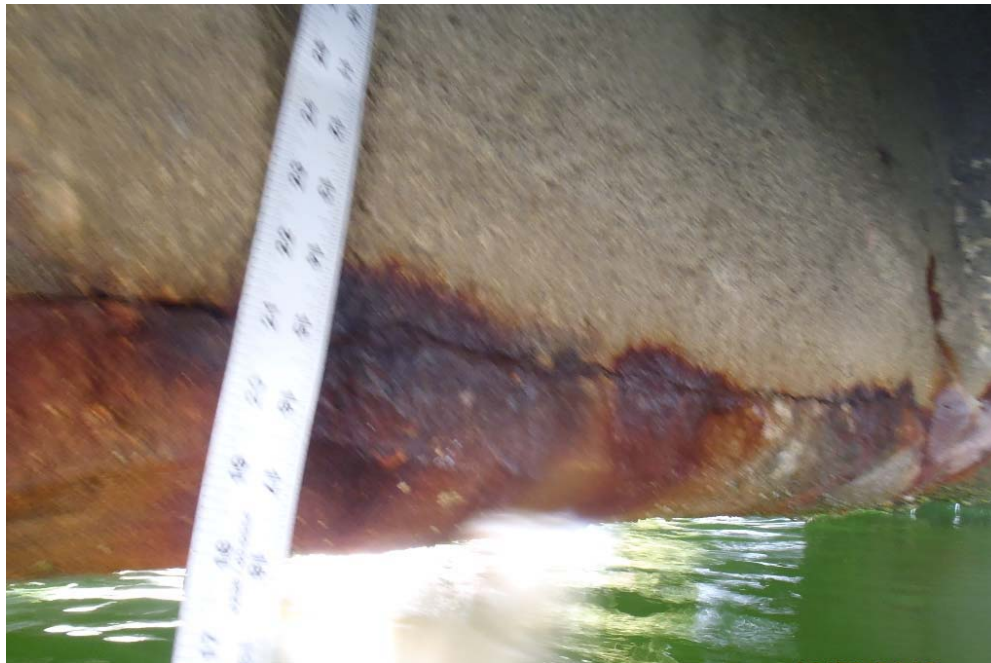
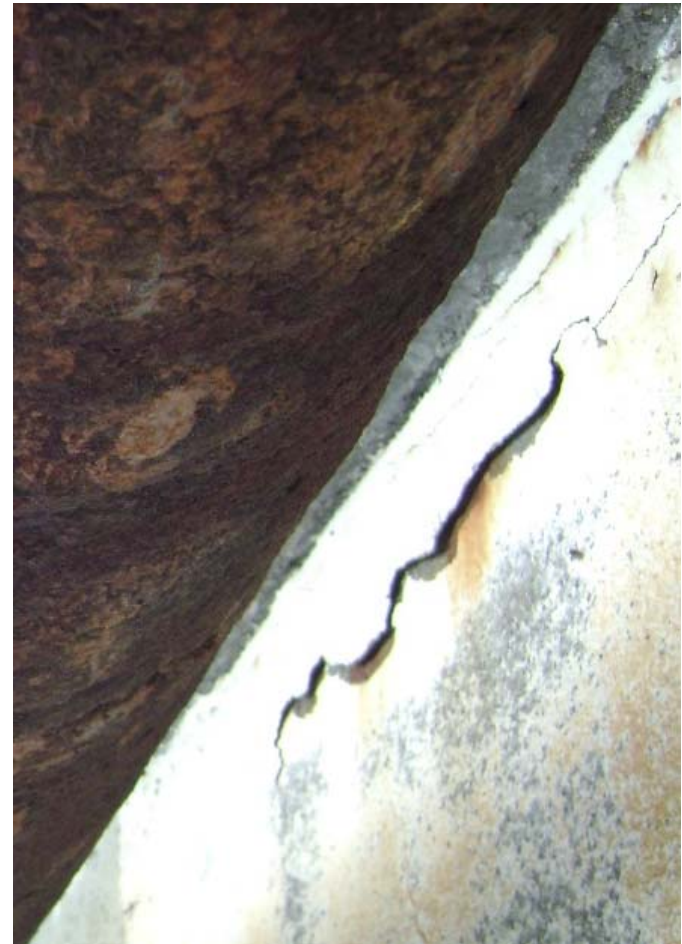
- Cracks – minor in Beams & Substructures
- Surface Corrosion- in exposed Reinforcing steel bars

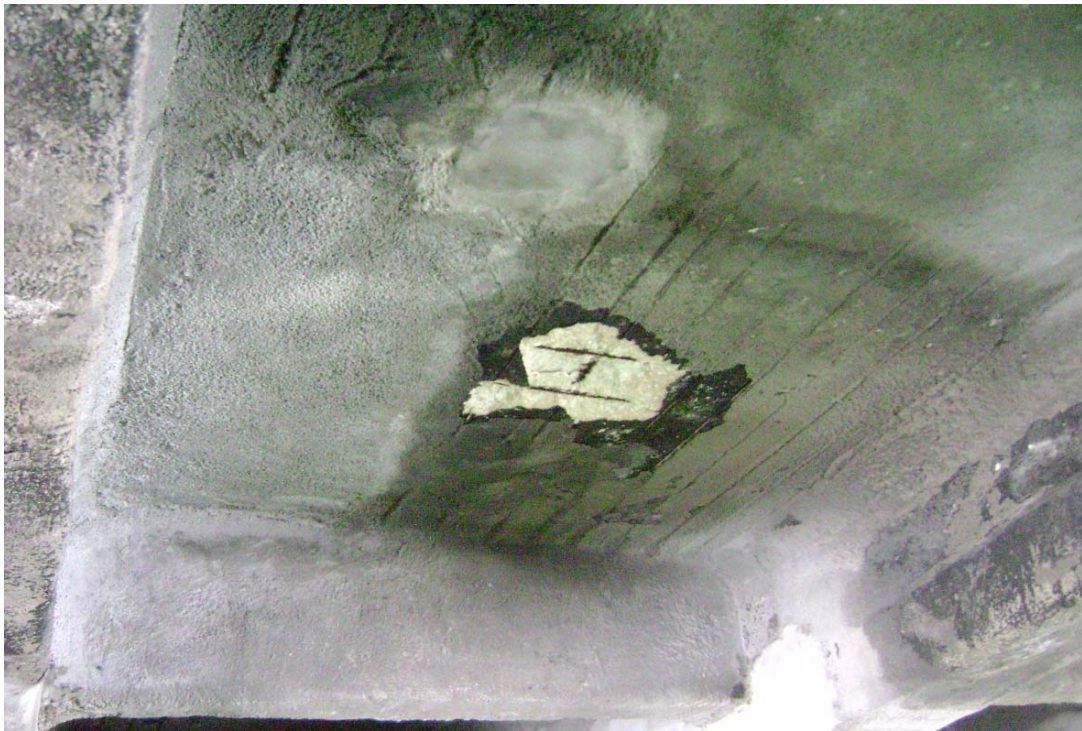
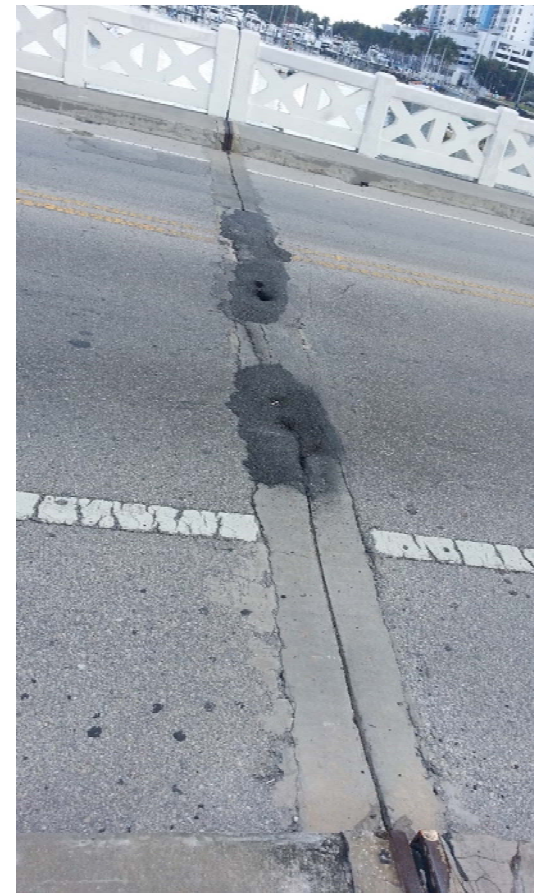
- Transverse Cracks through asphalt in structural member Joints
- Exposed reinforcing bars in slabs

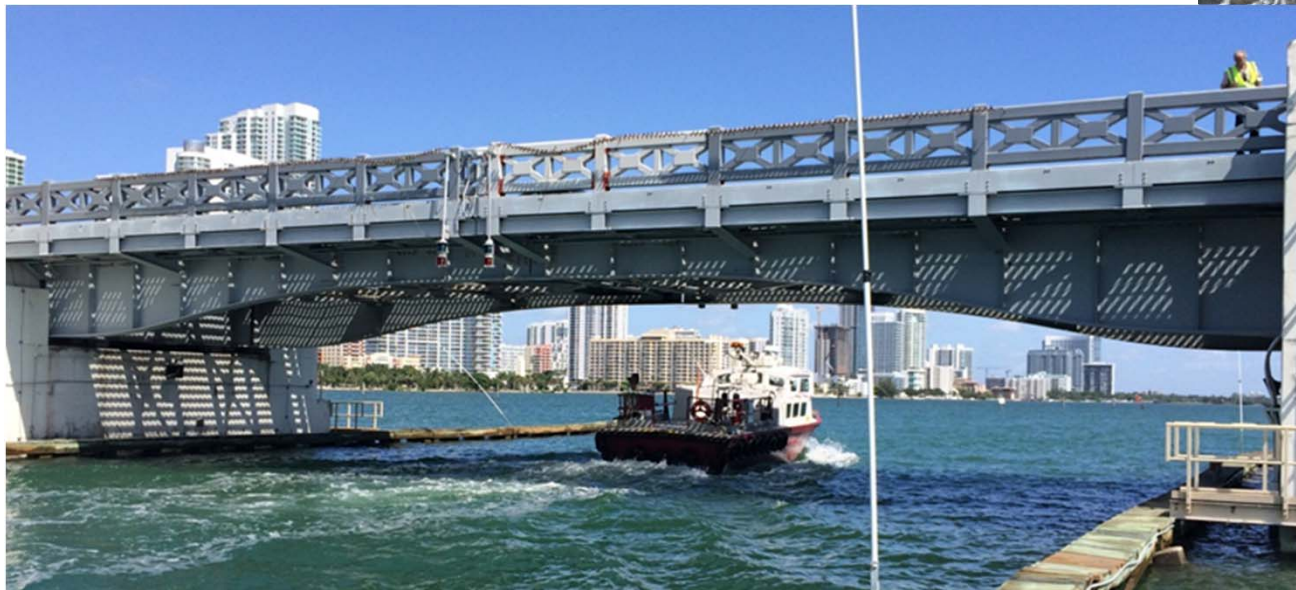
West Bascule (874459) – Main Span

- **Overall in Good Condition**
 - Bascule Span Replaced 1999
 - 12-ft Vert. Clearance at Fender
 - 16-ft Vert. Clearance at Center

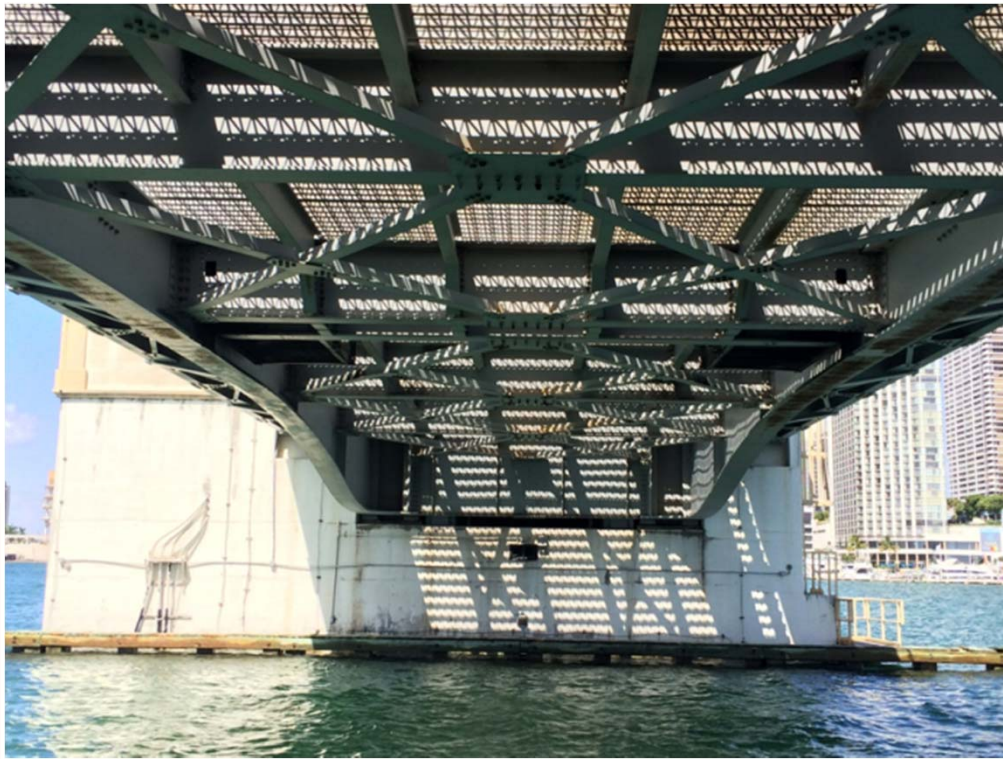
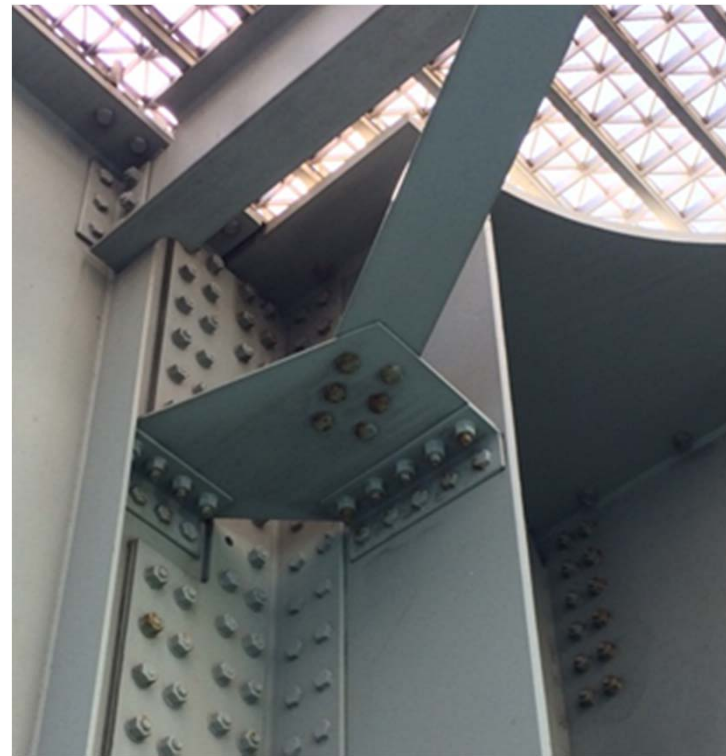
West Bascule (874459) – Main Span

- **Steel Bascule Leaf**
 - Minor Steel Corrosion
 - Protective Coatings/Paint Needs Replacement

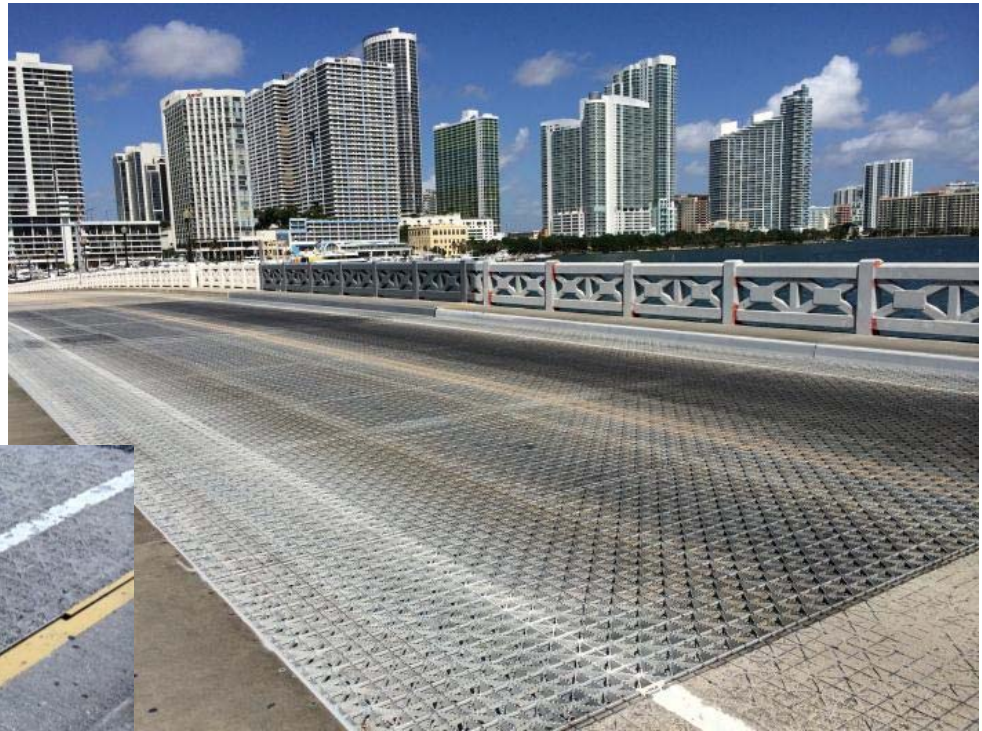
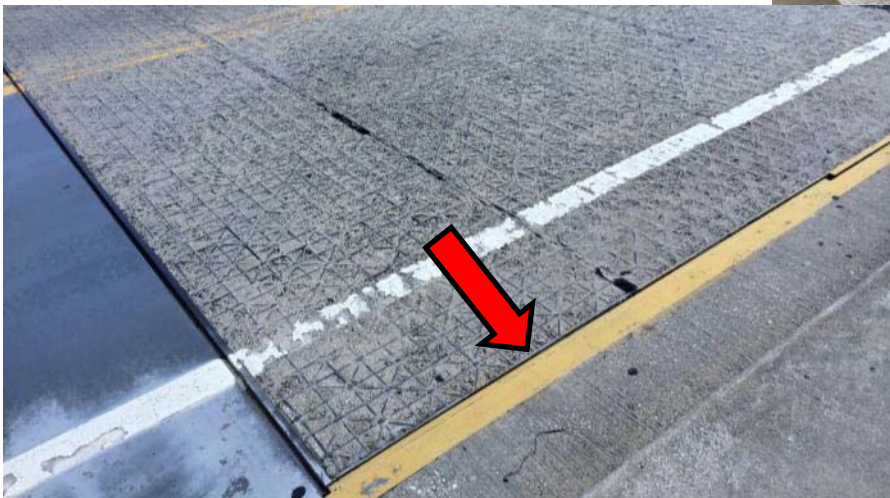
West Bascule (874459) – Main Span

- **Undesirable Roadway Features**

- Steel Open Grid Deck
 - Poor Skid Resistance
 - Not Bicycle Friendly
 - Noisy
 - Maintenance Concerns
- Deck Joints in Shoulder
 - Potential Bicycle Hazard

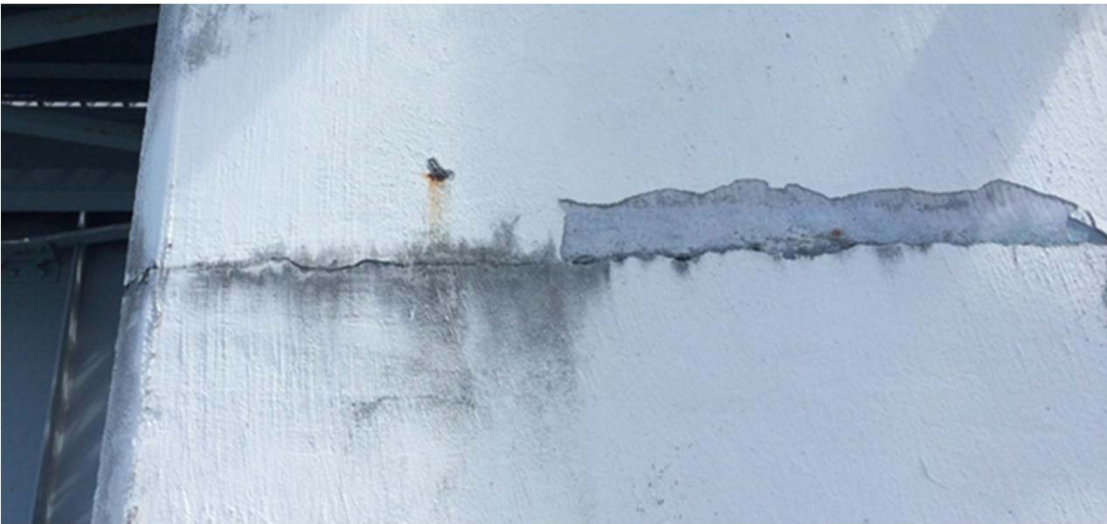
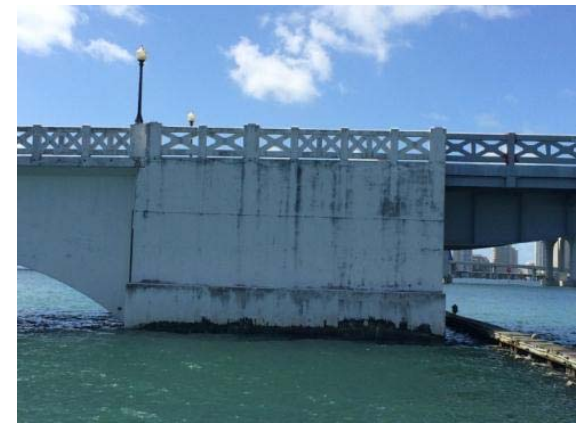
West Bascule (874459) – Main Span

- **Concrete Bascule Piers**
 - Concrete Cracking
 - Flaking Decorative Coatings
 - Openings in Pier Below 100-yr Storm Surge Elevation/Potential for Flooding

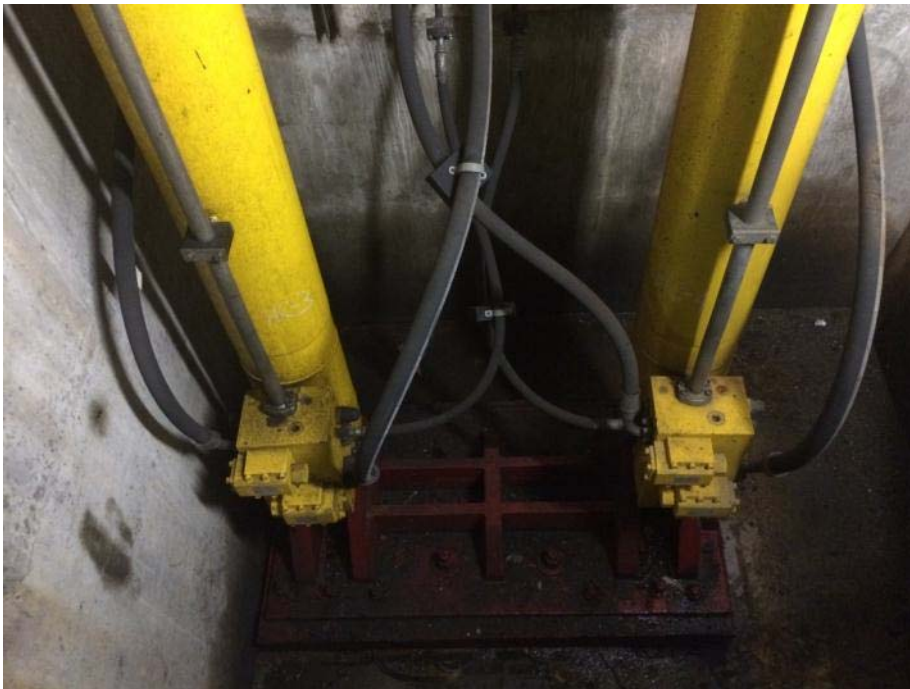
West Bascule (874459) – Main Span

- **Electrical-Mechanical**
 - Minor Conduit and Wiring Issues
 - Minor Hydraulic Fluid Leaks
 - Moderate Wear of Span Lock Shoes

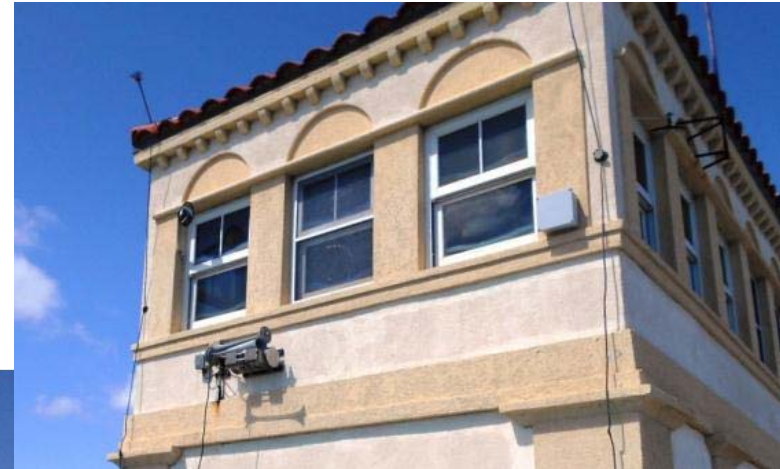
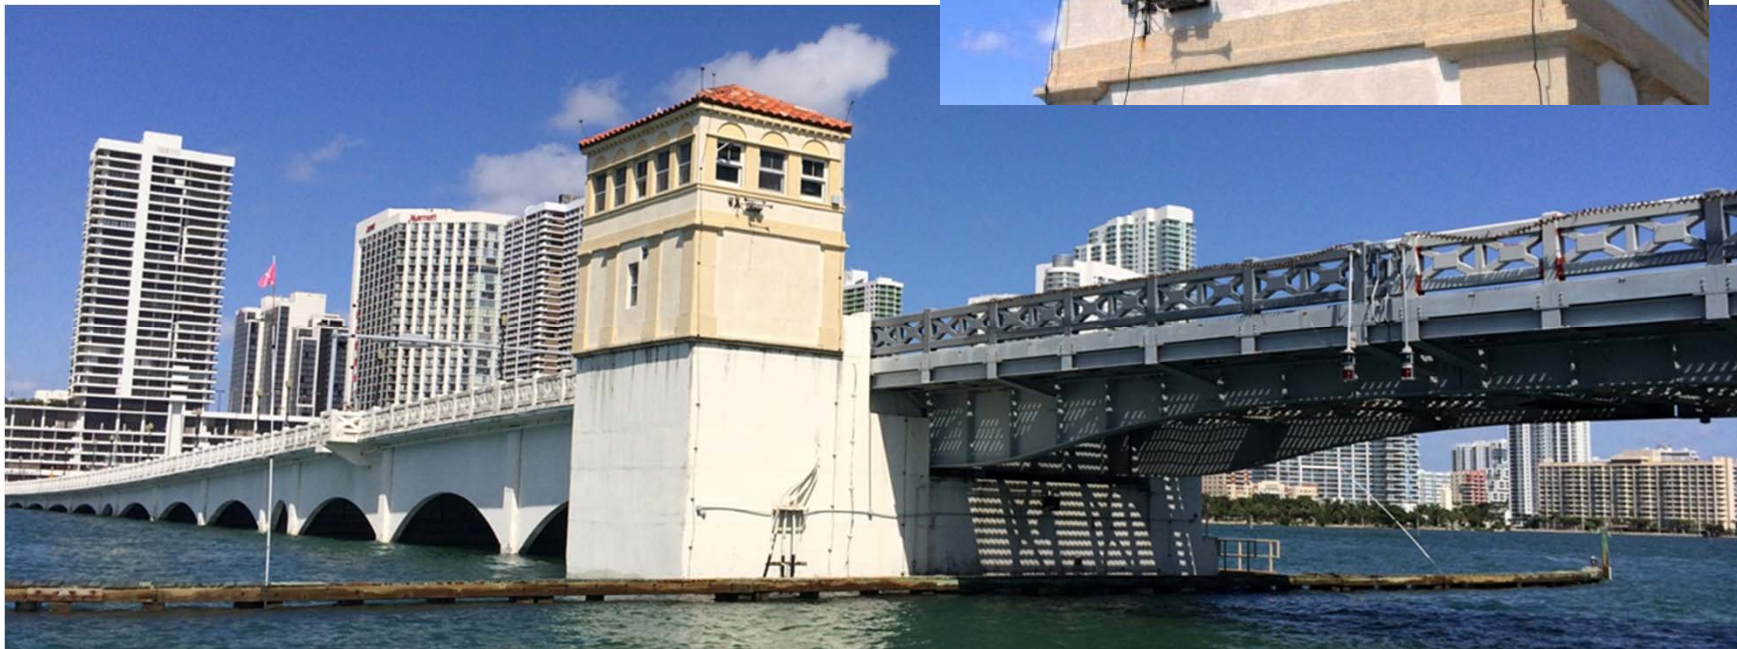
West Bascule (874459) – Main Span

- **Control House**
 - Windows Need Replacement

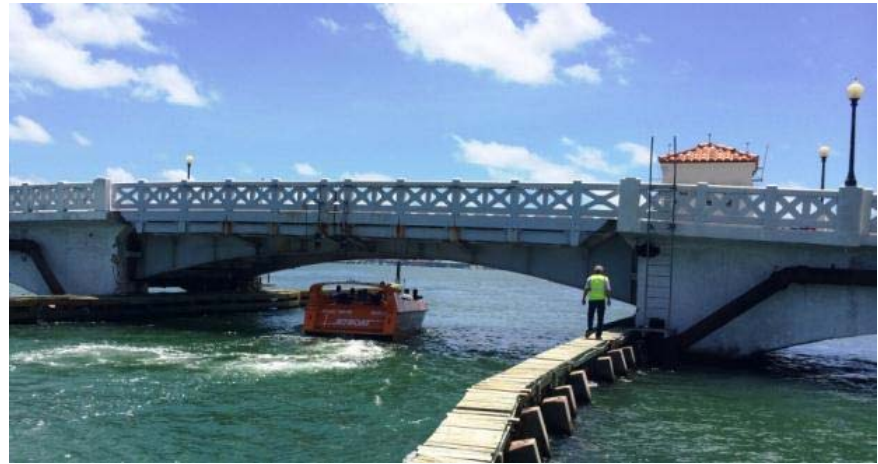
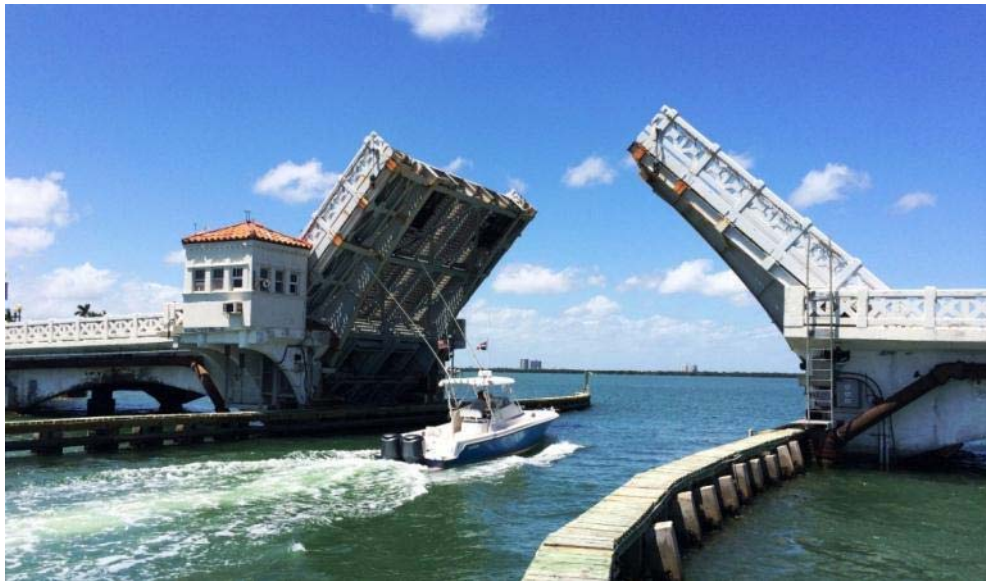
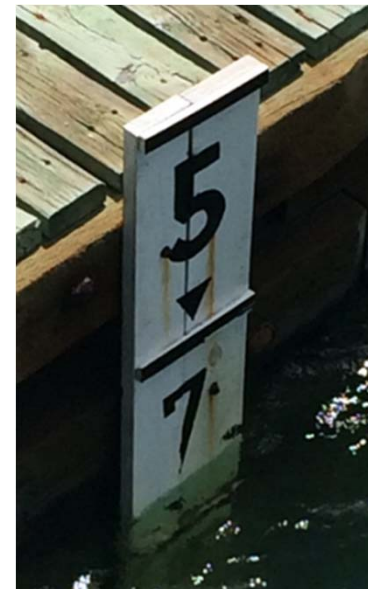
East Bascule (874474) – Main Span

- **Fair Overall Condition**
 - Bascule Leaf Replaced 1998
 - 8-ft Vert. Clearance at Fender
 - 12-ft Vert. Clearance at Center
 - Frequent Openings
 - Exposure to Splashing

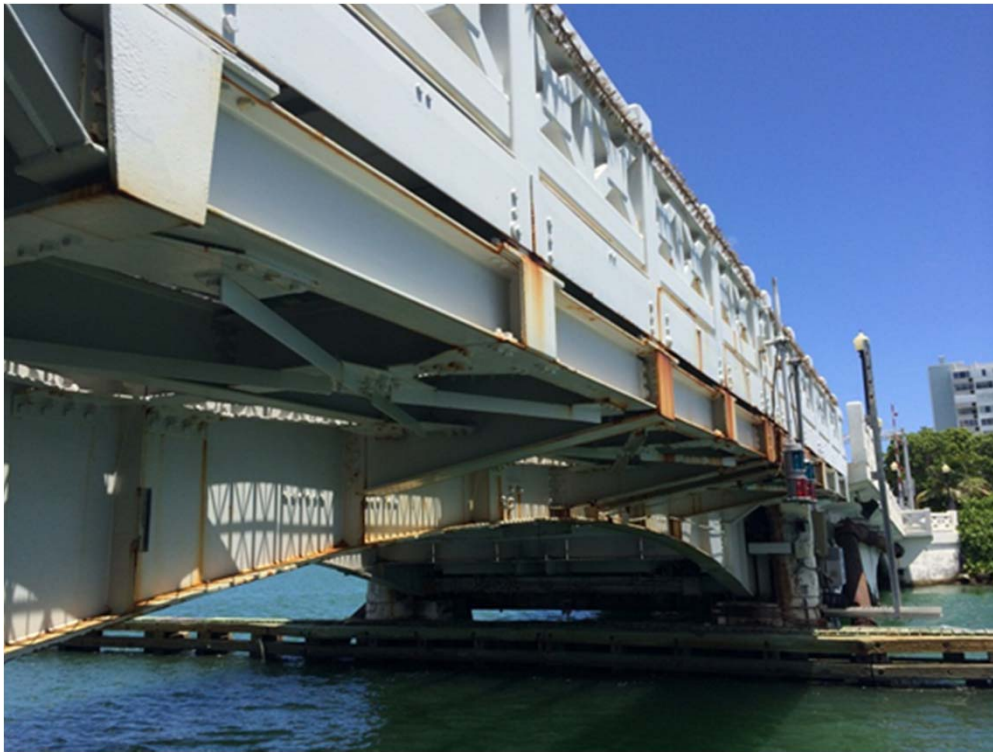
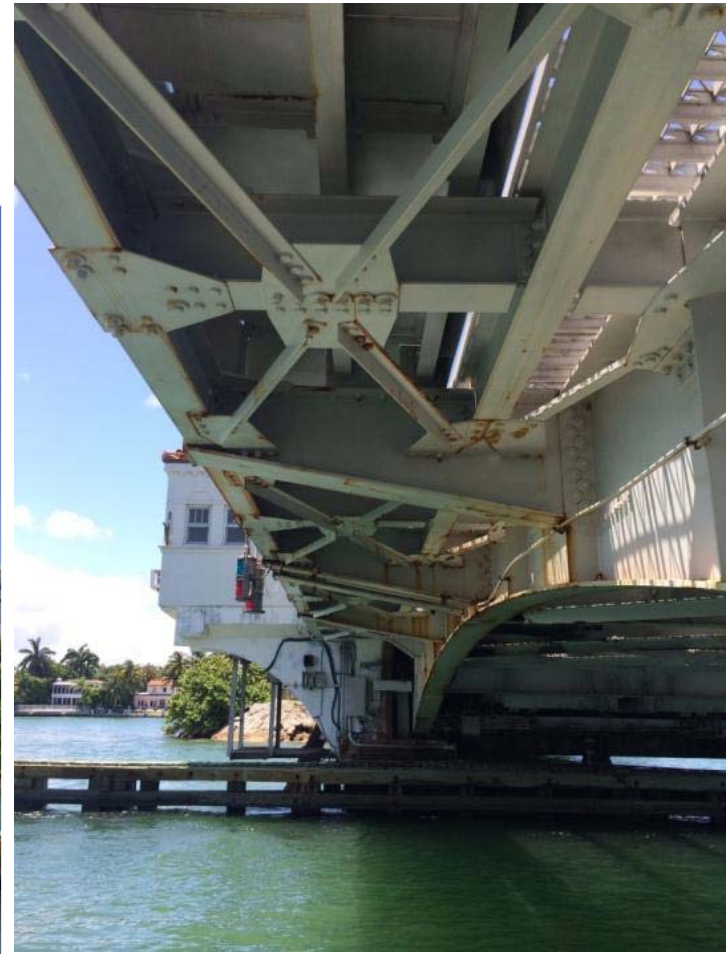
East Bascule (874474) – Main Span

- **Steel Bascule Leaf**
 - Minor Corrosive Deterioration
 - Protective Coatings/Paint System Failure (Repainted 2012)

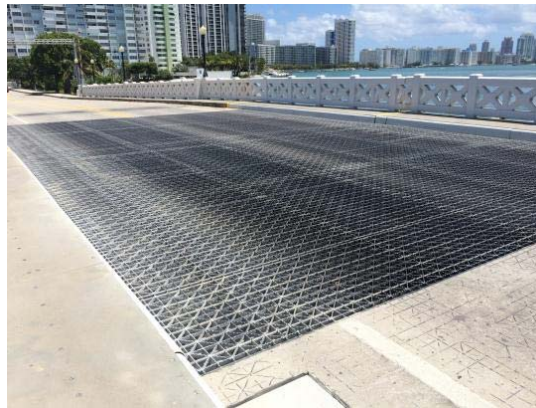
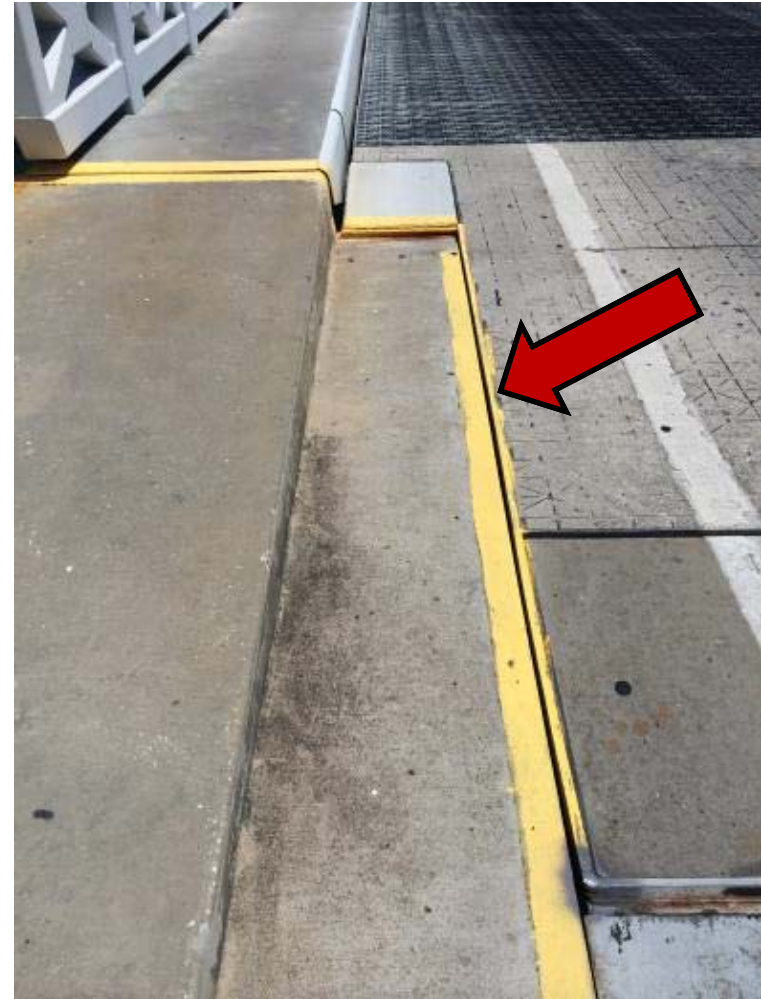
East Bascule (874474) – Main Span

- **Undesirable Roadway Features**

- Steel Open Grid Deck
 - Poor Skid Resistance
 - Not Bicycle Friendly
 - Noisy
 - Maintenance Concerns
- Deck Joints in Shoulder
 - Potential Bicycle Hazard

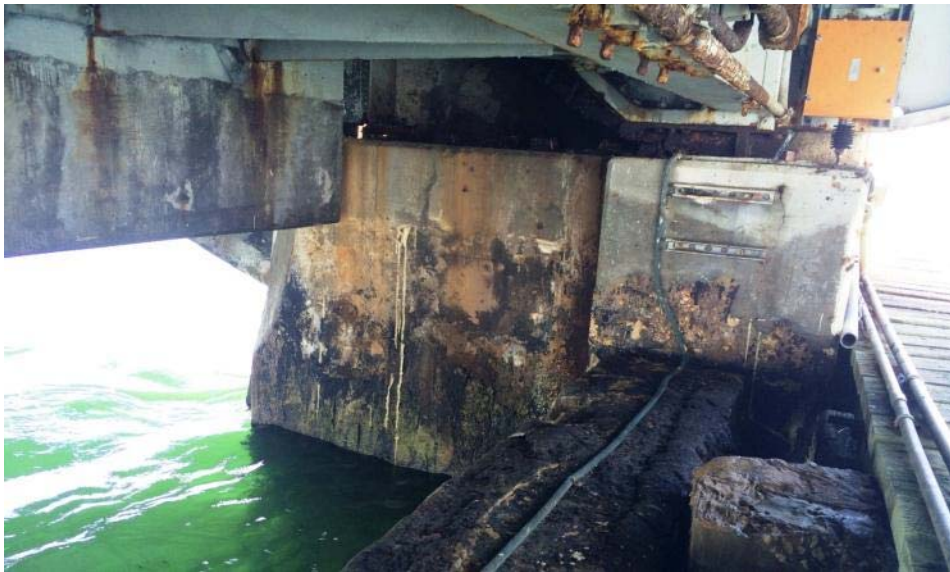
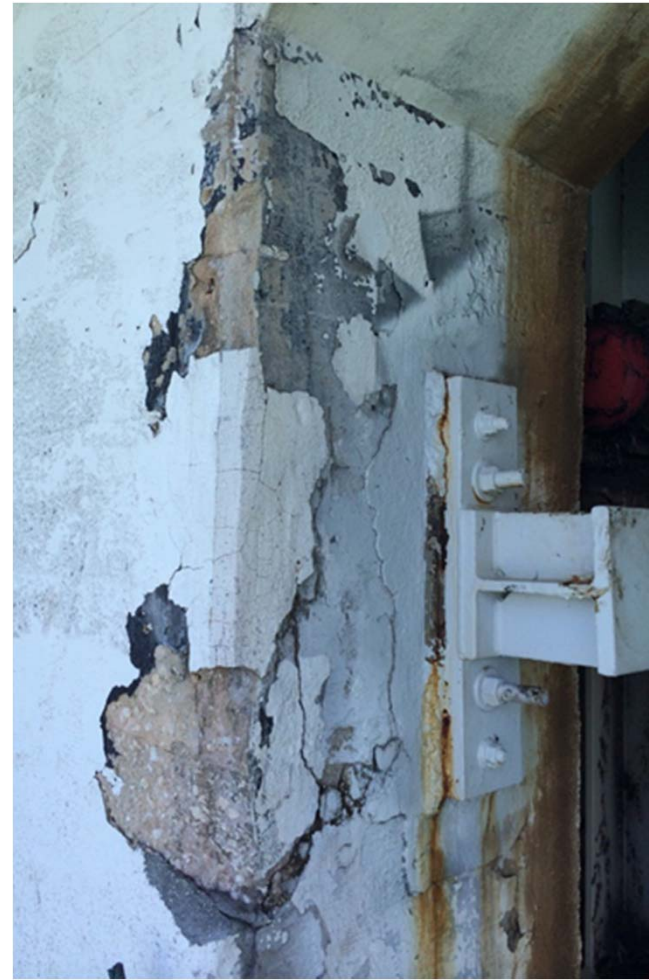
East Bascule (874474) – Main Span

- **Concrete Bascule Piers (87+ Years Old)**
 - Concrete Cracking
 - Flaking Decorative Coatings
 - Open Piers with Extreme Exposure
 - Entire Piers/Leaves Below 100-yr Storm
 - Surge Elevation/Potential for Flooding

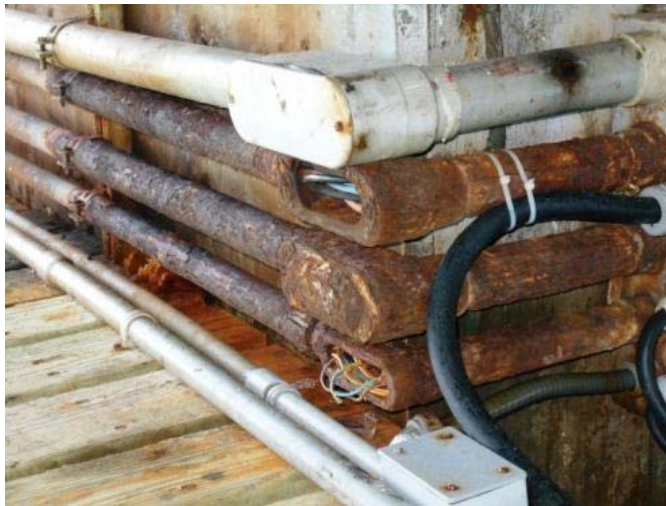
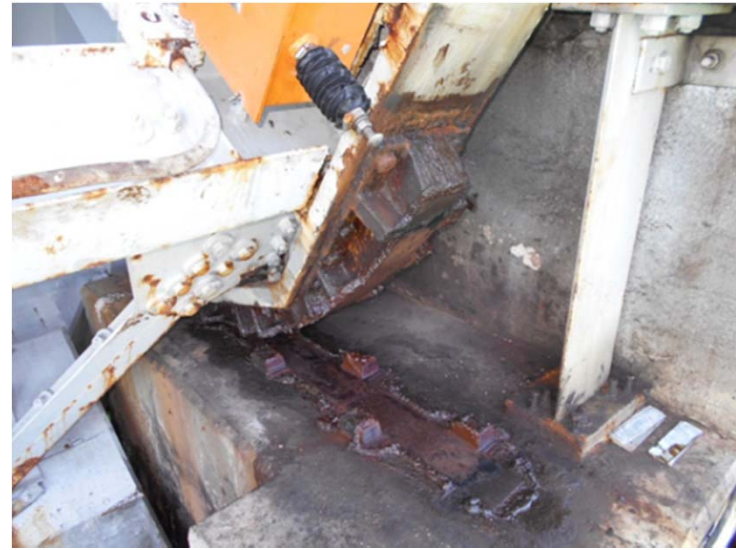
East Bascule (874474) – Main Span

- **Electrical-Mechanical (Replaced 1998)**
 - Extensive Corrosion of Electrical Conduit
 - Minor Conduit and Wiring Issues
 - Slow Operation (2 Minutes to Raise or Lower Span)
 - Poor Machinery Alignment
 - Moderate Wear of Rolling Tracks and Treads
 - Moderate Wear of Span Lock Shoes

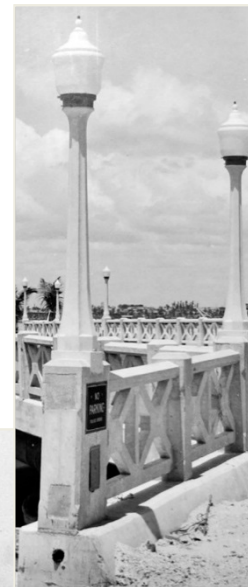
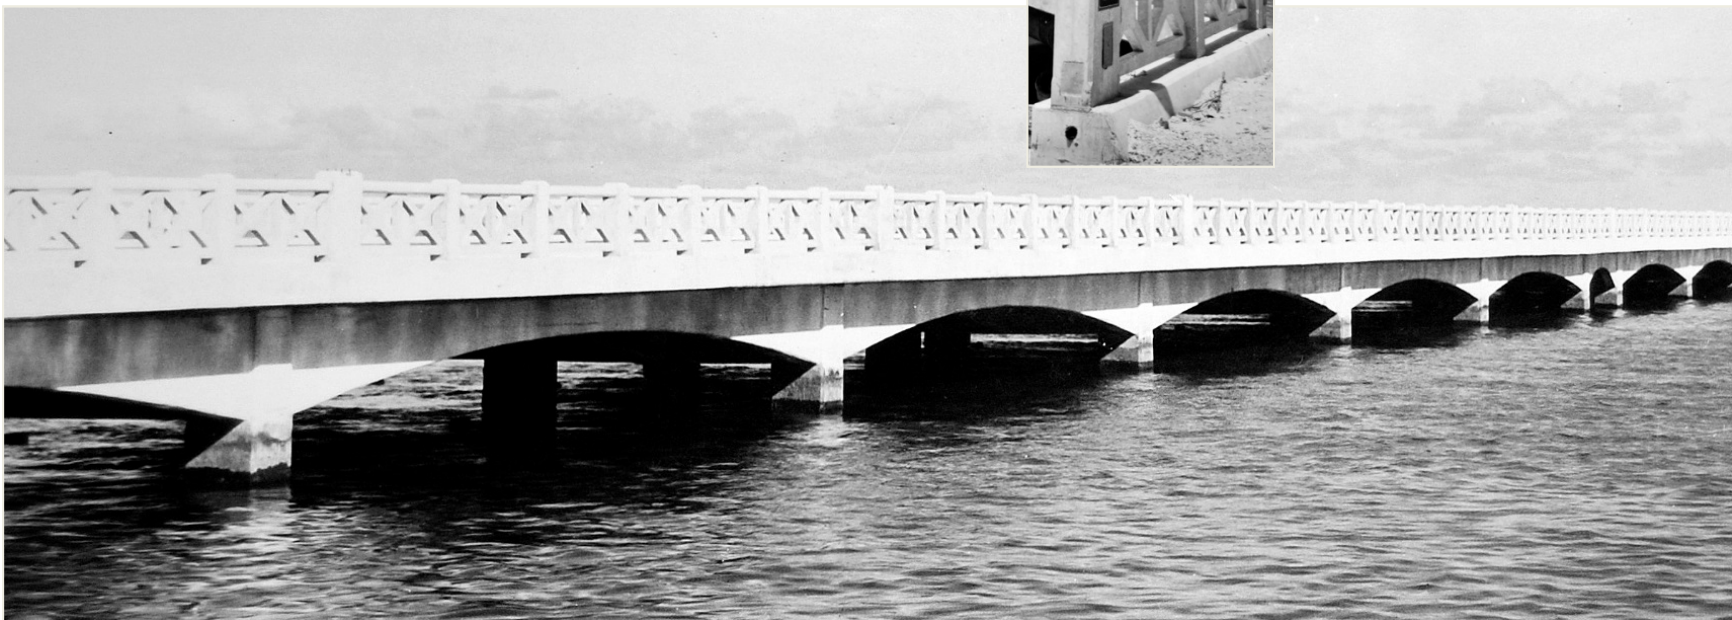
Maintain the historic character

- Bridge railings
- Light poles
- Arched form of the concrete superstructure

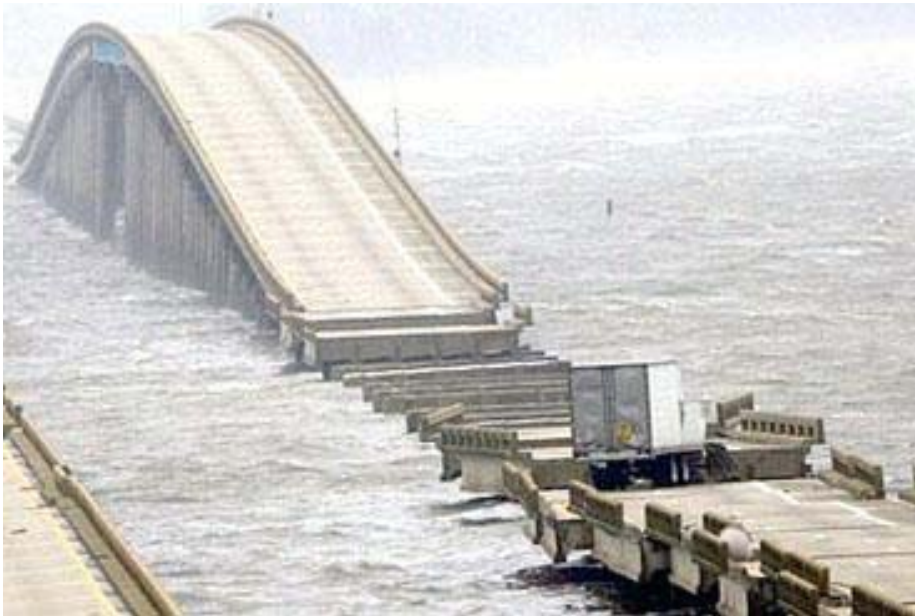
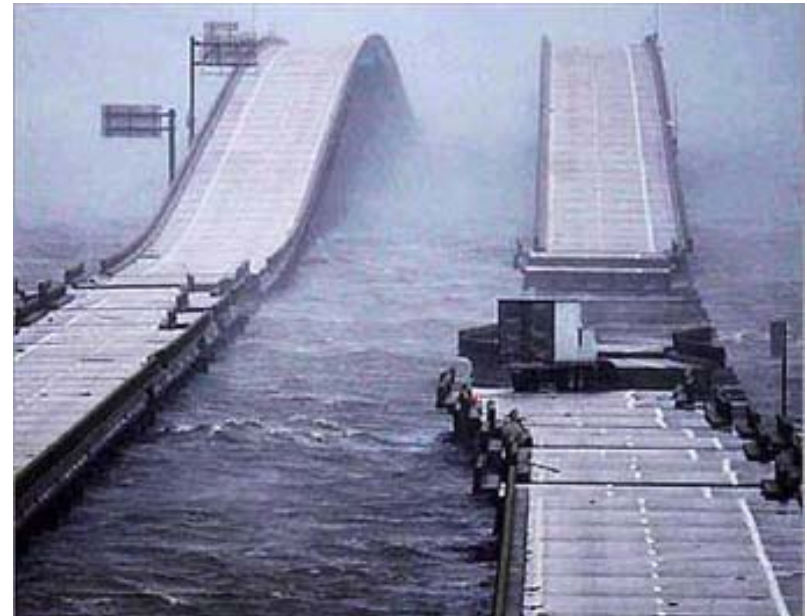
I-10 Escambia Bay, FL. - Hurricane Ivan - 2005

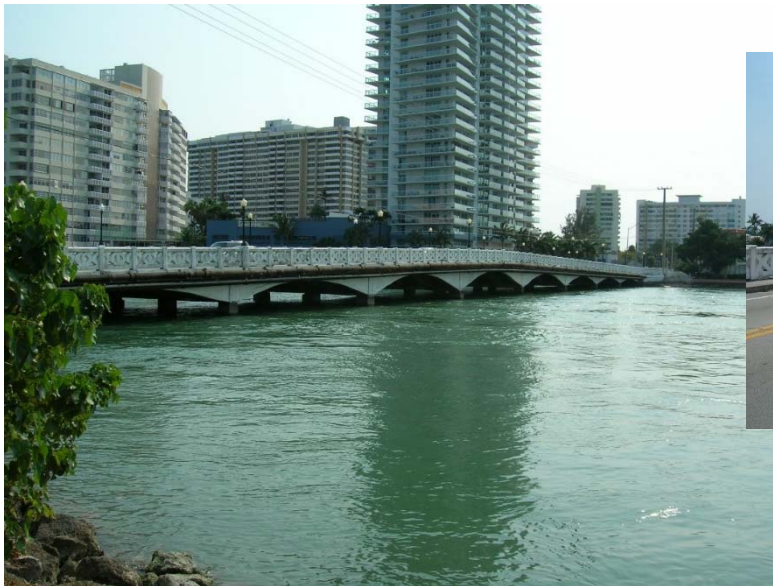
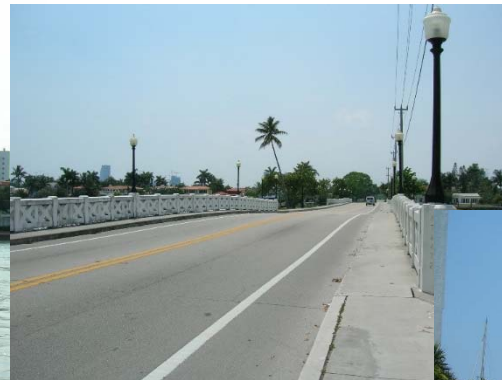
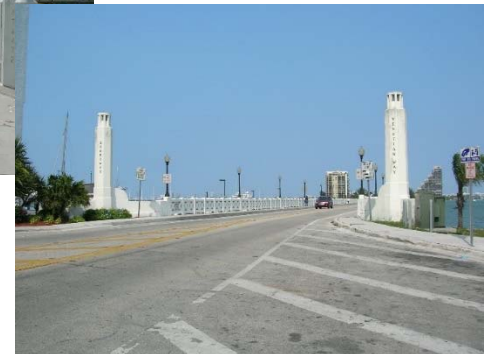
- Listed in the National Register of Historic Places and locally listed by the Cities of Miami and Miami Beach
- Notable structural features include the arched beams, geometrically designed guardrails and octagonal concrete entrance towers - additional significant features will be determined as part of CRAS
- Twelve bridges containing two bascule spans connected by a two lane road
- Extends cross six islands of which the four central islands were created from material dredged from the bay bottom for a residential development
