# CULTURAL RESOURCE ASSESSMENT SURVEY

I-95/State Road (SR) 9 Project Development and Environment (PD&E) Study  
From South of SR 860/Miami Gardens Drive to North of Broward County Line  
Miami-Dade County, Florida

Financial Management Number: 414964-1-22-01  
Federal Aid Project Number: N/A  
Efficient Transportation Decision Making (ETDM): 14419

## **Cultural Resources Assessment Survey**

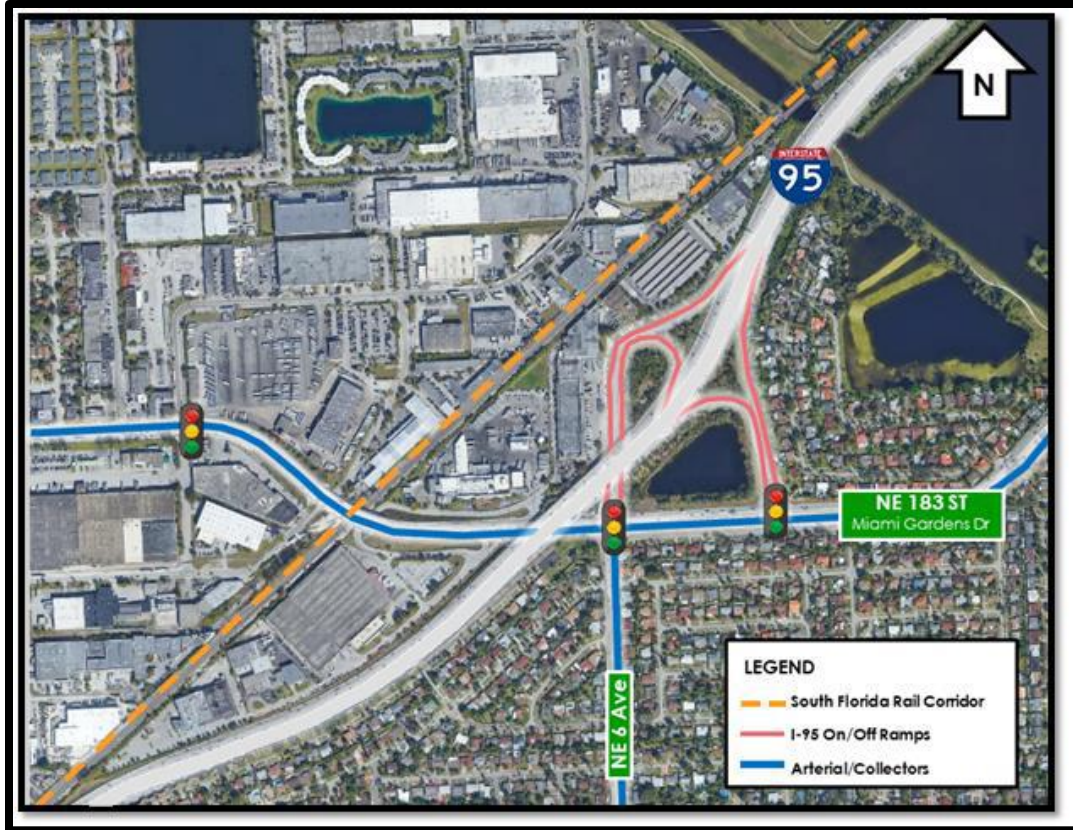
Figure 2 - 2: Interchange at SR 860/Miami Gardens Drive

The eastern on- and off-ramps form a signalized Turbo (T)-intersection with Miami Gardens Drive; eastbound traffic going to I-95 northbound has a dual left turn lane condition. SR 915/NE 6<sup>th</sup> Avenue forms a signalized intersection with the western on- and off-ramps. Miami Gardens Drive generally consists of three lanes in each direction from the I-95 overpass bridge, west to the end of the project limits at the signalized intersection with NE 2<sup>nd</sup> Avenue. A bridge carries Miami Gardens Drive over the SFRC, which is located parallel to and to the west of I-95.

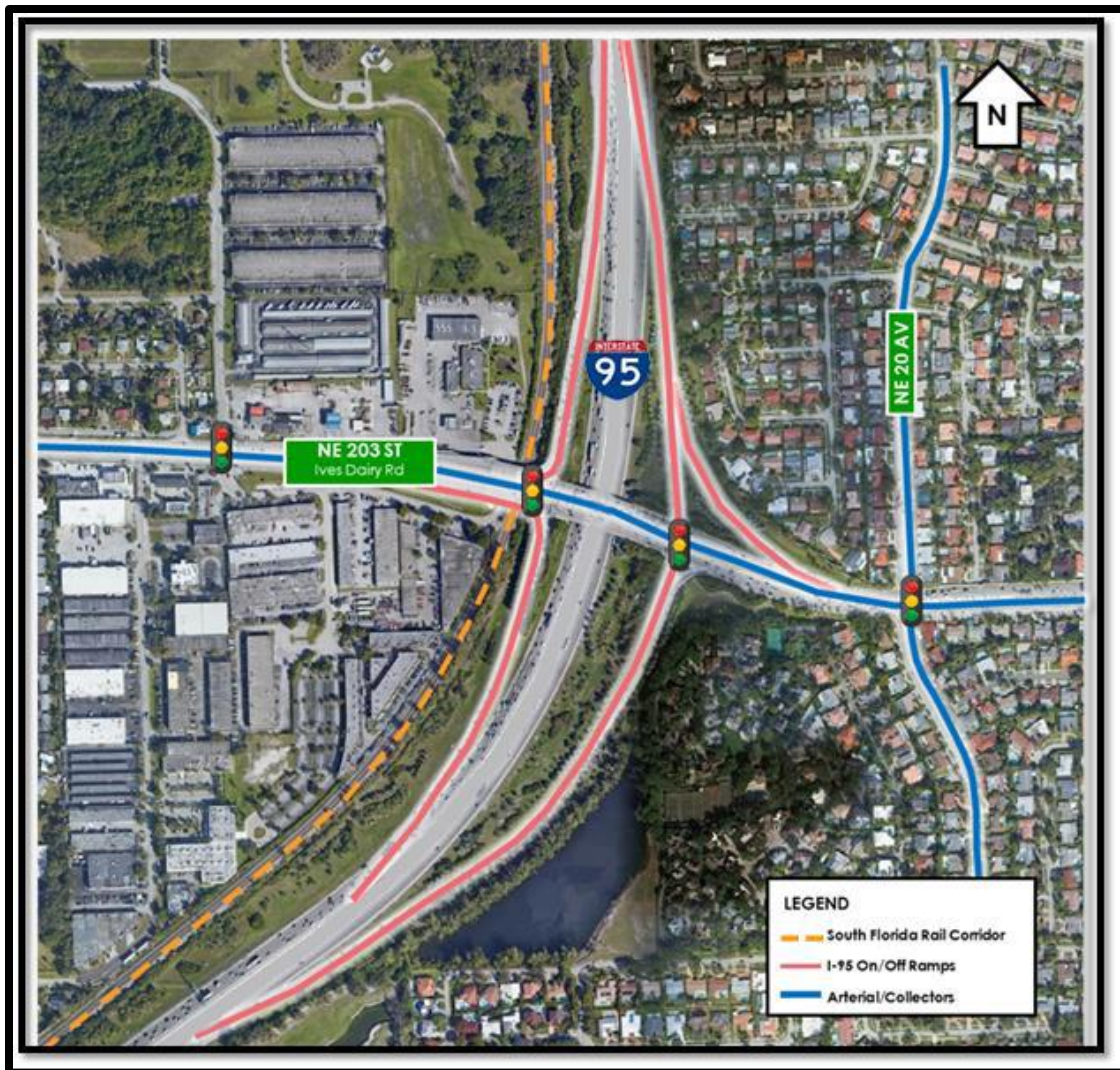
**CR 854/Ives Dairy Road** – The interchange at Ives Dairy Road has a diamond configuration with the southbound on- and off-ramps tightly located close to the mainline as depicted in **Figure 2-4**. Ives Dairy Road is under Miami-Dade County ROW jurisdiction. There are two signalized ramp terminal intersections which serve the on- and off-ramp traffic on both sides of the interchange. From the ramp terminal intersections, signal spacing to the east is approximately 900 feet and to the west is 1,200 feet. Similar to the interchange at Miami Gardens Drive, the SFRC is located just west of the I-95 segment.

**Figure 2 - 4: Interchange of CR 854/Ives Dairy Road**

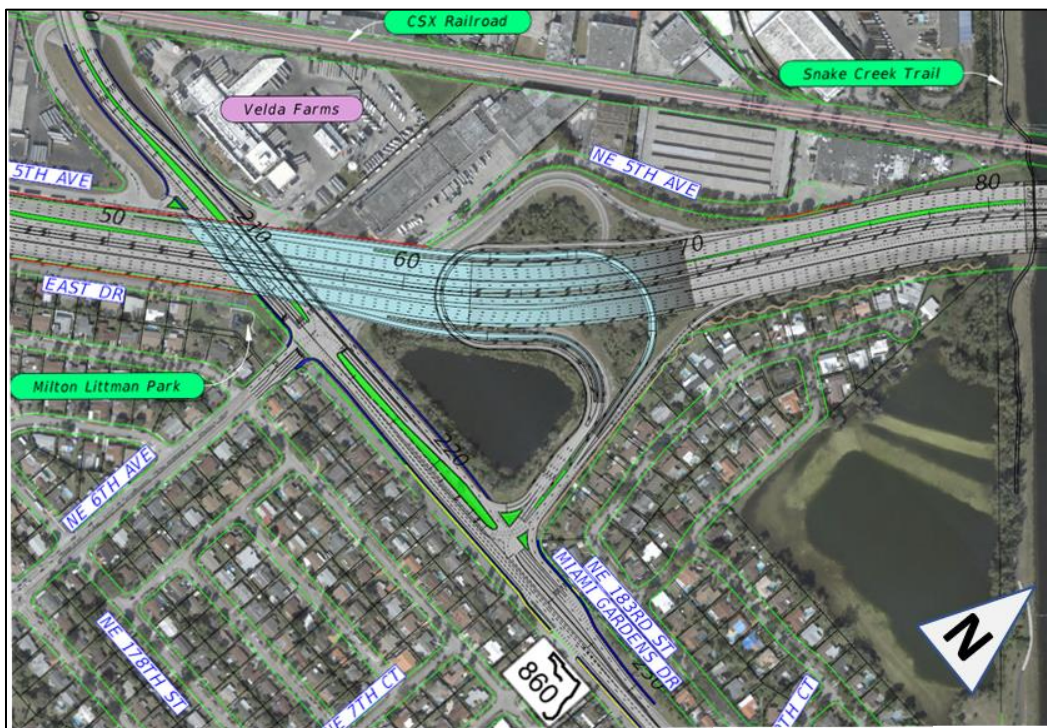
**Figure 3 - 2: Proposed Configuration - Alternative 1 – SR 860/Miami Gardens Drive**

**SR 860/Miami Gardens Drive** - The proposed improvements at Miami Gardens Drive (**Figure 3-2**) consist of consolidating the ramp terminal to one location for both northbound and southbound on- and off-ramps. This single ramp terminal intersection would be located at the existing ramp terminal intersection on the east side of the I-95 corridor with an expanded T-intersection. The existing signalization conditions will remain in place. The eastbound dual left turn lanes are proposed to remain at-grade similar to existing conditions. Bicycle lanes and sidewalks are provided, fulfilling the project's Purpose and Need to enhance multi-modal transportation options and access to transit within the project area. **Figure 3-3** depicts the proposed Miami Gardens Drive typical section for Alternative 1.

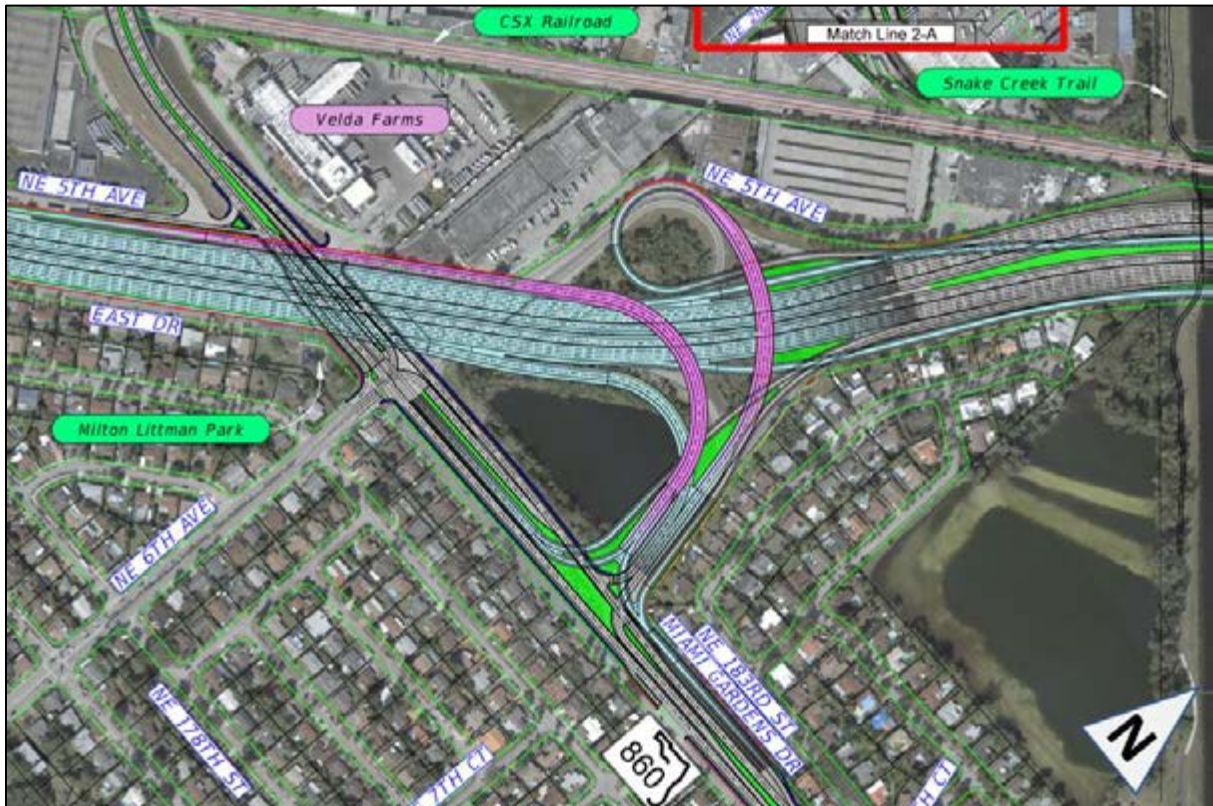
**SR 860/Miami Gardens Drive** - The proposed improvements at Miami Gardens Drive consist of a grade-separated on-ramp as depicted in **Figure 3-7**. This configuration will allow for traffic to free flow onto the mainline, as opposed to Alternative 1, which provides at-grade traffic signal control. **Figure 3-8** depicts a rendering of the proposed Miami Gardens Drive typical section for Alternative 2.

**Figure 3 - 7: Proposed Configuration - Alternative 2 – SR 860/Miami Gardens Drive**

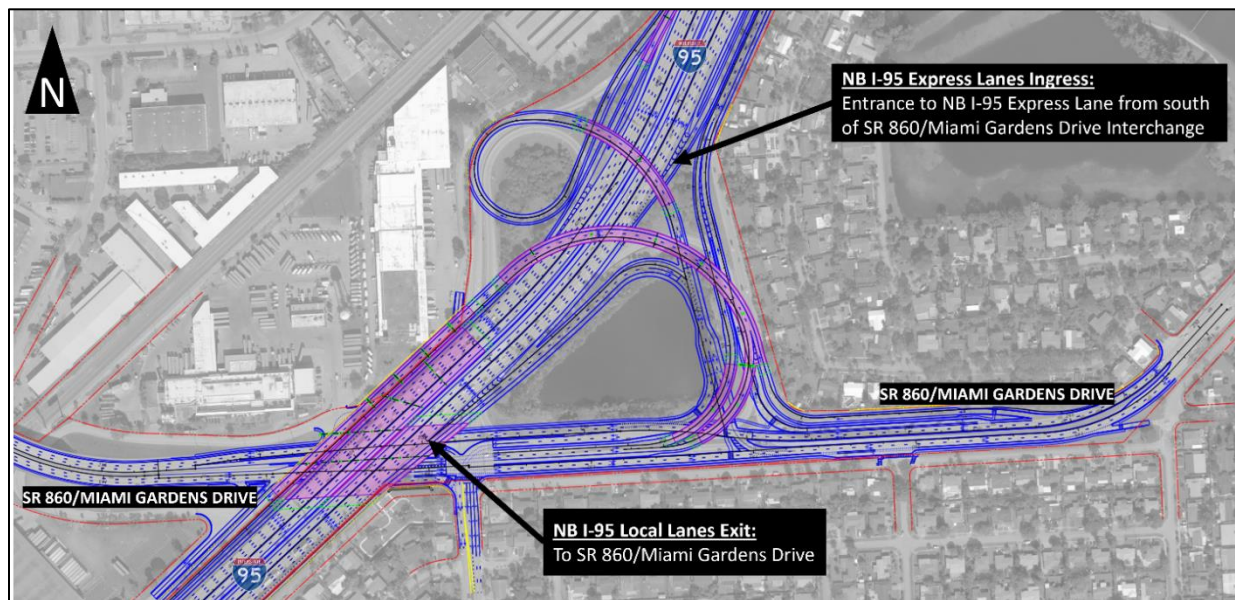
**SR 860/Miami Gardens Drive** – The same as in Alternative 2, the proposed improvements at Miami Gardens Drive consist of a grade-separated on-ramp as depicted in **Figure 3-12**. This configuration will allow for traffic to free flow onto the mainline. **Figure 3-13** depicts a rendering of the proposed Miami Gardens Drive typical section for the Alternative 3. In addition, the northbound and southbound off-ramps will connect at a signalized intersection in advance of the end of the ramp at Miami Gardens Drive. The purpose for this new signal-controlled intersection is to eliminate the weaving friction on the ramp segment between the two intersections.

**Figure 3 - 12: Proposed Configuration - Alternative 3 – SR 860/Miami Gardens Drive**

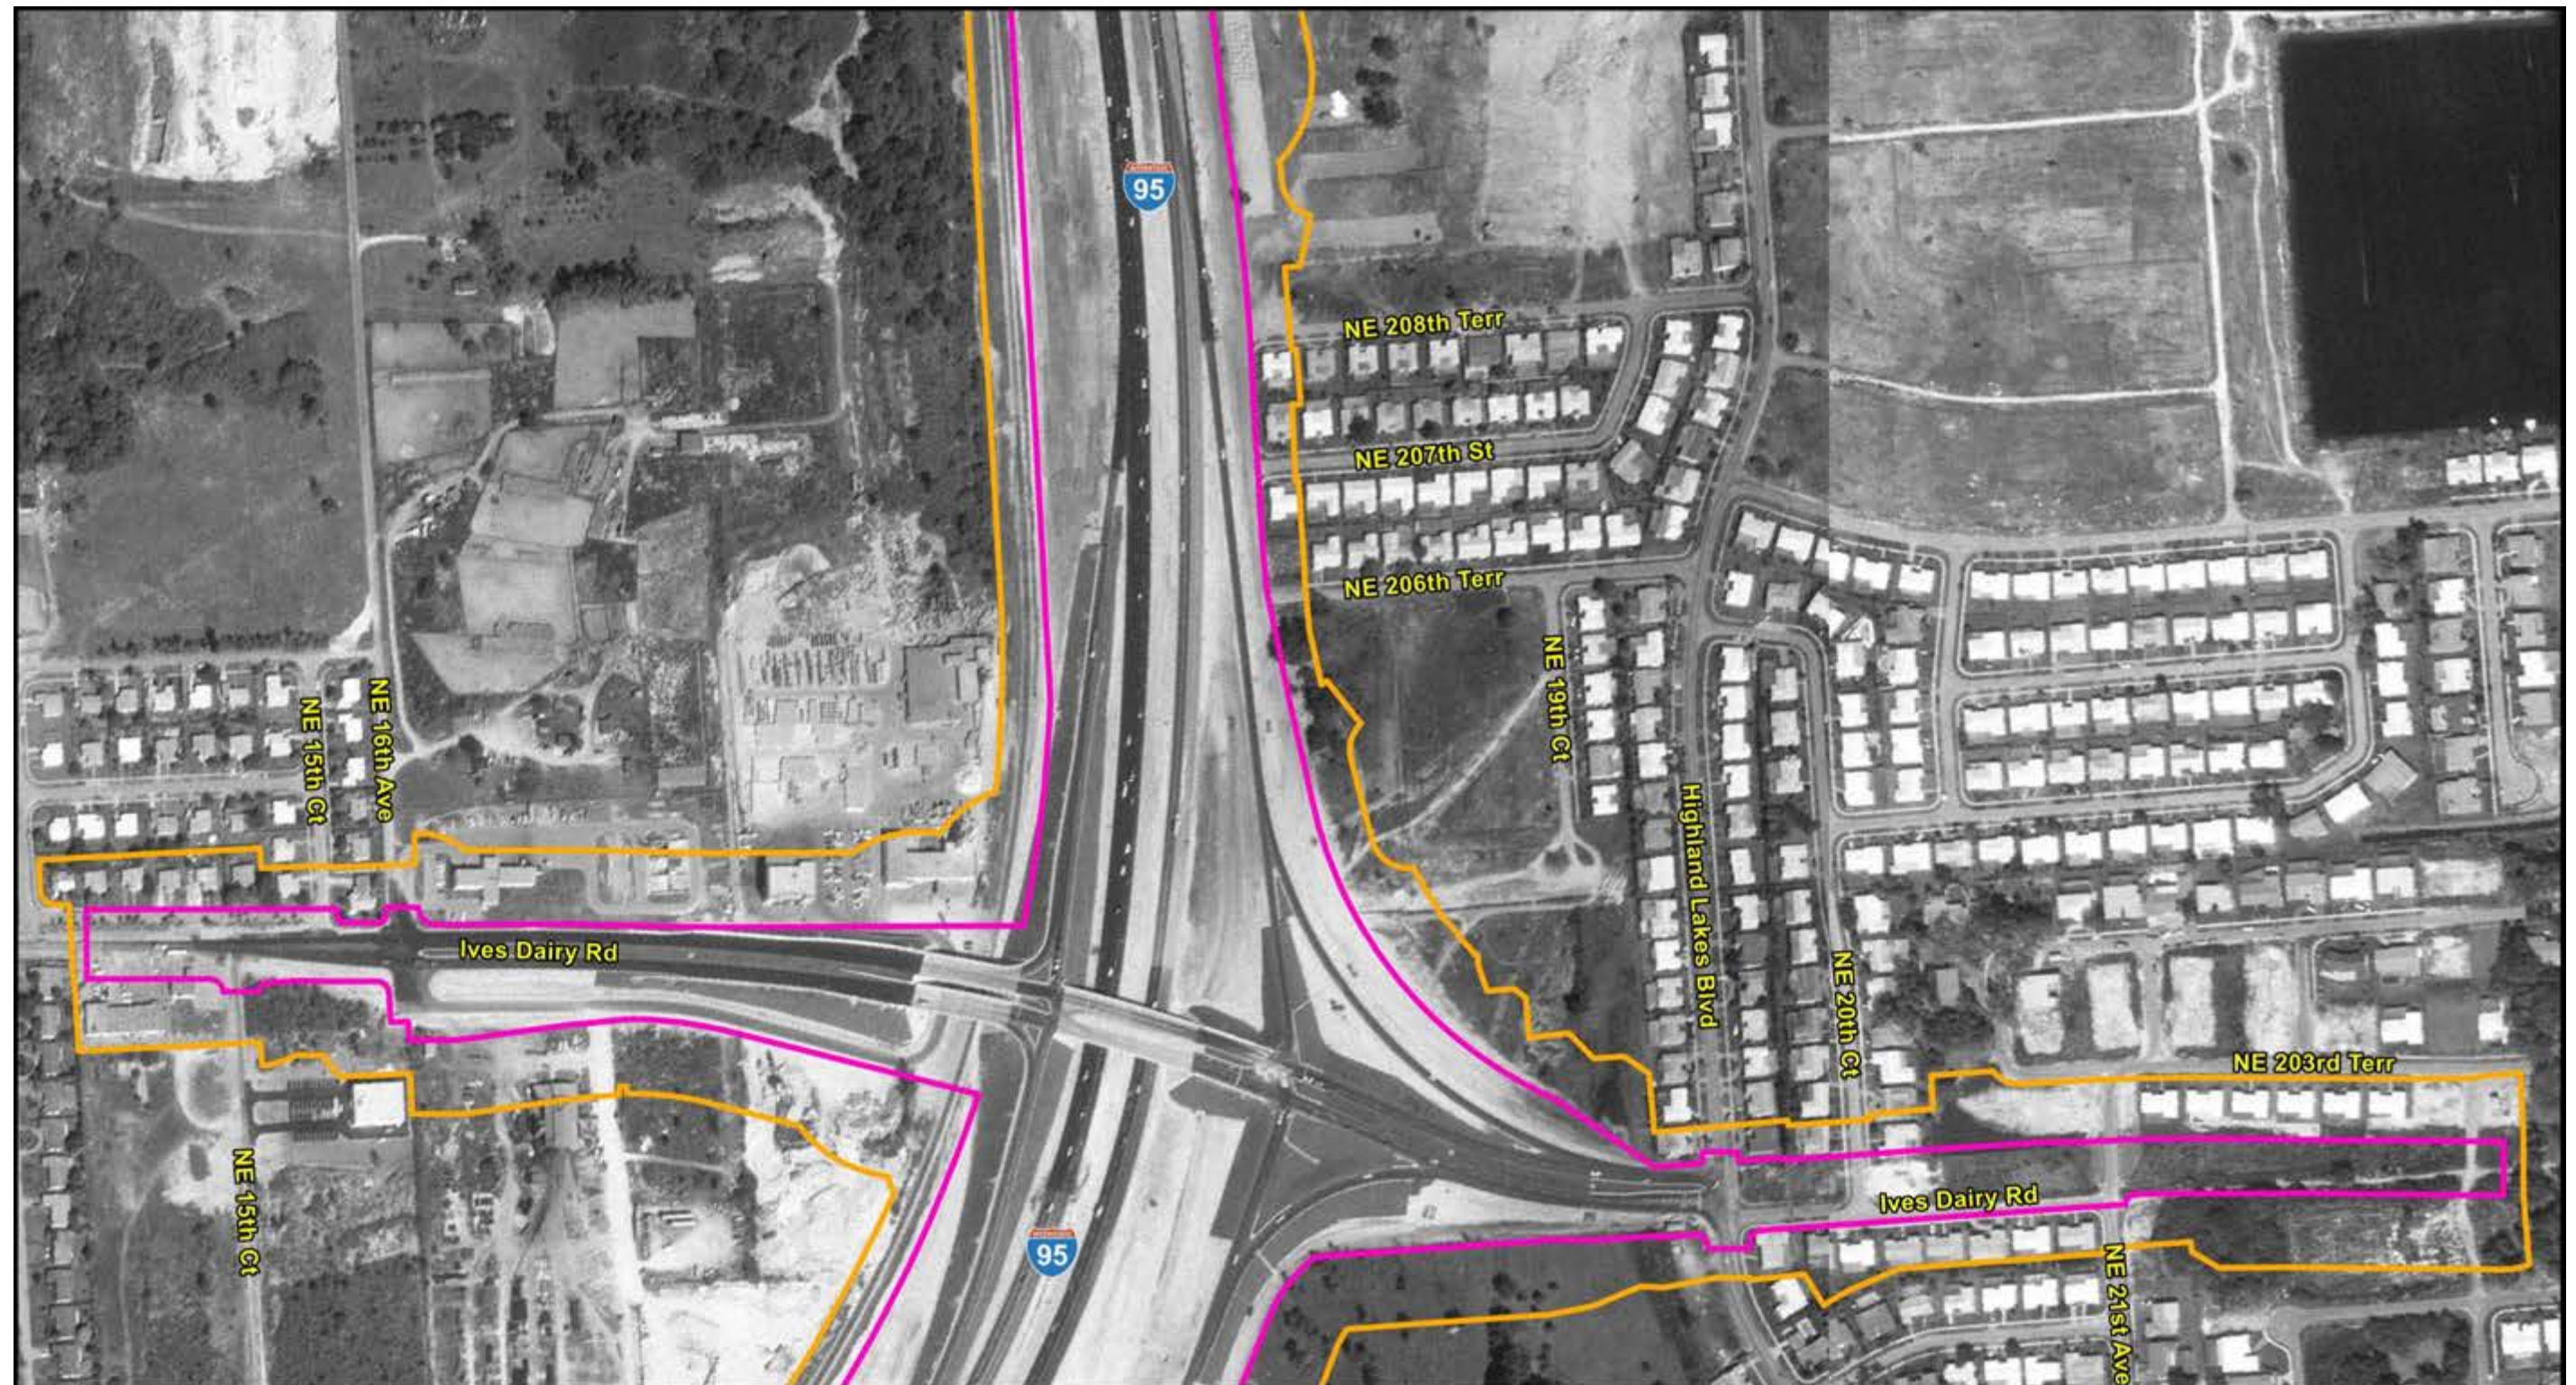
**Figure 5 - 4f: Project APEs on 1971 Historic Aerials (Map 5 of 7)**

By the 1971 aerials (**Figures 5-4a through 5-4-h**), the project area was densely developed, nearly to the same degree as the modern-day project corridor. The northern end of I-95 was not yet as wide as today's highway. By this aerial, the remaining historic subdivisions can be seen in **Figure 5-4f**, some of which were still under construction. The 1971 aerials also show the Riviera Condo Apartments, the Rolling Green Condominiums, the Diplomat Presidential Golf Course (**Figure 5-4d**) the FDOT North Dade Maintenance Yard (**Figure 5-4f**), and the Rolen Lake Gardens apartment complex (**Figure 5-4g**). Some redevelopment has occurred over the past fifty years, but the density of development has remained.

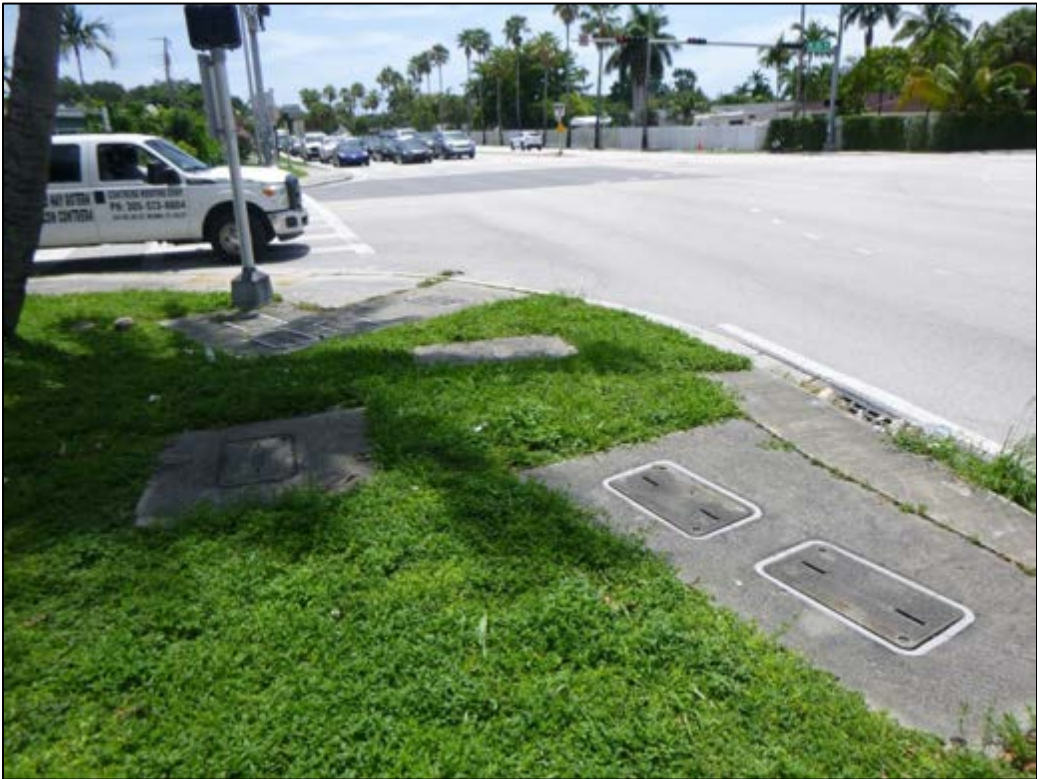
Most of the archaeological APE was considered to have low archaeological site potential based on the results of previous survey work in the area, past environmental conditions, or the extent of previous disturbance that resulted from interstate construction, surrounding development, and utility and drainage system installation. One area along Ives Dairy Road that was considered to have slightly higher archaeological site potential due to its former location on the Big Snake Creek bank could not be tested due to the extent of hardscape and underground utilities in the area (Figure 11-1).

**Figure 11 – 1: NE 203<sup>rd</sup> Street and NE 20<sup>th</sup> Avenue Hardscape and Buried Utilities within the Archaeological APE, Facing Southeast**

The pedestrian survey did not identify any areas within the archaeological APE where subsurface testing could be conducted. The existing conditions within the project APE are illustrated on aerial maps in **Appendix B** and representative photographs of the APE are included in **Figures 11-1** through **11-8**.

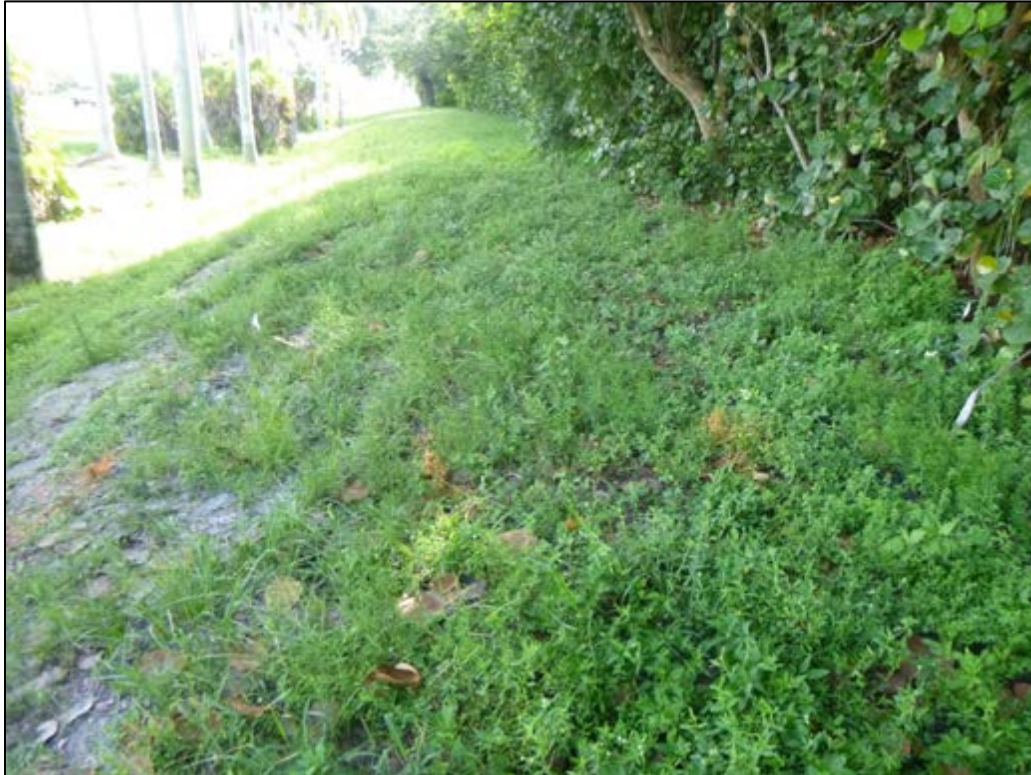
The area considered to have the highest potential for undiscovered archaeological sites is adjacent to the former Presidential Golf Course (**Figures 11-2** and **11-3**). Historic aerial images suggest that this area west of a designated archaeological zone had hammock vegetation prior to development and was located on a former creek bank. Furthermore, adjacent native vegetation includes native hammock species such as live oak and gumbo limbo. However, the current conditions in the APE include a steep slope down to a drainage ditch, an existing fence between the ROW and the former golf course, and fiber optic cable lines. Due to the presence of the underground utilities and other obstructions, no subsurface testing was possible.

**Figure 11 – 2: Fiber Optic Cable Marked Between the Seagrape Barrier and Manicured Palm Trees on the Eastern Limited Access ROW of I-95 in the Moderate Probability Zone of the Archaeological APE, Facing North**

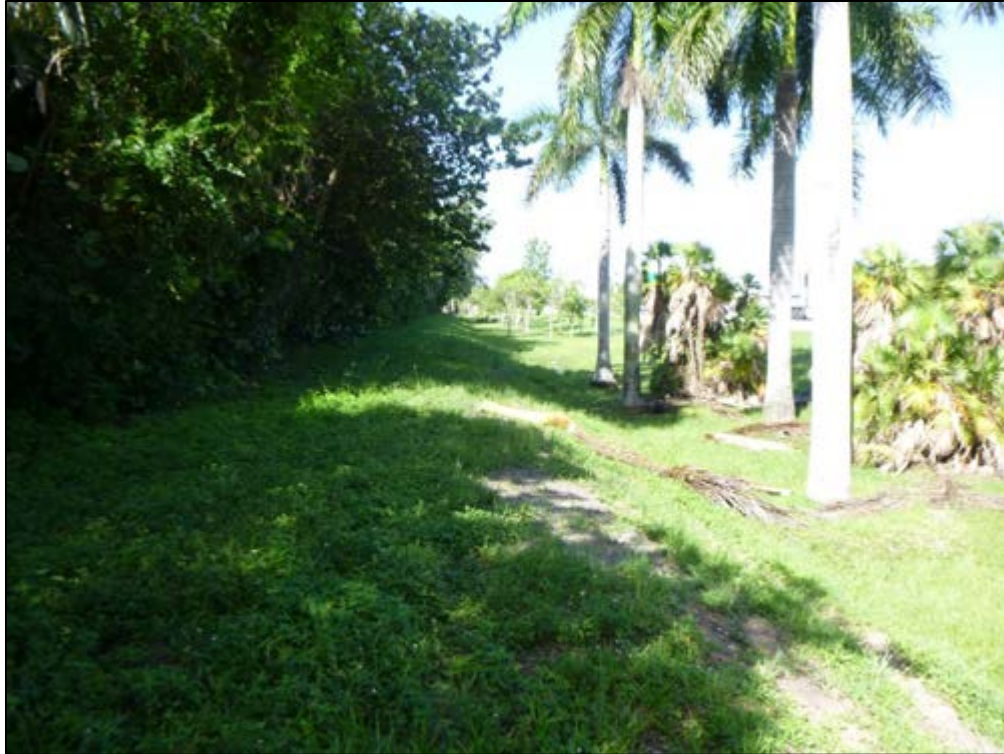
**Figure 11 – 3: Elevated Berm in the Moderate Probability Area within the Archaeological APE, Facing Southwest**

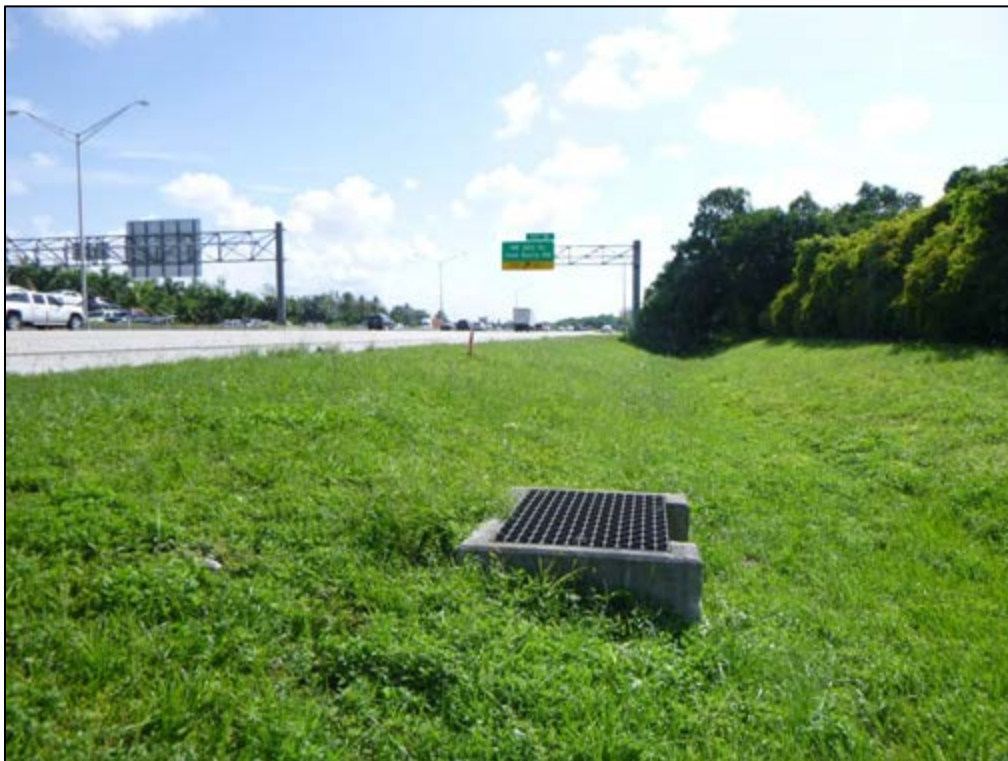
**Figure 11 – 4: Berms and Ditches within the Archaeological APE on the Eastern I-95 ROW near the NE 203<sup>rd</sup> Street Interchange, Facing Northeast**

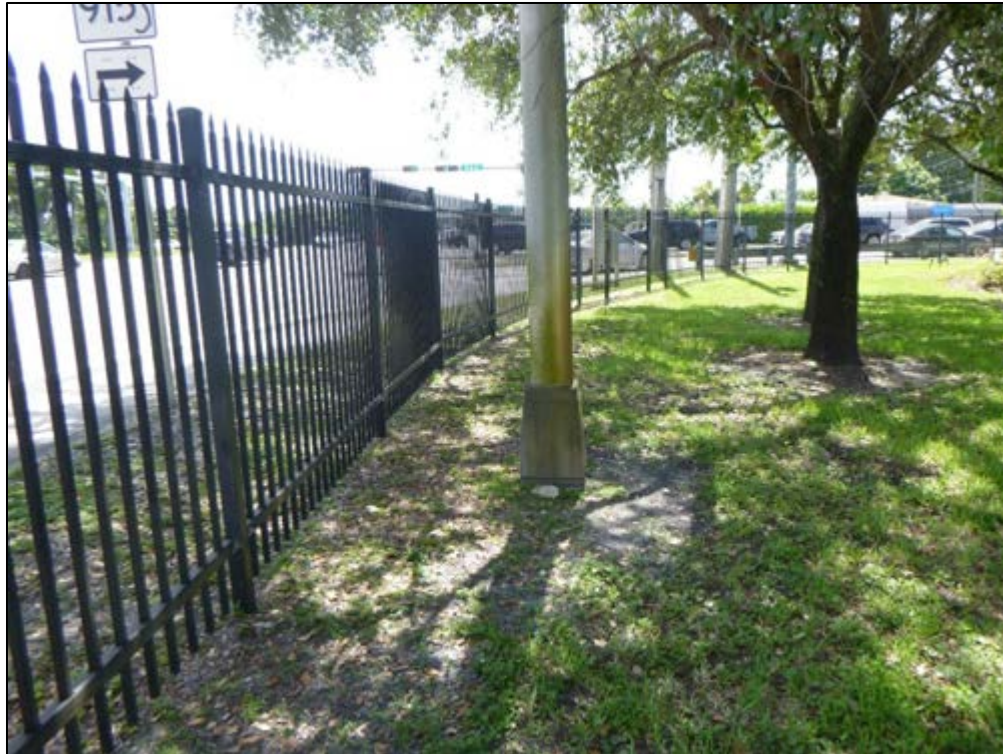
**Figure 11 – 5: Buried Lighting Utilities and Fence within the Archaeological APE along Miami Gardens Drive East of I-95, Facing East**

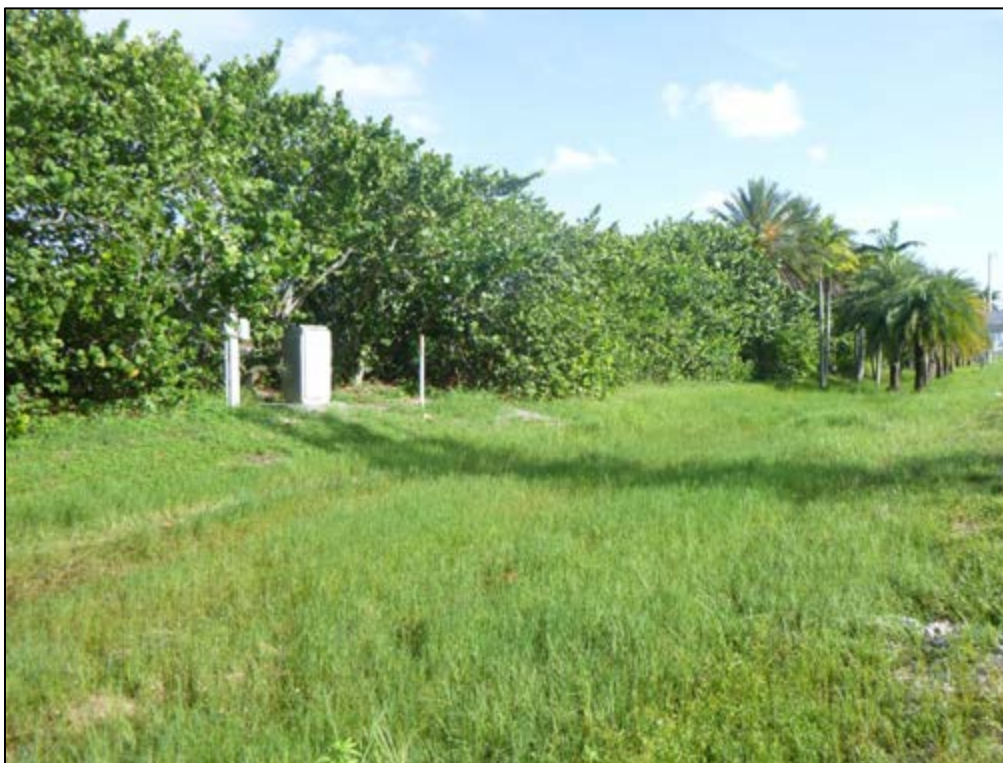
**Figure 11 – 6: Berm, Ditch, Utilities, and Exposed Road Fill in the Archaeological APE on the Western I-95 ROW near the north end of the APE, Facing Northwest**

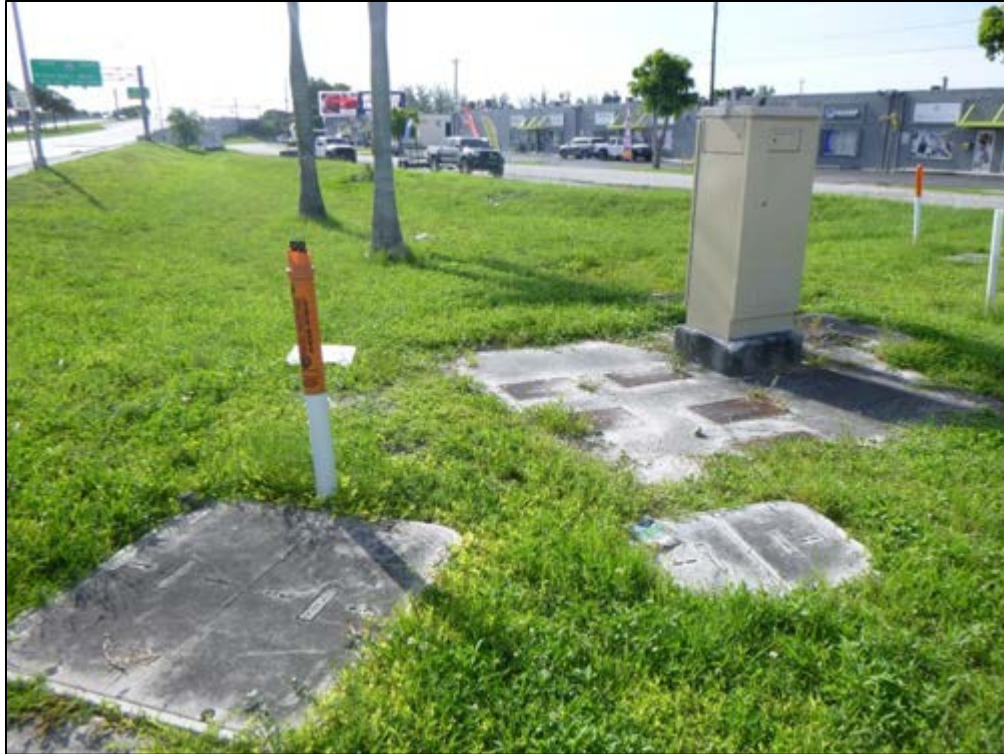
**Figure 11 – 7: Buried Utilities within the Archaeological APE south of Ives Dairy Road Approaching I-95, Facing East**

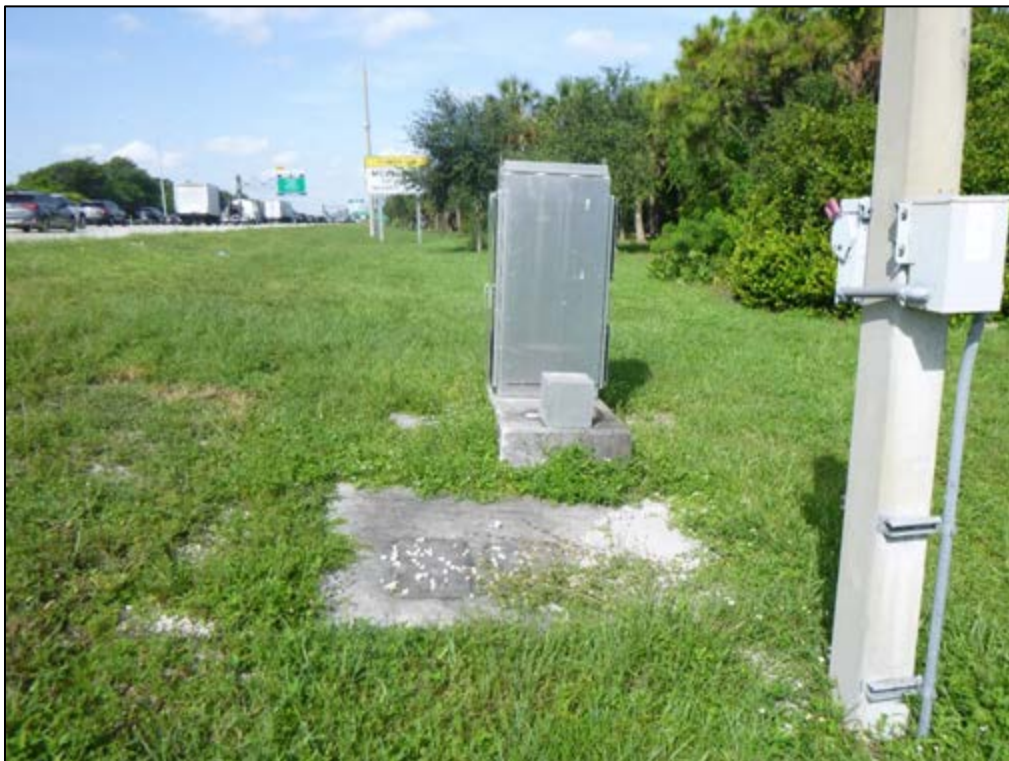
**Figure 11 – 8: Buried Utilities and Exposed Road Fill in the Archaeological APE on the Western I-95 ROW across from the Moderate Probability Area, Facing Southwest**

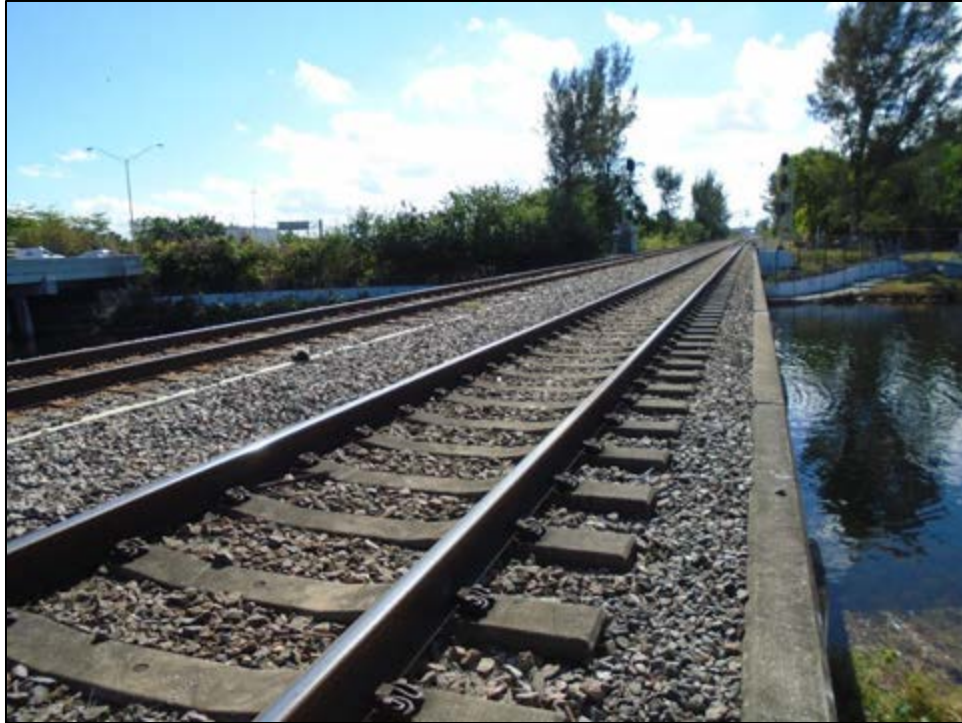
**Figure 11 – 14: CSX Railroad (8DA10753) over Snake Creek Canal, Determined National Register-Eligible, facing Southwest**

This intact portion of rail within the current APE in Miami-Dade County is one of many that comprise the overall Seaboard Air Line (CSX) system. According to historic aerials, the portions of the CSX Railroad located within the APE still follow its historic route. The portions of the railroad within the APE have been previously recorded and were determined to be National Register-eligible within Miami-Dade County by the SHPO in 2013 and 2018 due to its contributions to the patterns of Community Planning & Development and Transportation in Florida under Criterion A. An updated form was prepared to record historic spurs located within the APE.

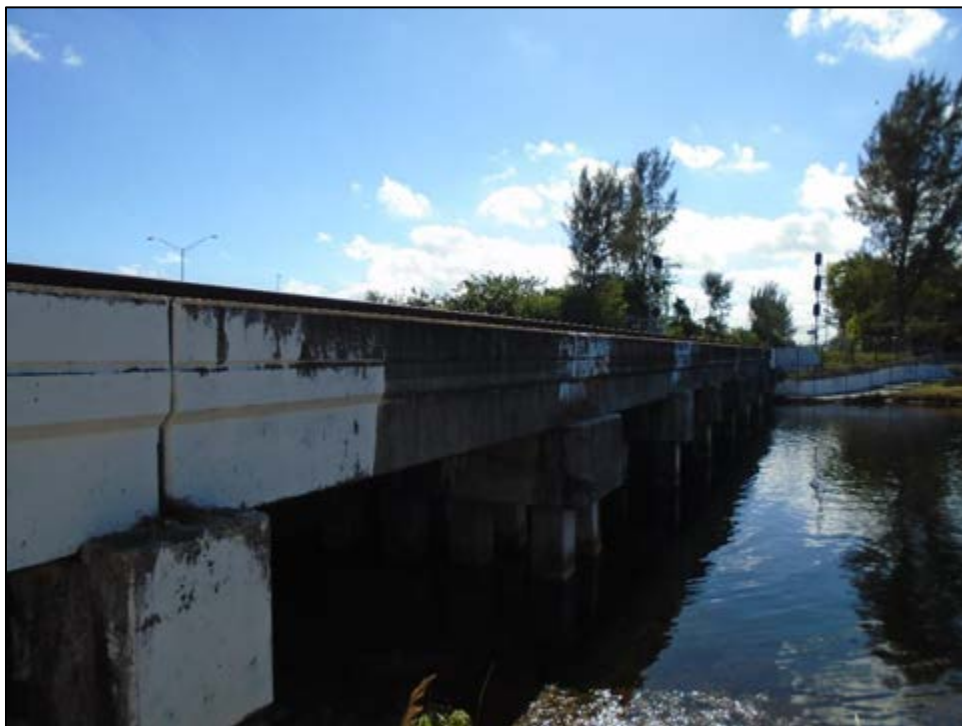
**Figure 11 – 15: CSX Railroad (8DA10753) over Snake Creek Canal, Bridge Substructure, Determined National Register-Eligible, facing South**

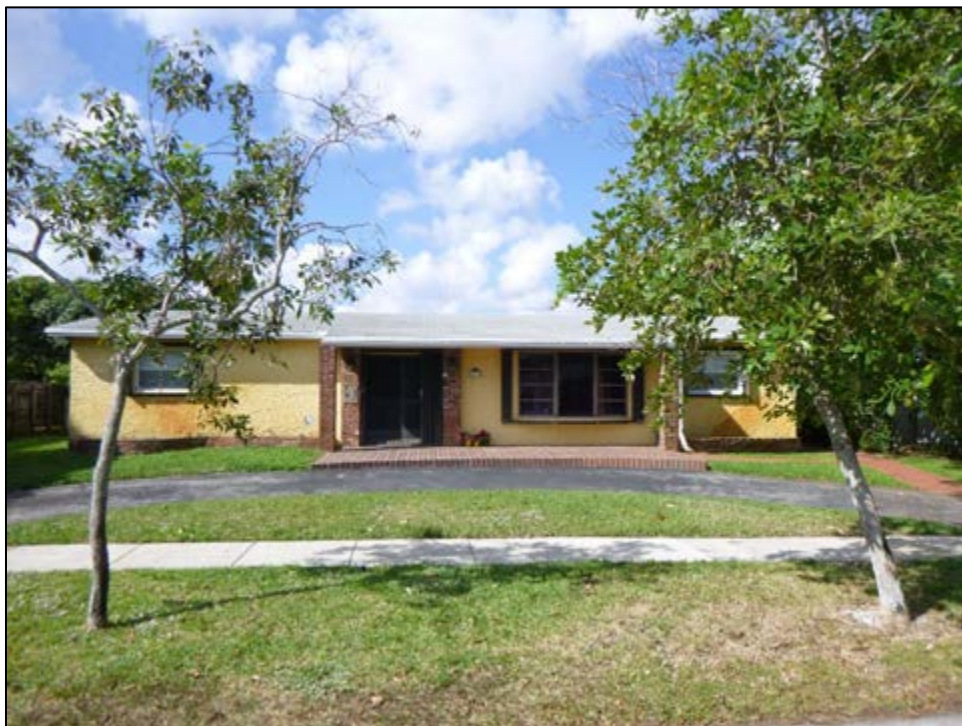
**Figure 11 – 59: 18300 NE 7<sup>th</sup> Court (8DA14268), Determined National Register-Ineligible, facing West**

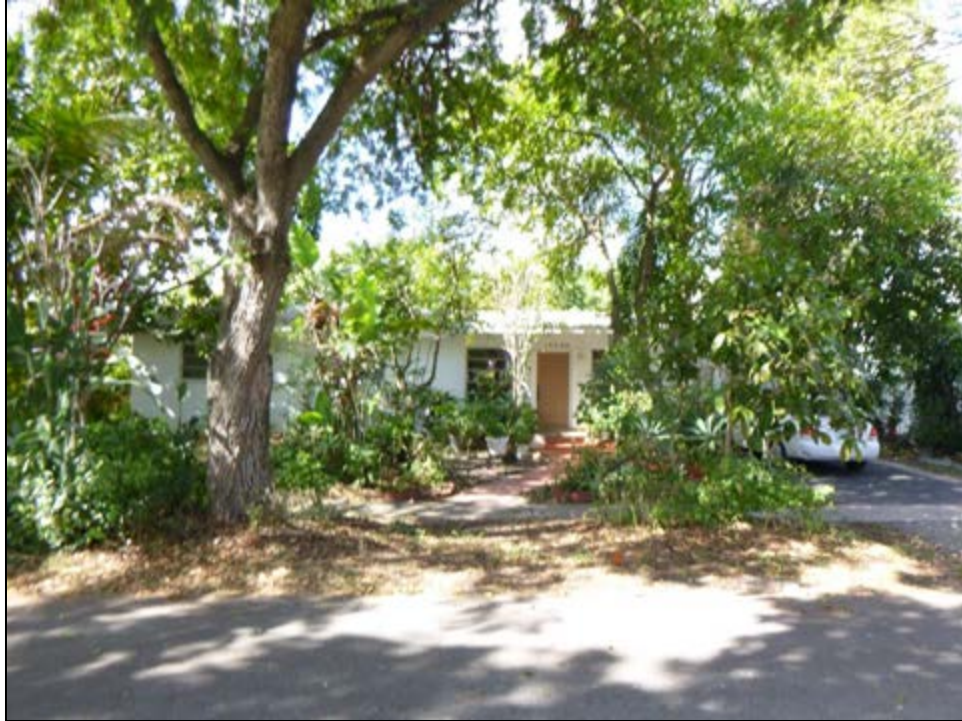
**Figure 11 – 60: 18320 NE 7<sup>th</sup> Court (8DA14269), Determined National Register-Ineligible, facing West**

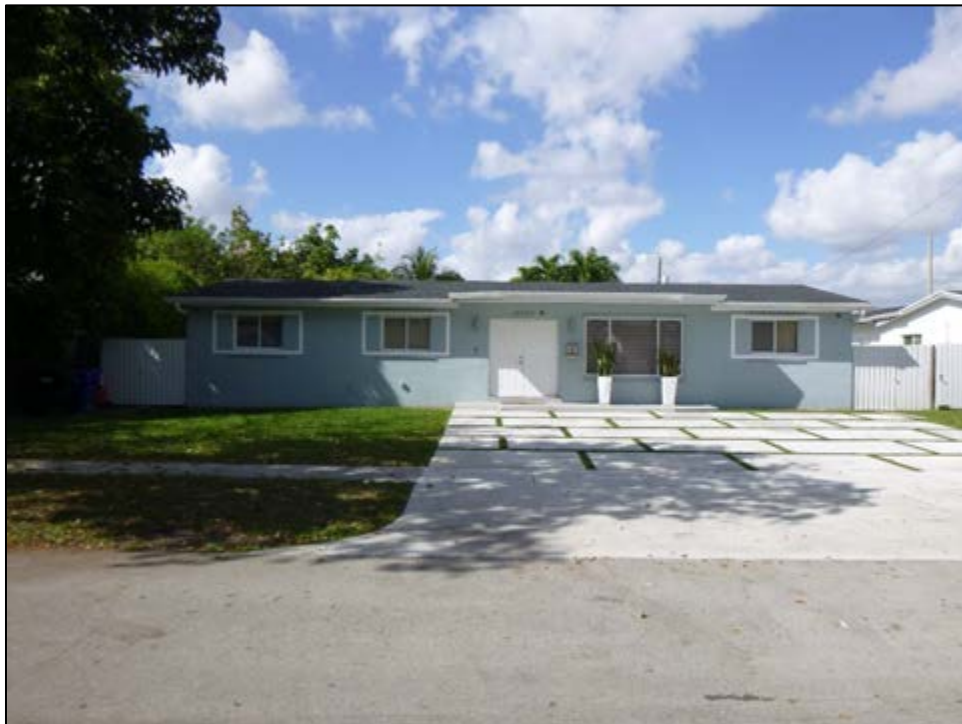
**Figure 11 – 61: 18340 NE 7<sup>th</sup> Court (8DA14270), Determined National Register-Ineligible, facing West**

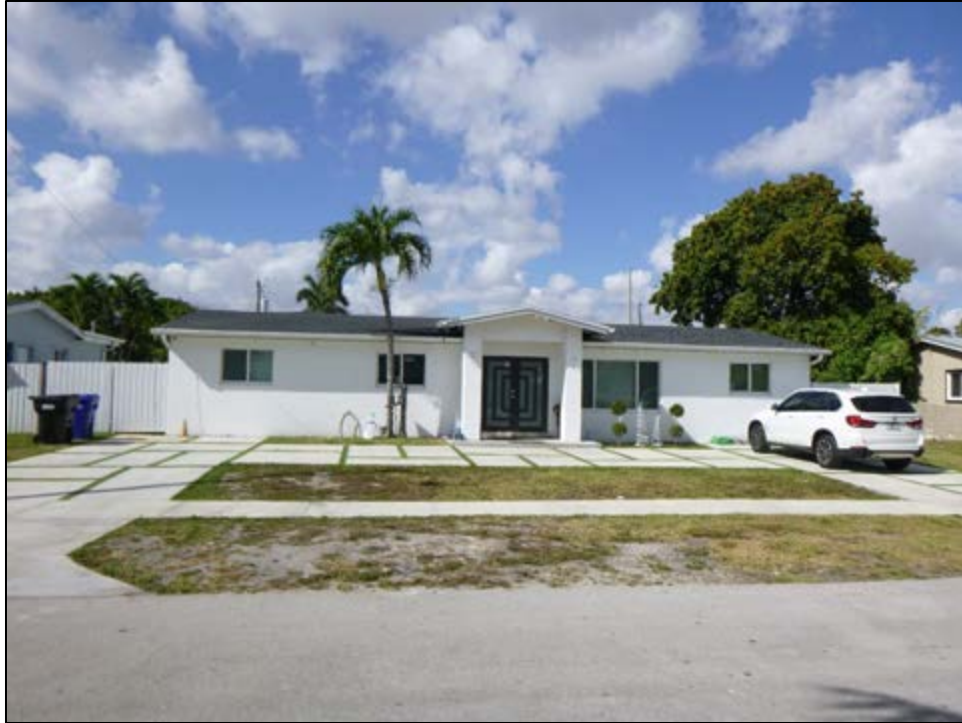
**Figure 11 – 62: 18360 NE 7<sup>th</sup> Court (8DA14271), Determined National Register-Ineligible, facing West**

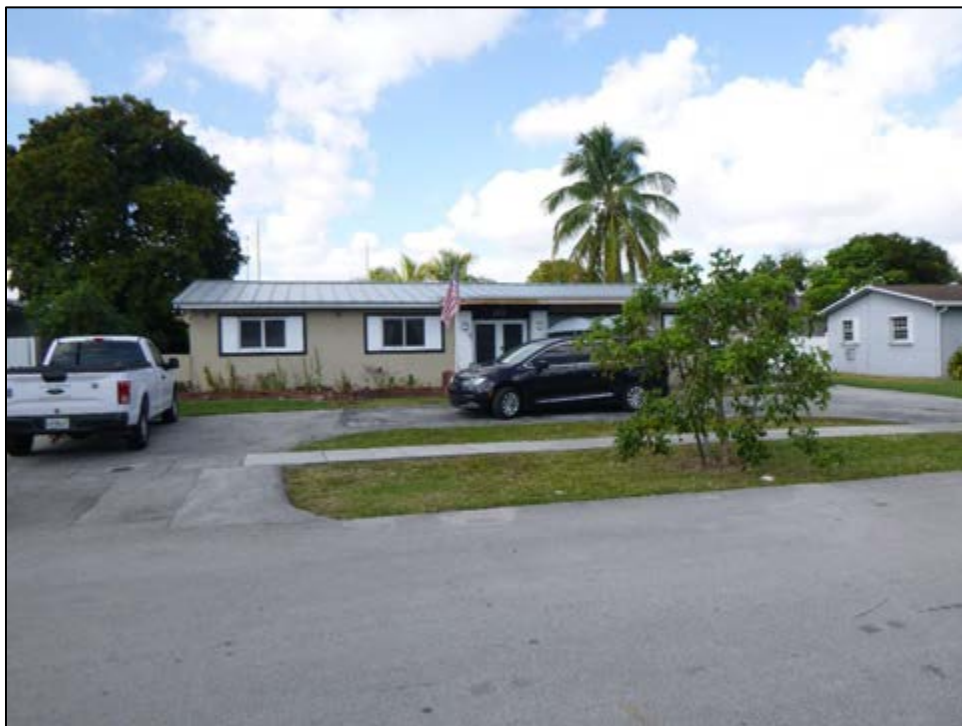
**Figure 11 – 63: 18400 NE 7<sup>th</sup> Court (8DA14272), Determined National Register-Ineligible, facing Northwest**

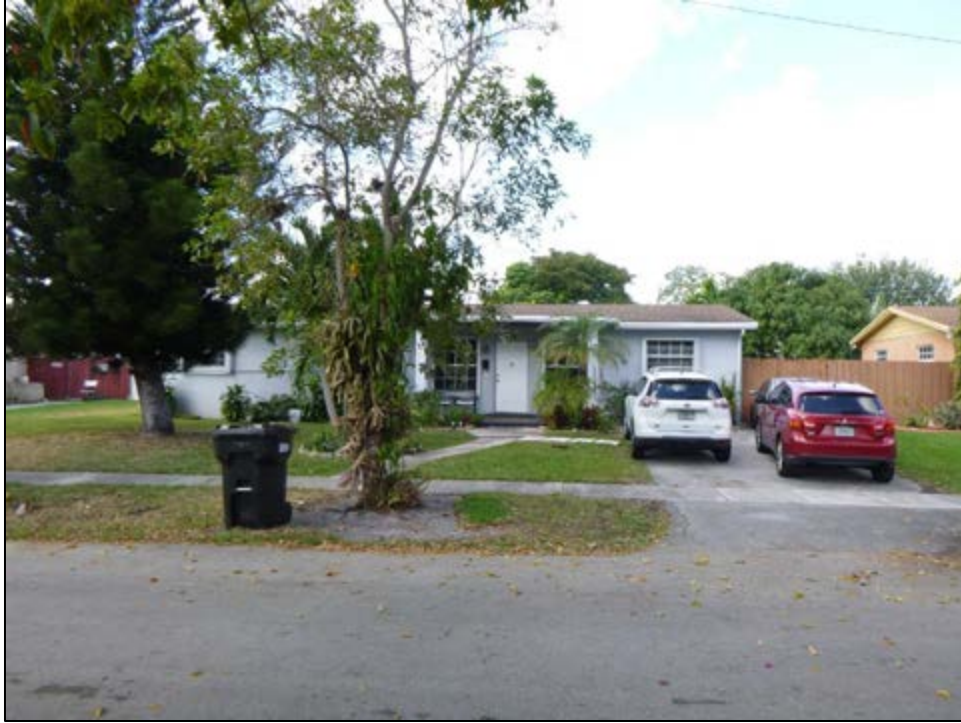
**Figure 11 – 64: 18430 NE 7<sup>th</sup> Court (8DA14273), Determined National Register-Ineligible, facing Northwest**

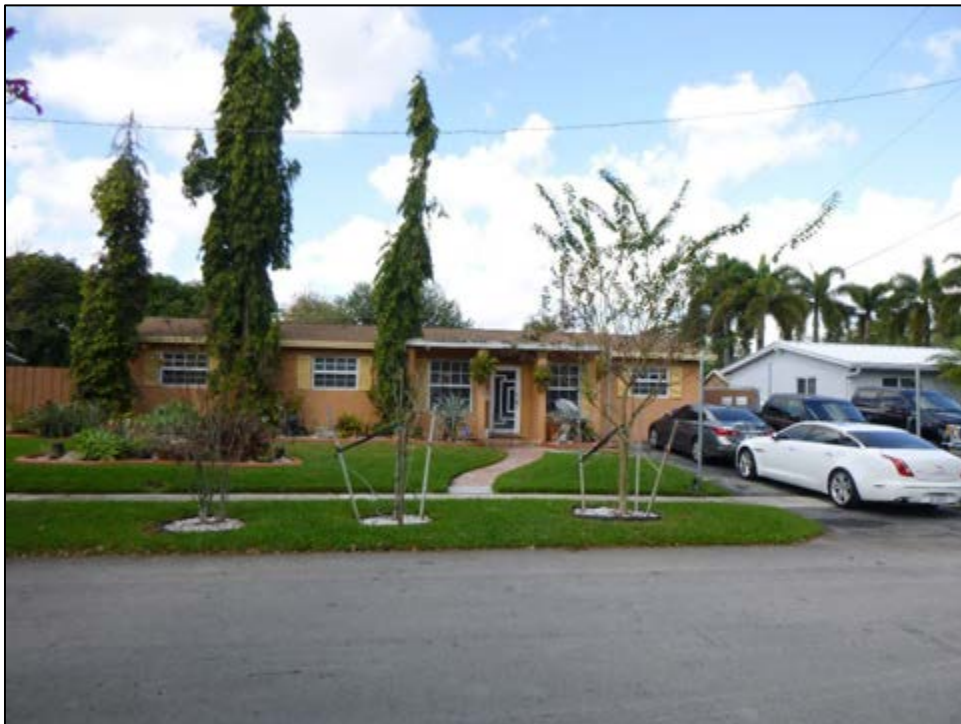
**Figure 11 – 65: 18460 NE 7<sup>th</sup> Court (8DA14274), Determined National Register-Ineligible, facing Northwest**
