# CULTURAL RESOURCE ASSESSMENT SURVEY

I-95/State Road (SR) 9 Project Development and Environment (PD&E) Study  
From South of SR 860/Miami Gardens Drive to North of Broward County Line  
Miami-Dade County, Florida

Financial Management Number: 414964-1-22-01  
Federal Aid Project Number: N/A  
Efficient Transportation Decision Making (ETDM): 14419

## **Cultural Resources Assessment Survey**

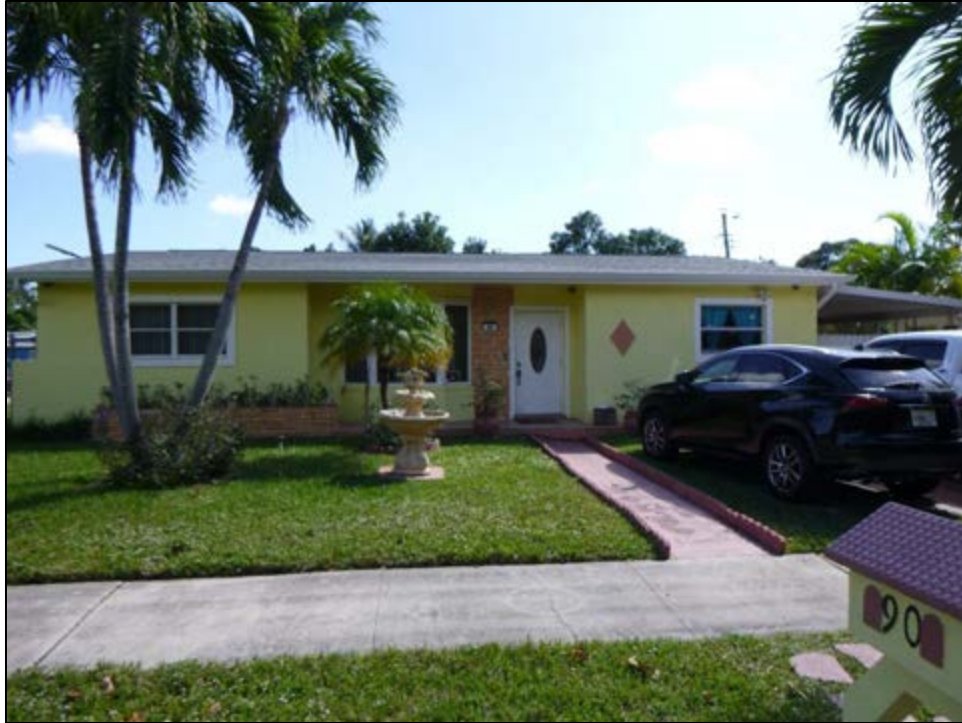
**Figure 11 – 66: 90 East Drive (8DA14278), Determined National Register-Ineligible, facing Southeast**

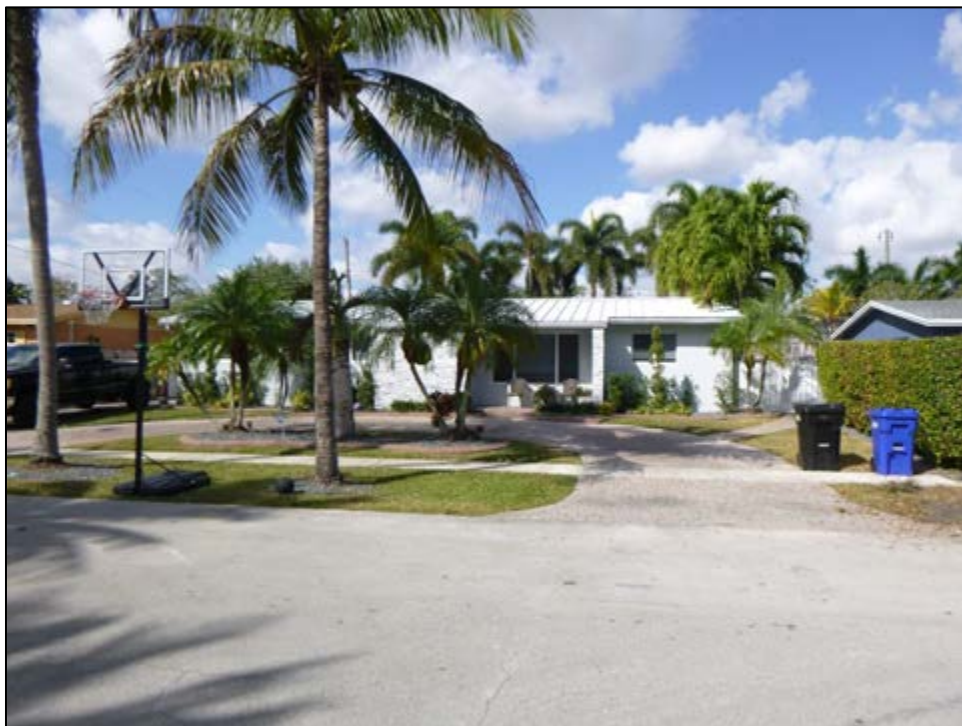
**Figure 11 – 67: 18480 NE 7<sup>th</sup> Court (8DA14279), Determined National Register-Ineligible, facing Northwest**

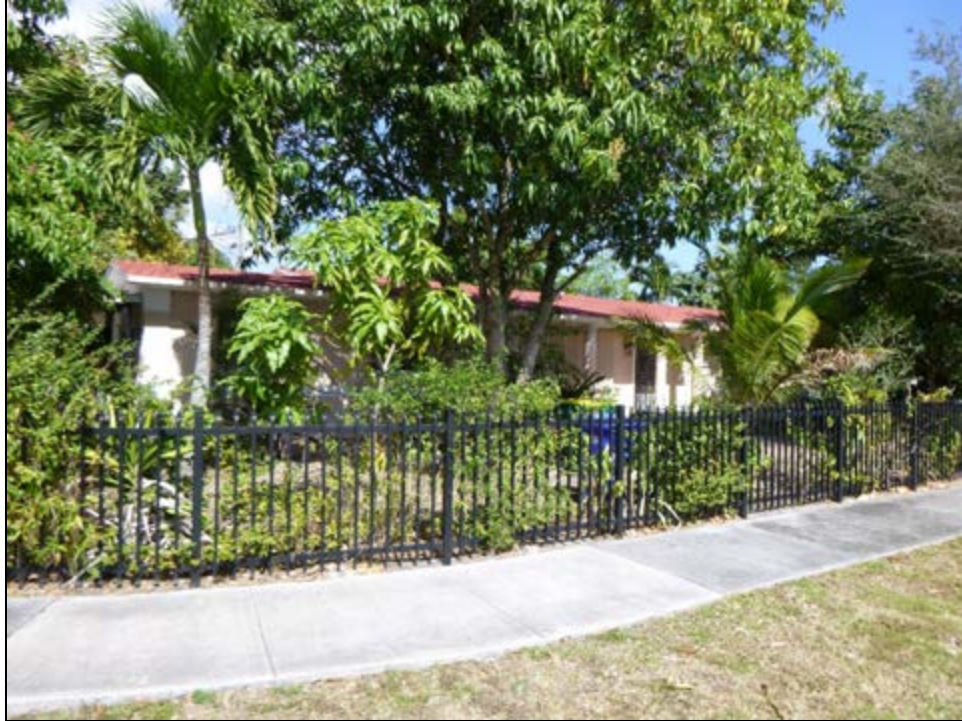
**Figure 11 – 68: 111 NE 175<sup>th</sup> St. (8DA19659), Not Evaluated by the SHPO, Considered National Register-Ineligible, facing Southeast**

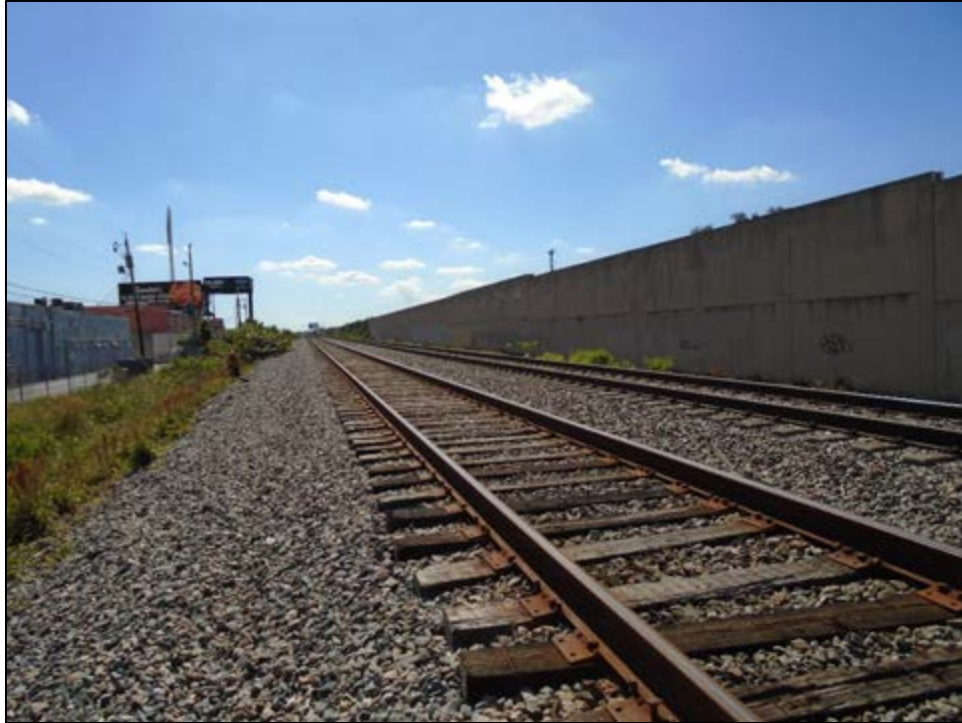
**Figure 11 – 70: Seaboard Air Line (CSX) Railroad (8BD4649) Within the APE, Determined National Register-Eligible, facing South**

Refer to the 8DA10753 narrative for the history of the railroad. This intact portion of rail within the current APE in Broward County is one of many that comprise the overall Seaboard Air Line (CSX) system. According to historic aerials, the portion of the Seaboard Air Line (CSX) Railroad located within the APE still follows its historic route. The portion of the railroad within the APE has been previously recorded and was determined to be National Register-eligible by the SHPO in 2018 due to its contributions to the patterns of Community Planning & Development and Transportation in Florida under Criterion A. An updated form was not prepared as there has been no change in eligibility since it was last recorded.

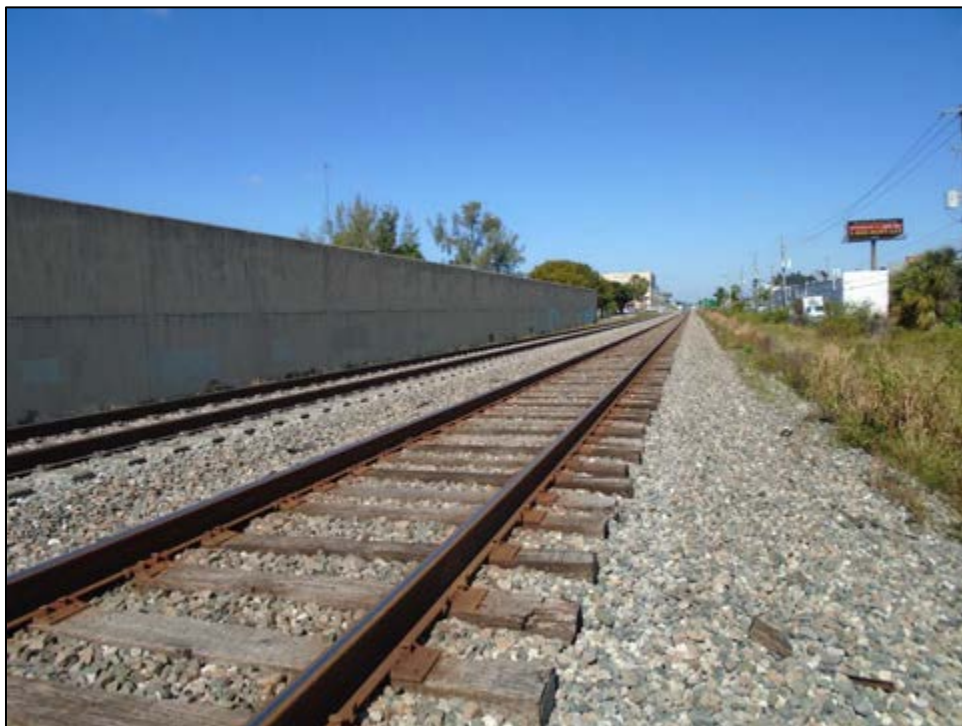
**Figure 11 – 71: Seaboard Air Line (CSX) Railroad (8BD4649) Within the APE, Determined National Register-Eligible, facing North**

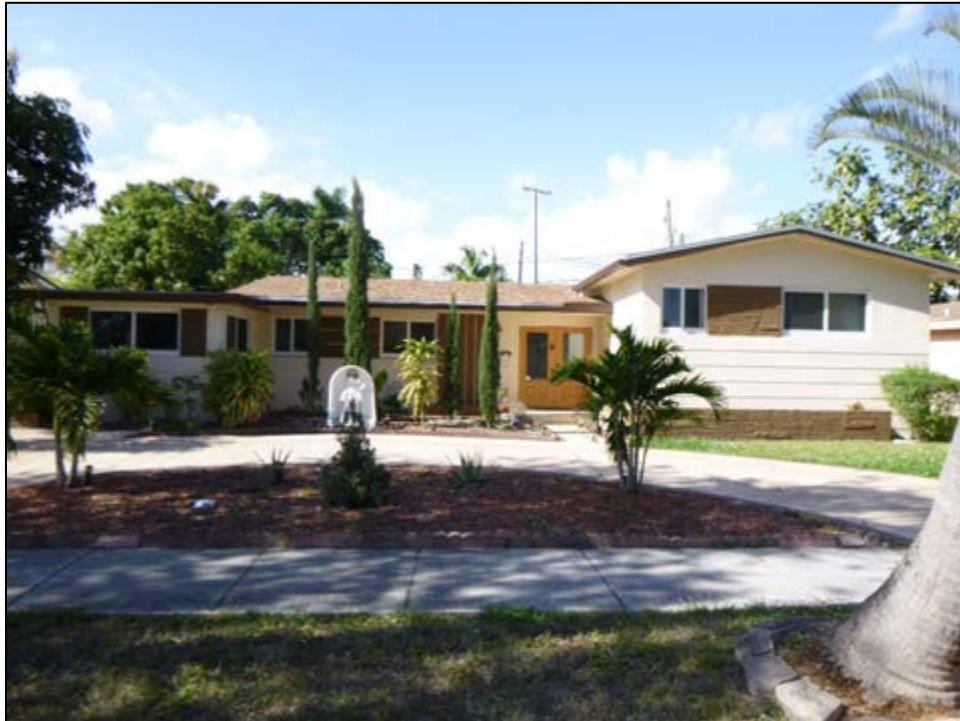
**Figure 11 – 72: 561 NE 180<sup>th</sup> Drive (8DA21385), c. 1957, Considered National Register-Ineligible, facing Northwest**

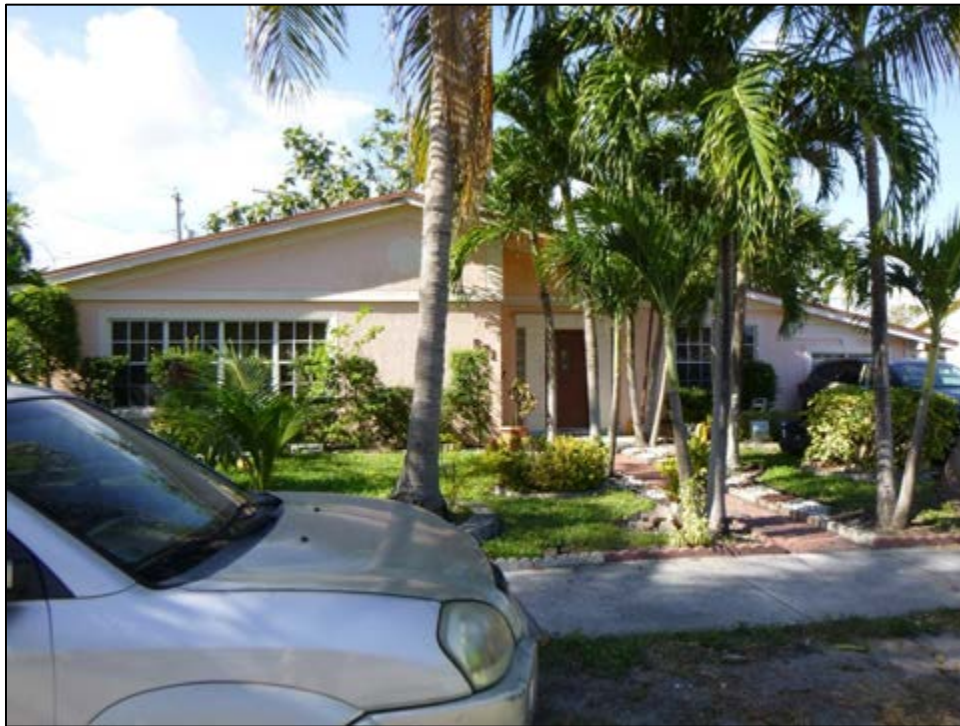
**Figure 11 – 73: 571 NE 180<sup>th</sup> Drive (8DA21386), c. 1957, Considered National Register-Ineligible, facing Northwest**

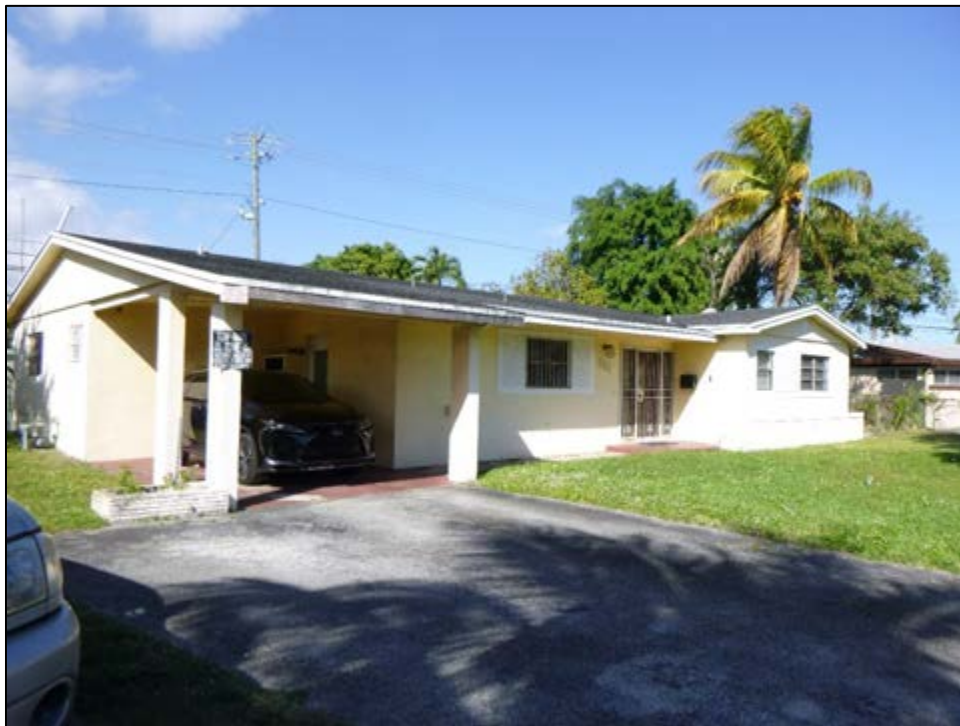
**Figure 11 – 74: 581 NE 180<sup>th</sup> Drive (8DA21387), c. 1957, Considered National Register-Ineligible, facing North**

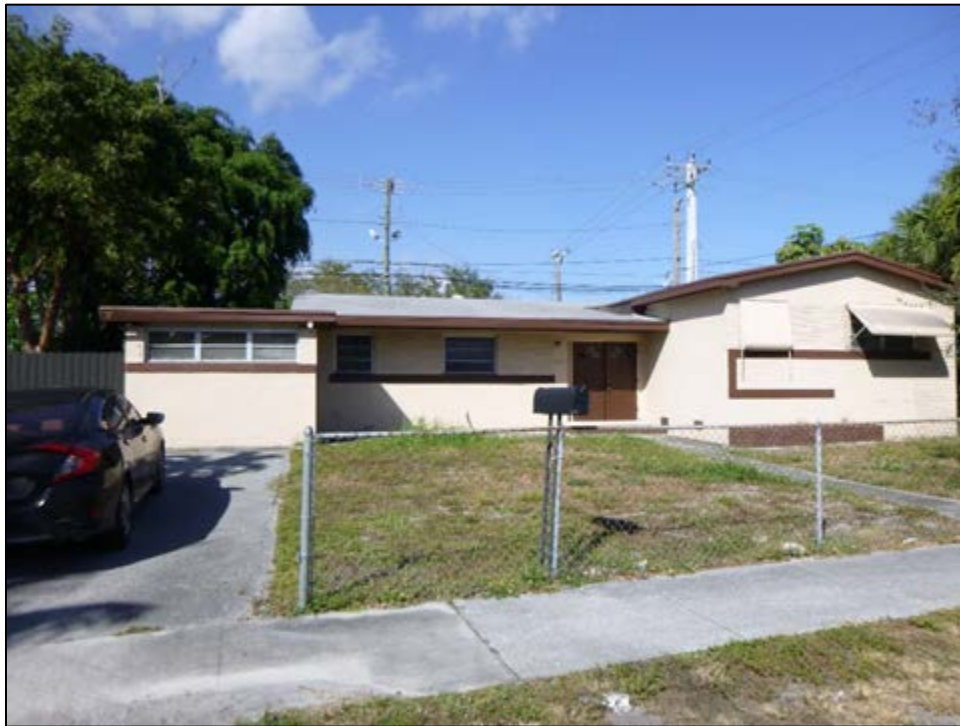
**Figure 11 – 75: 591 NE 180<sup>th</sup> Drive (8DA21388), c. 1957, Considered National Register-Ineligible, facing North**

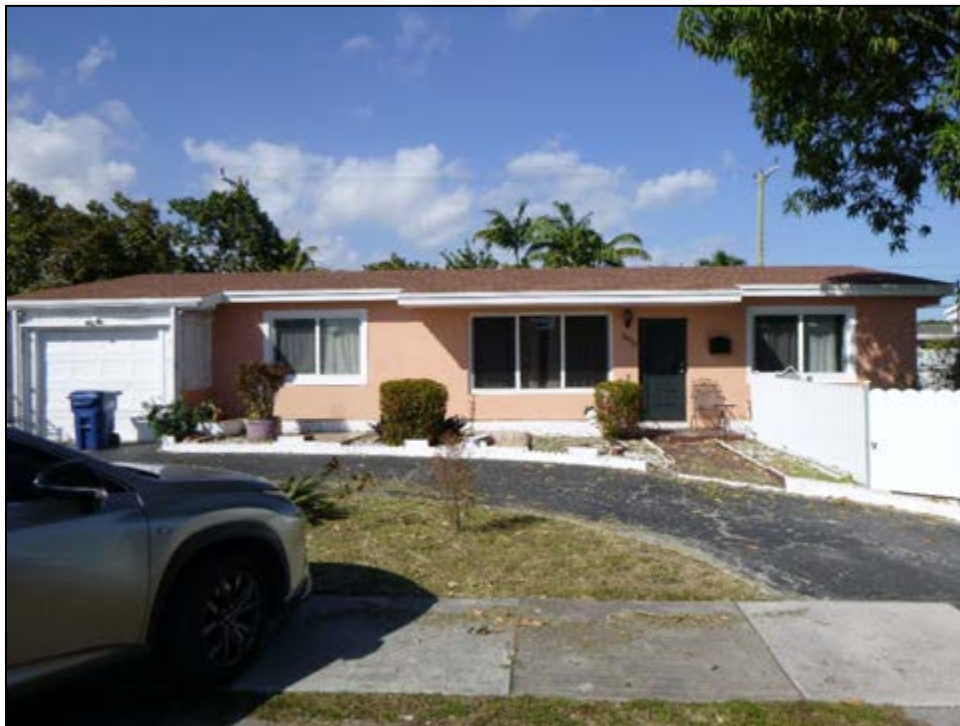
**Figure 11 – 76: 695 NE 180<sup>th</sup> Street (8DA21389), c. 1956, Considered National Register-Ineligible, facing North**

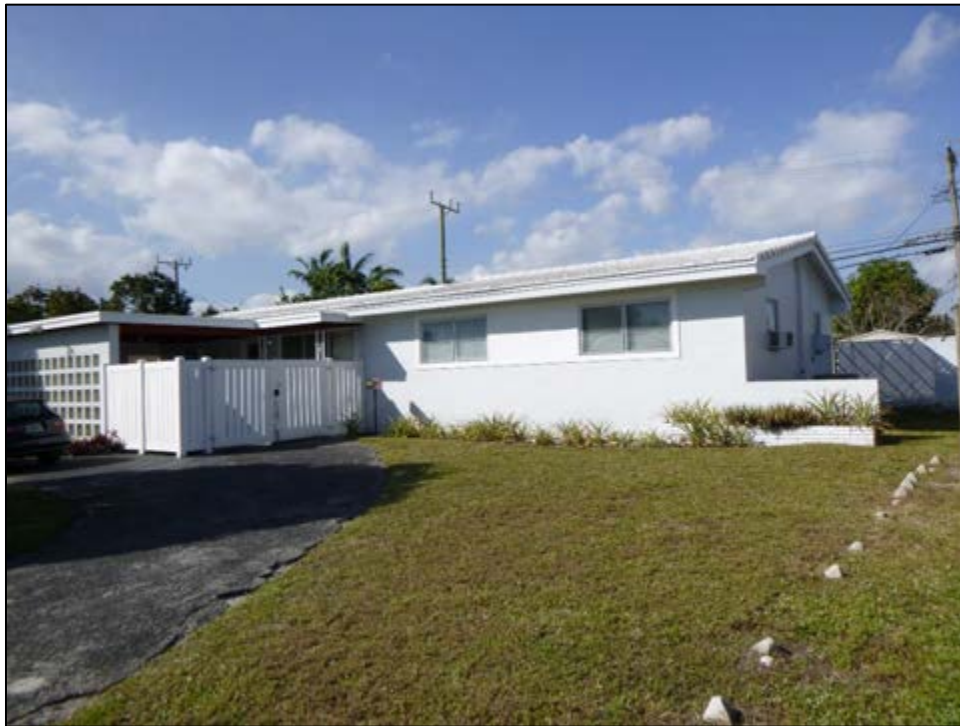
**Figure 11 – 77: 701 NE 180<sup>th</sup> Street (8DA21390), c. 1956, Considered National Register-Ineligible, facing Northwest**

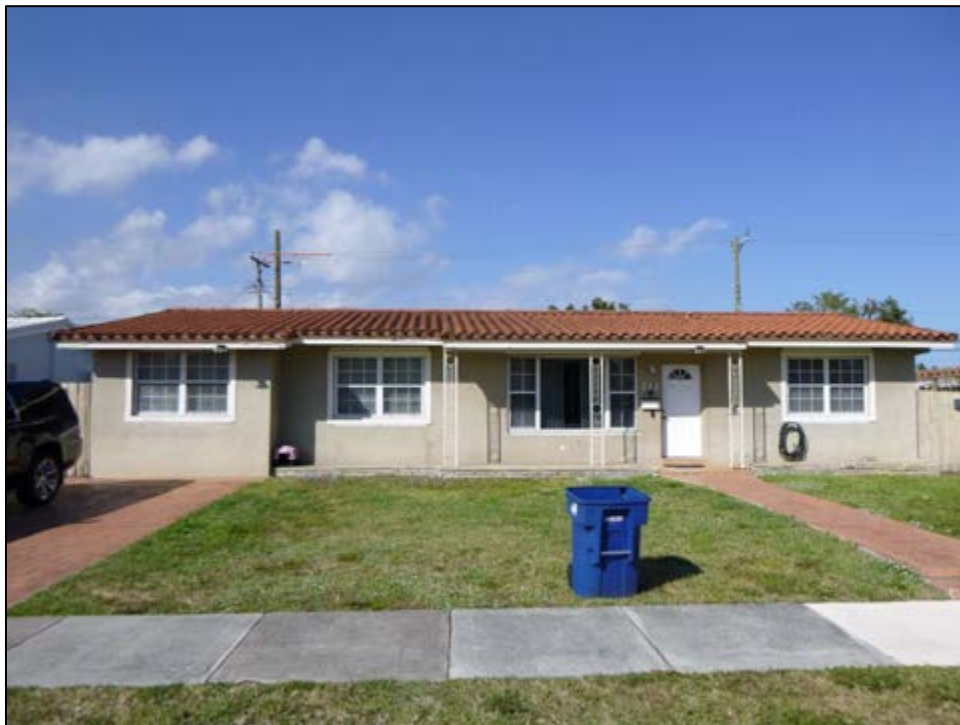
**Figure 11 – 78: 711 NE 180<sup>th</sup> Street (8DA21391), c. 1957, Considered National Register-Ineligible, facing North**

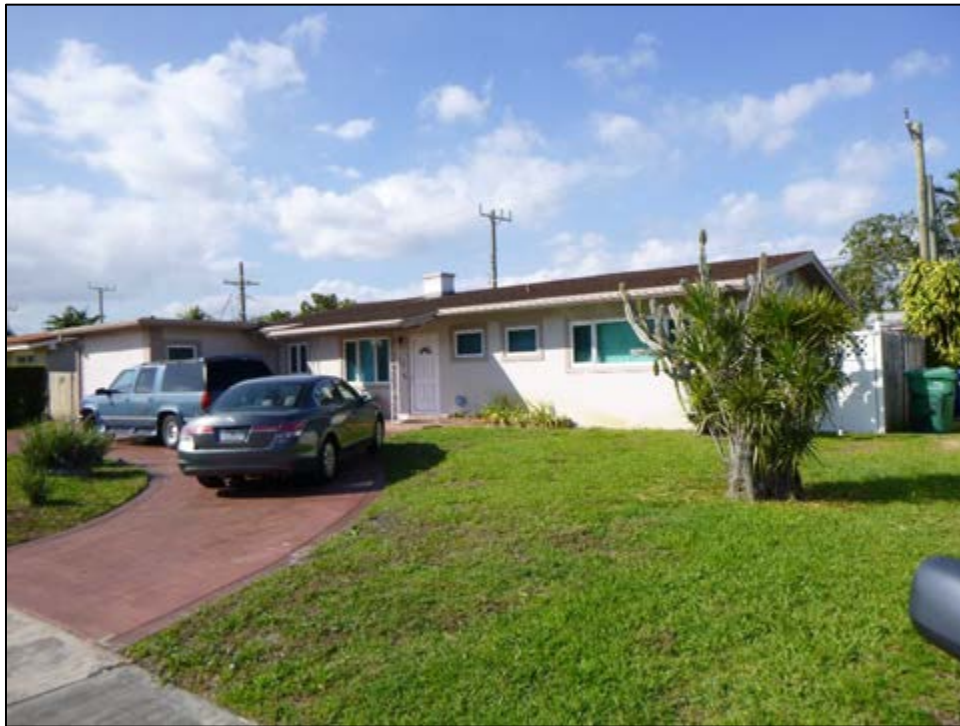
**Figure 11 – 79: 721 NE 180<sup>th</sup> Street (8DA21392), c. 1956, Considered National Register-Ineligible, facing Northwest**

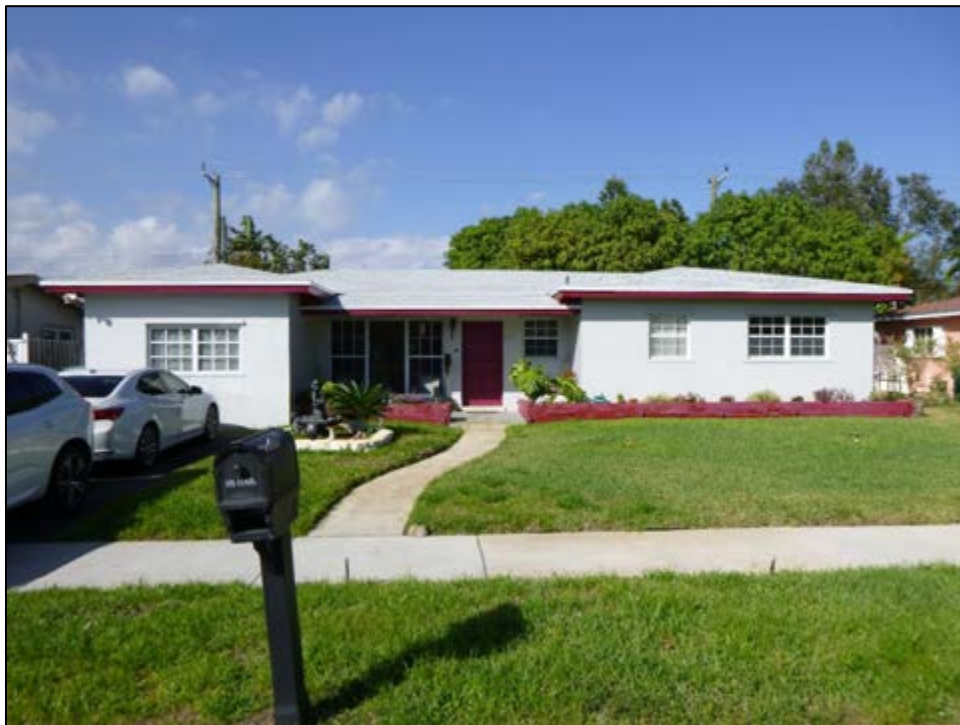
**Figure 11 – 80: 731 NE 180<sup>th</sup> Street (8DA21393), c. 1957, Considered National Register-Ineligible, facing North**

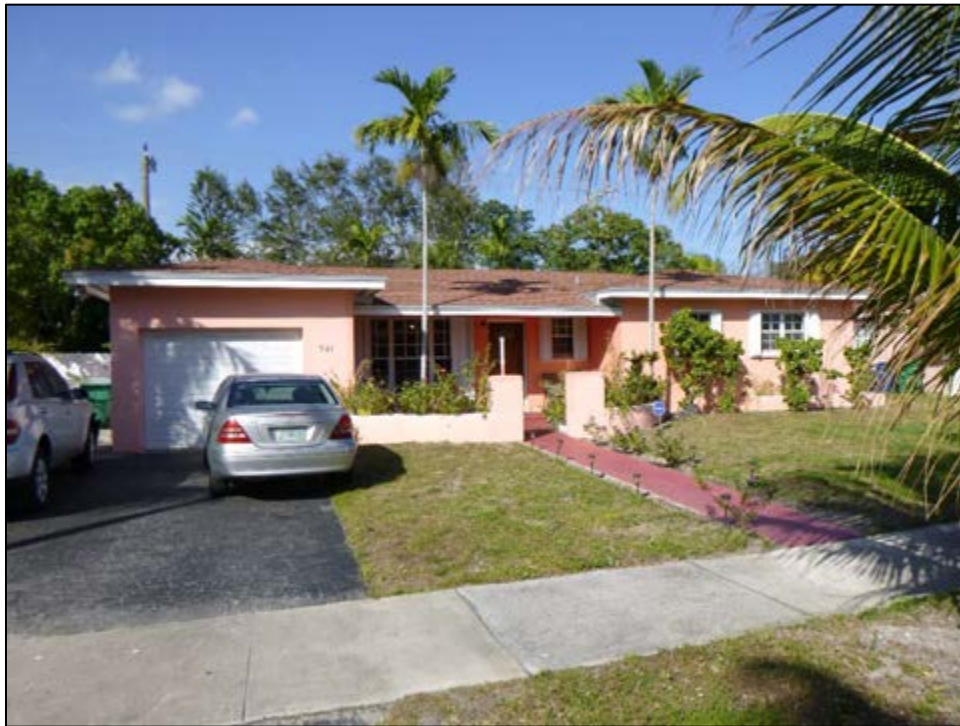
**Figure 11 – 81: 741 NE 180<sup>th</sup> Street (8DA21394), c. 1957, Considered National Register-Ineligible, facing North**

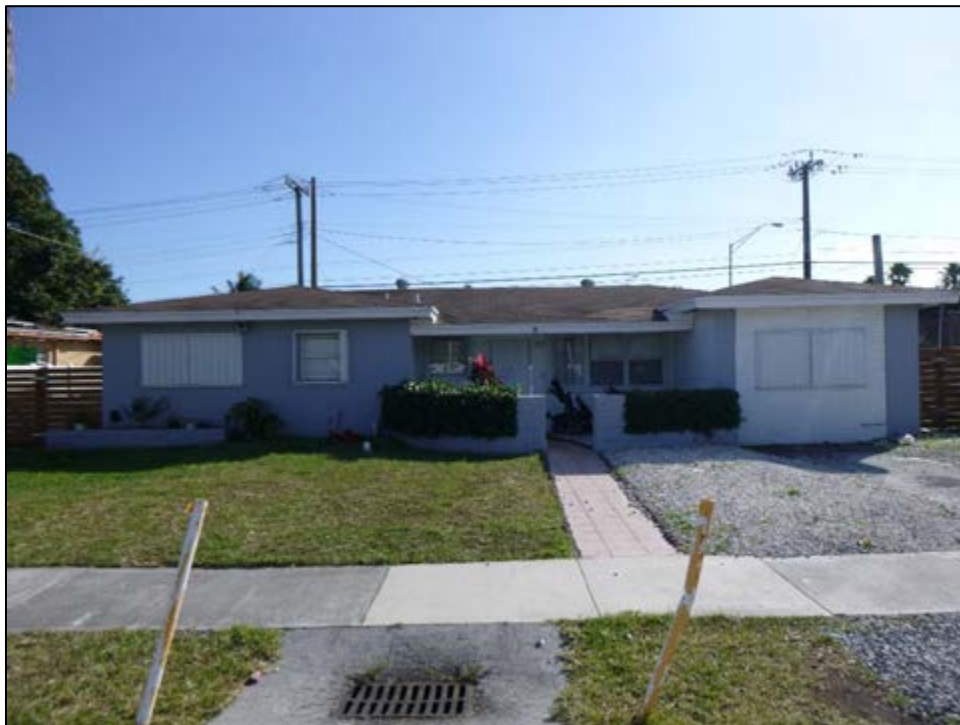
**Figure 11 – 82: 600 NE 181<sup>st</sup> Street (8DA21395), c. 1956, Considered National Register-Ineligible, facing South**

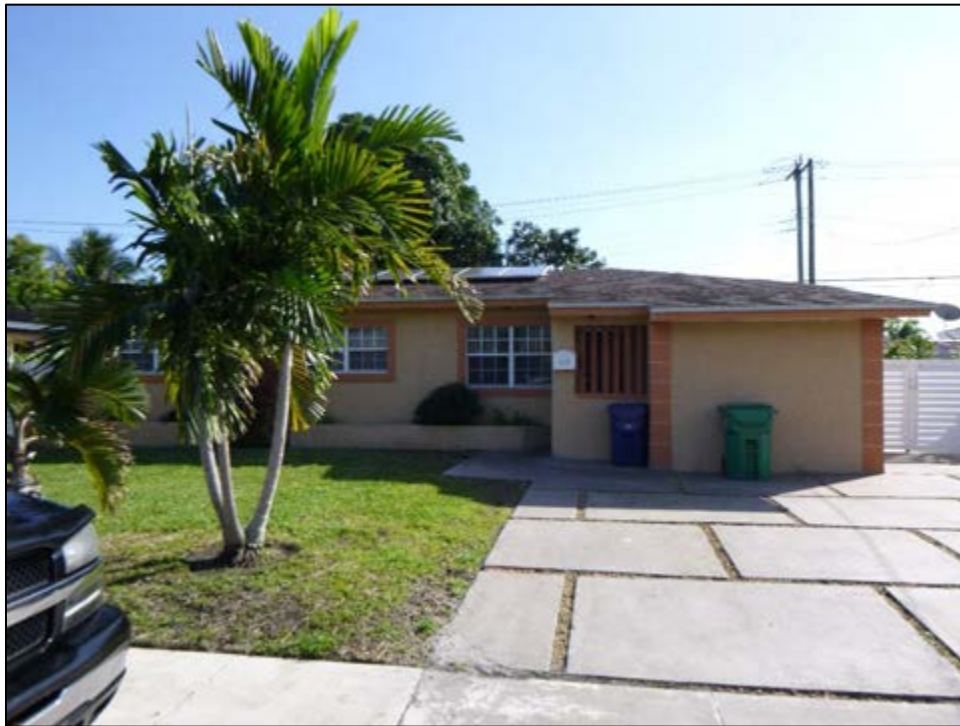
**Figure 11 – 83: 610 NE 181<sup>st</sup> Street (8DA21396), c. 1956, Considered National Register-Ineligible, facing South**

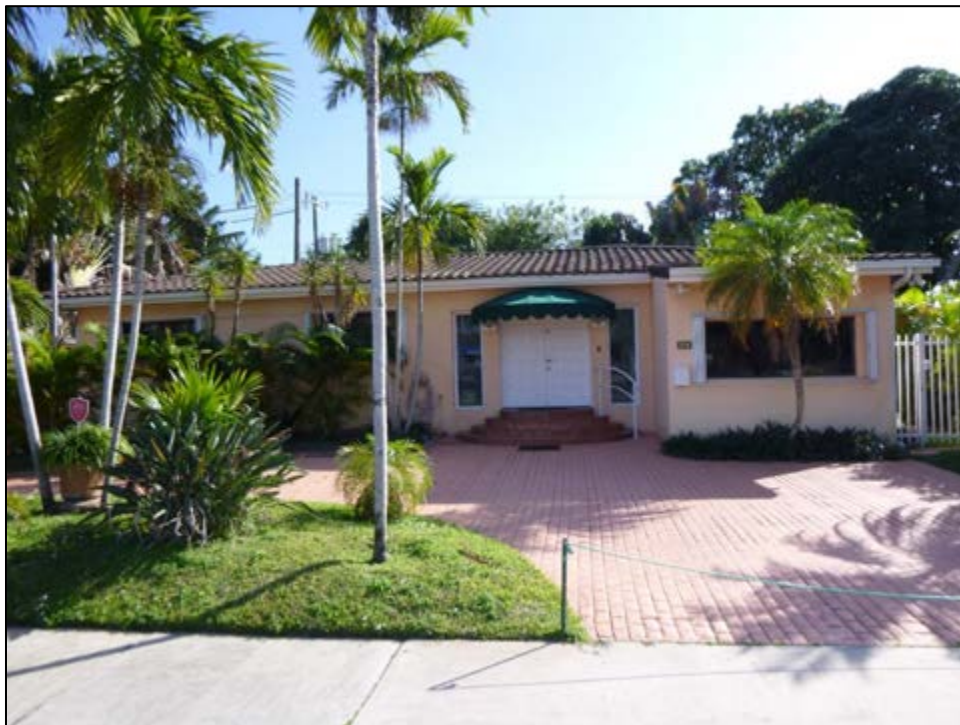
**Figure 11 – 84: 620 NE 181<sup>st</sup> Street (8DA21397), c. 1956, Considered National Register-Ineligible, facing South**

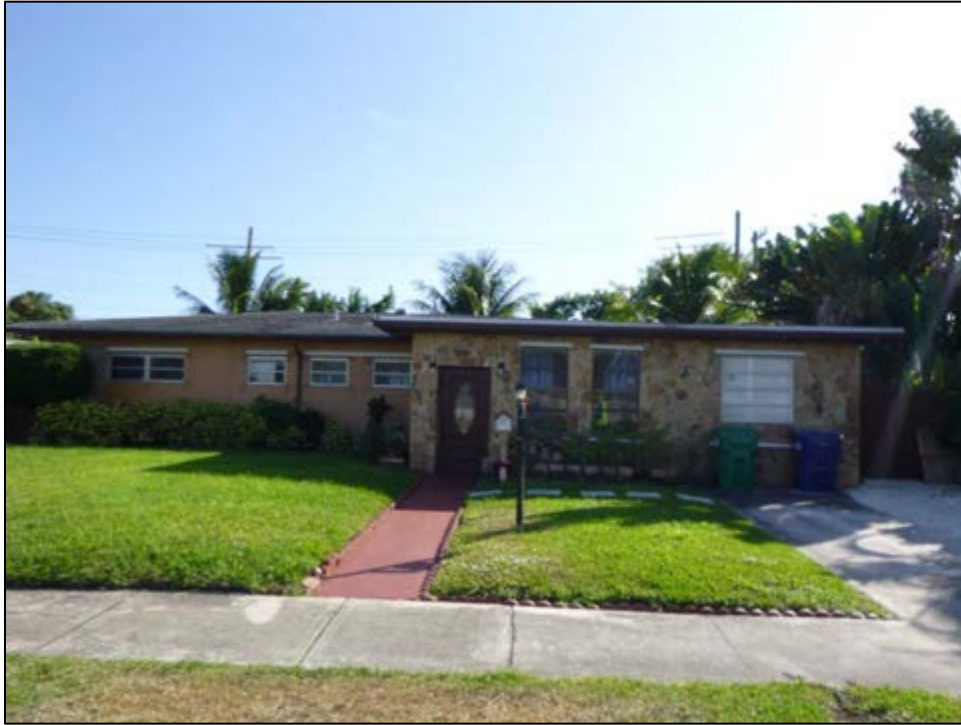
**Figure 11 – 85: 630 NE 181<sup>st</sup> Street (8DA21398), c. 1956, Considered National Register-Ineligible, facing South**

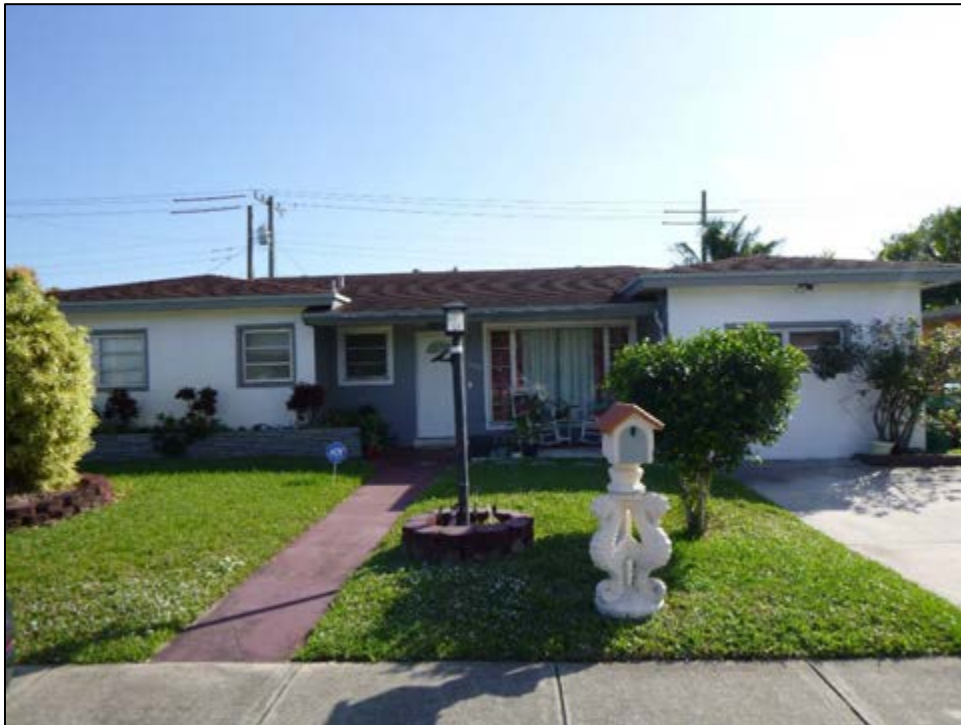
**Figure 11 – 86: 640 NE 181<sup>st</sup> Street (8DA21399), c. 1956, Considered National Register-Ineligible, facing South**

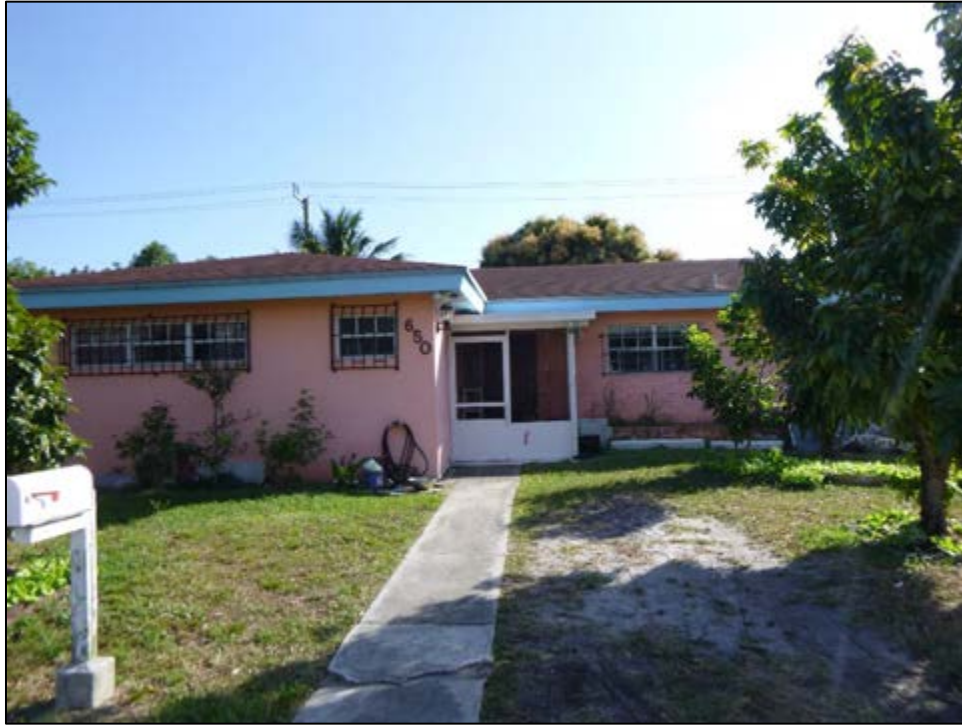
**Figure 11 – 87: 650 NE 181<sup>st</sup> Street (8DA21400), c. 1956, Considered National Register-Ineligible, facing South**

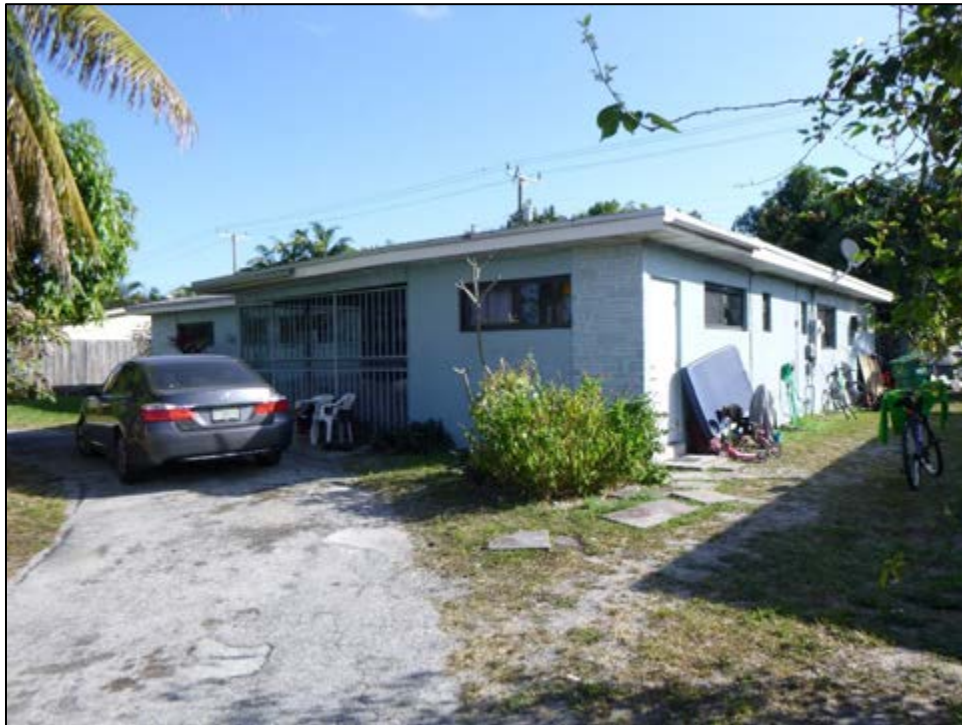
**Figure 11 – 88: 660 NE 181<sup>st</sup> Street (8DA21401), c. 1956, Considered National Register-Ineligible, facing Southeast**

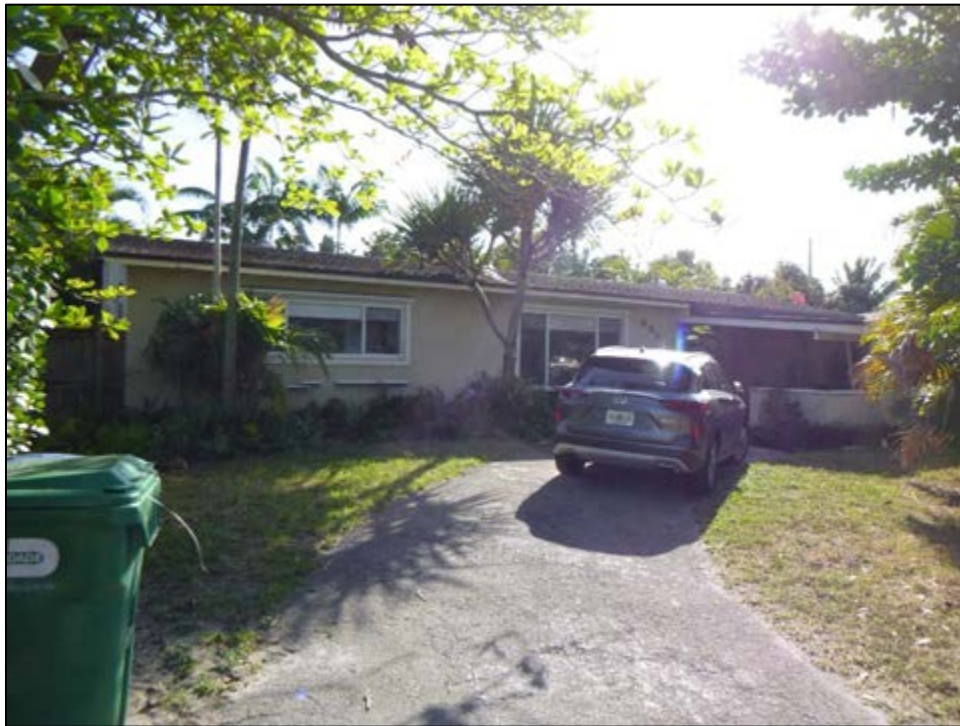
**Figure 11 – 89: 680 NE 181<sup>st</sup> Street (8DA21402), c. 1956, Considered National Register-Ineligible, facing Southwest**

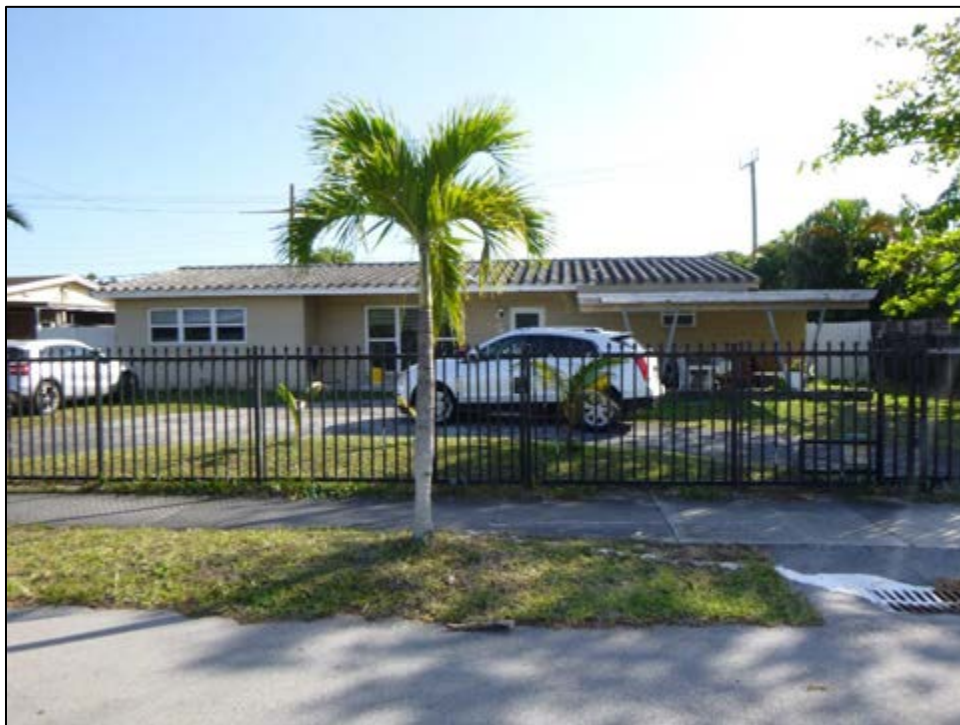
**Figure 11 – 90: 700 NE 181<sup>st</sup> Street (8DA21403), c. 1956, Considered National Register-Ineligible, facing South**

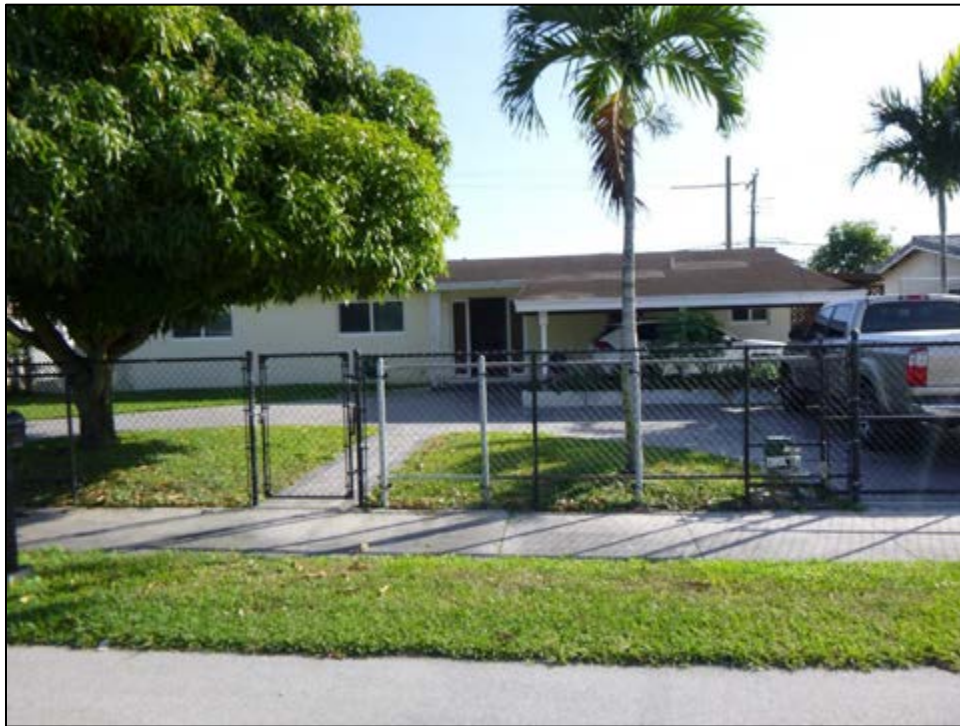
**Figure 11 – 91: 710 NE 181<sup>st</sup> Street (8DA21404), c. 1956, Considered National Register-Ineligible, facing South**

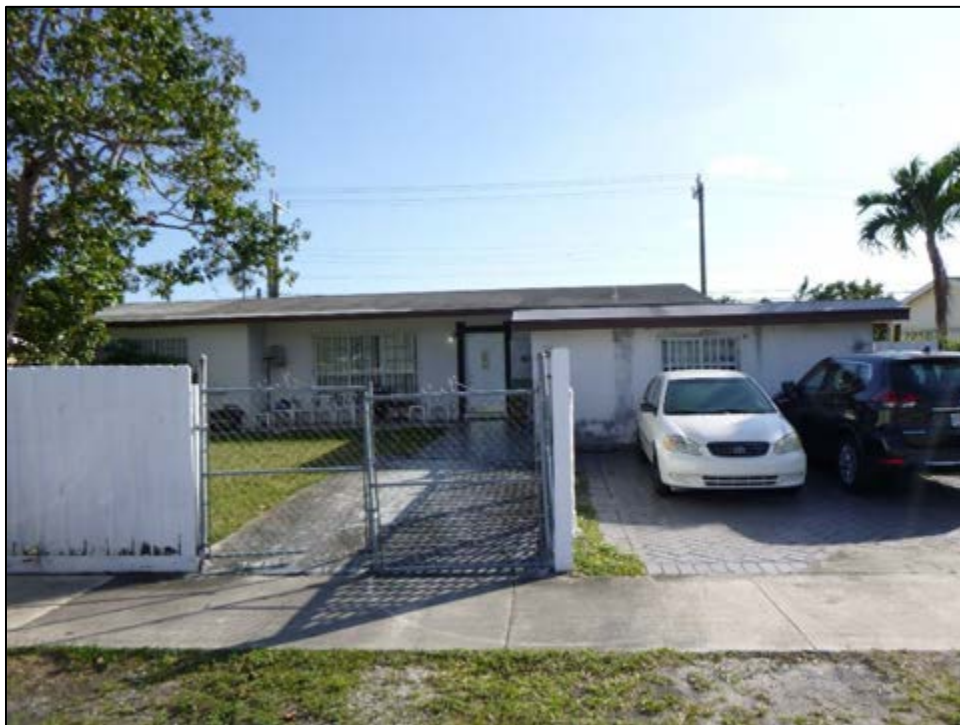
**Figure 11 – 92: 720 NE 181<sup>st</sup> Street (8DA21405), c. 1956, Considered National Register-Ineligible, facing South**

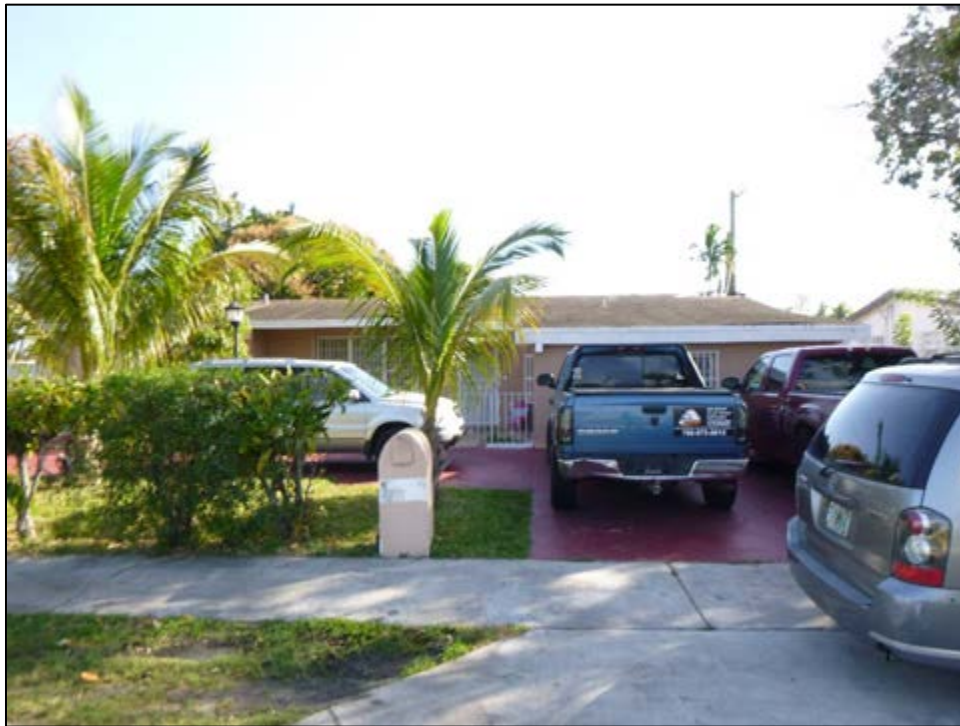
**Figure 11 – 93: 730 NE 181<sup>st</sup> Street (8DA21406), c. 1956, Considered National Register-Ineligible, facing South**

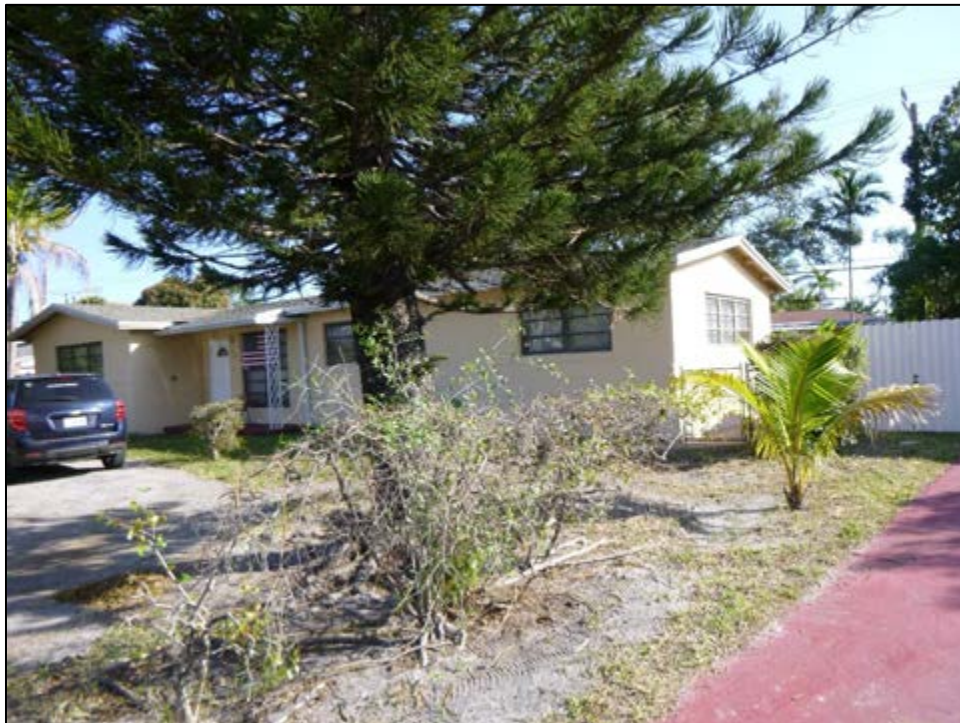
**Figure 11 – 94: 740 NE 181<sup>st</sup> Street (8DA21407), c. 1956, Considered National Register-Ineligible, facing Southeast**

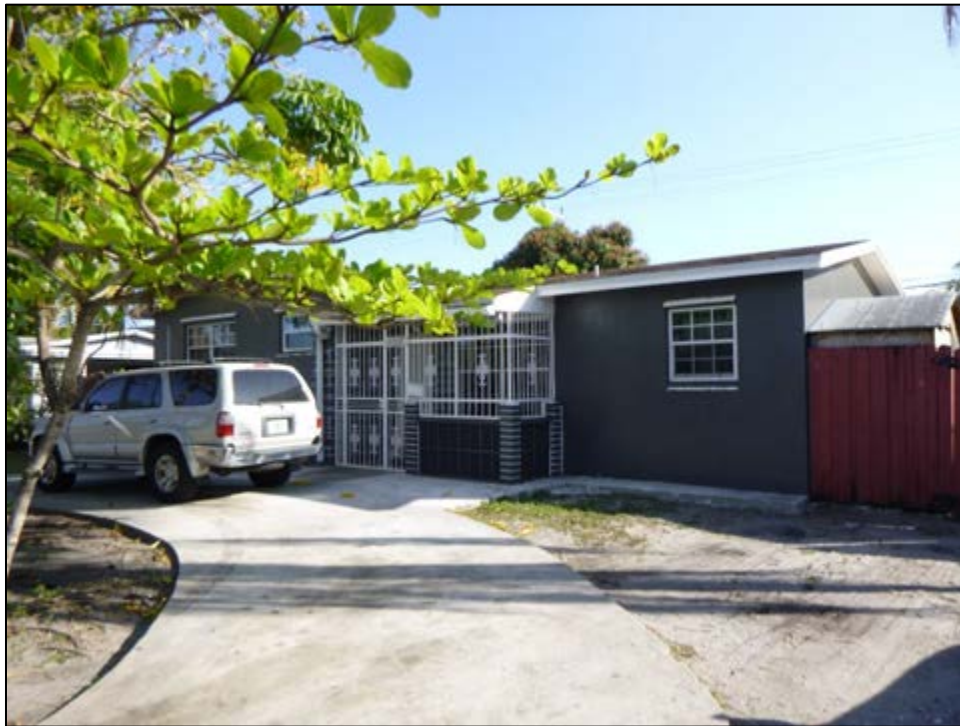
**Figure 11 – 95: 750 NE 181<sup>st</sup> Street (8DA21408), c. 1957, Considered National Register-Ineligible, facing Southeast**

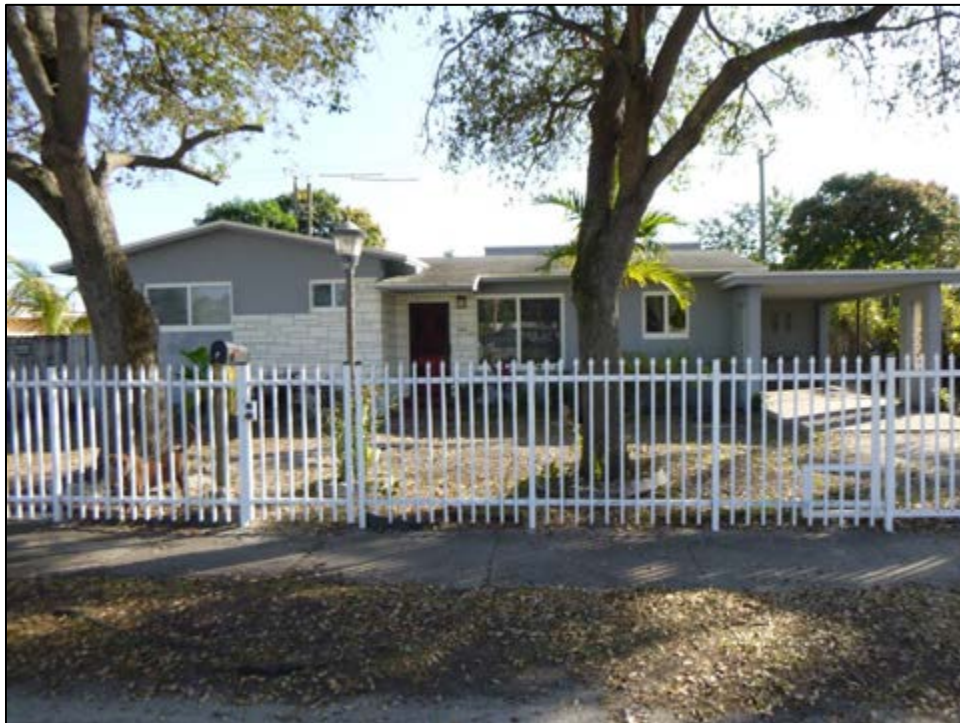
**Figure 11 – 96: 760 NE 181<sup>st</sup> Street (8DA21409), c. 1955, Considered National Register-Ineligible, facing South**

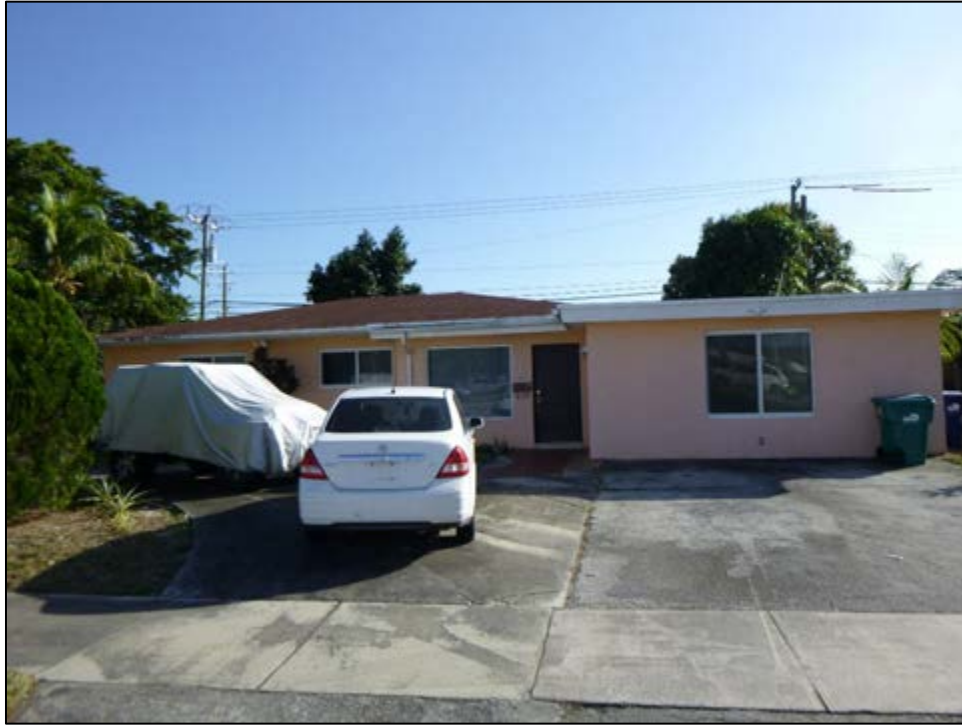
**Figure 11 – 97: 770 NE 181<sup>st</sup> Street (8DA21410), c. 1956, Considered National Register-Ineligible, facing South**
