# CULTURAL RESOURCE ASSESSMENT SURVEY

I-95/State Road (SR) 9 Project Development and Environment (PD&E) Study  
From South of SR 860/Miami Gardens Drive to North of Broward County Line  
Miami-Dade County, Florida

Financial Management Number: 414964-1-22-01  
Federal Aid Project Number: N/A  
Efficient Transportation Decision Making (ETDM): 14419

## **Cultural Resources Assessment Survey**

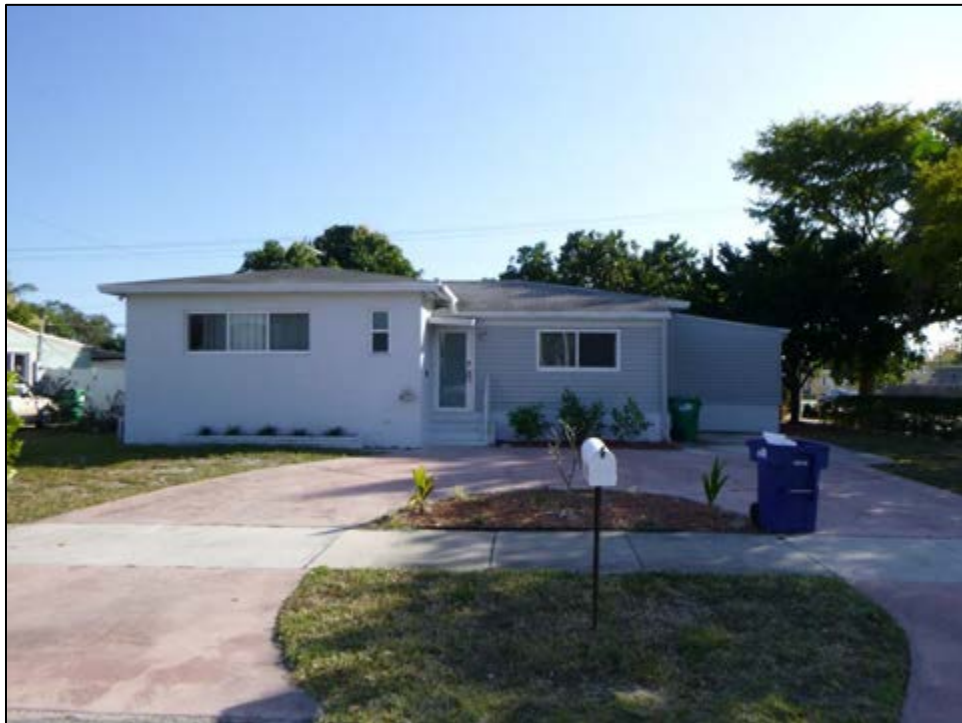
**Figure 11 – 98: 800 NE 181<sup>st</sup> Street (8DA21411), c. 1955, Considered National Register-Ineligible, facing South**

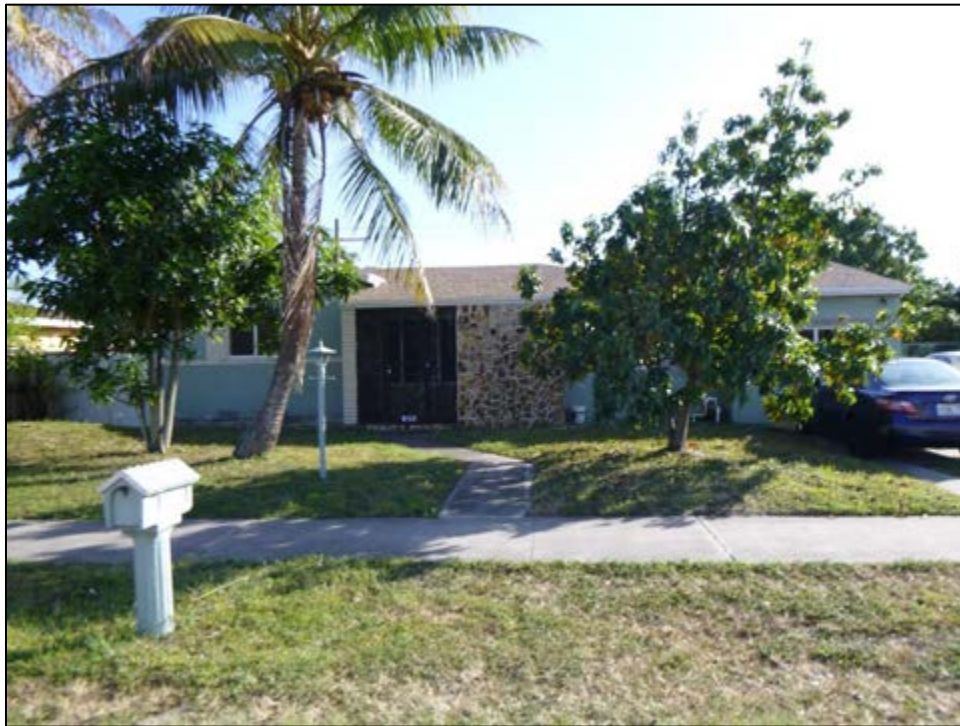
**Figure 11 – 99: 820 NE 181<sup>st</sup> Street (8DA21412), c. 1955, Considered National Register-Ineligible, facing South**

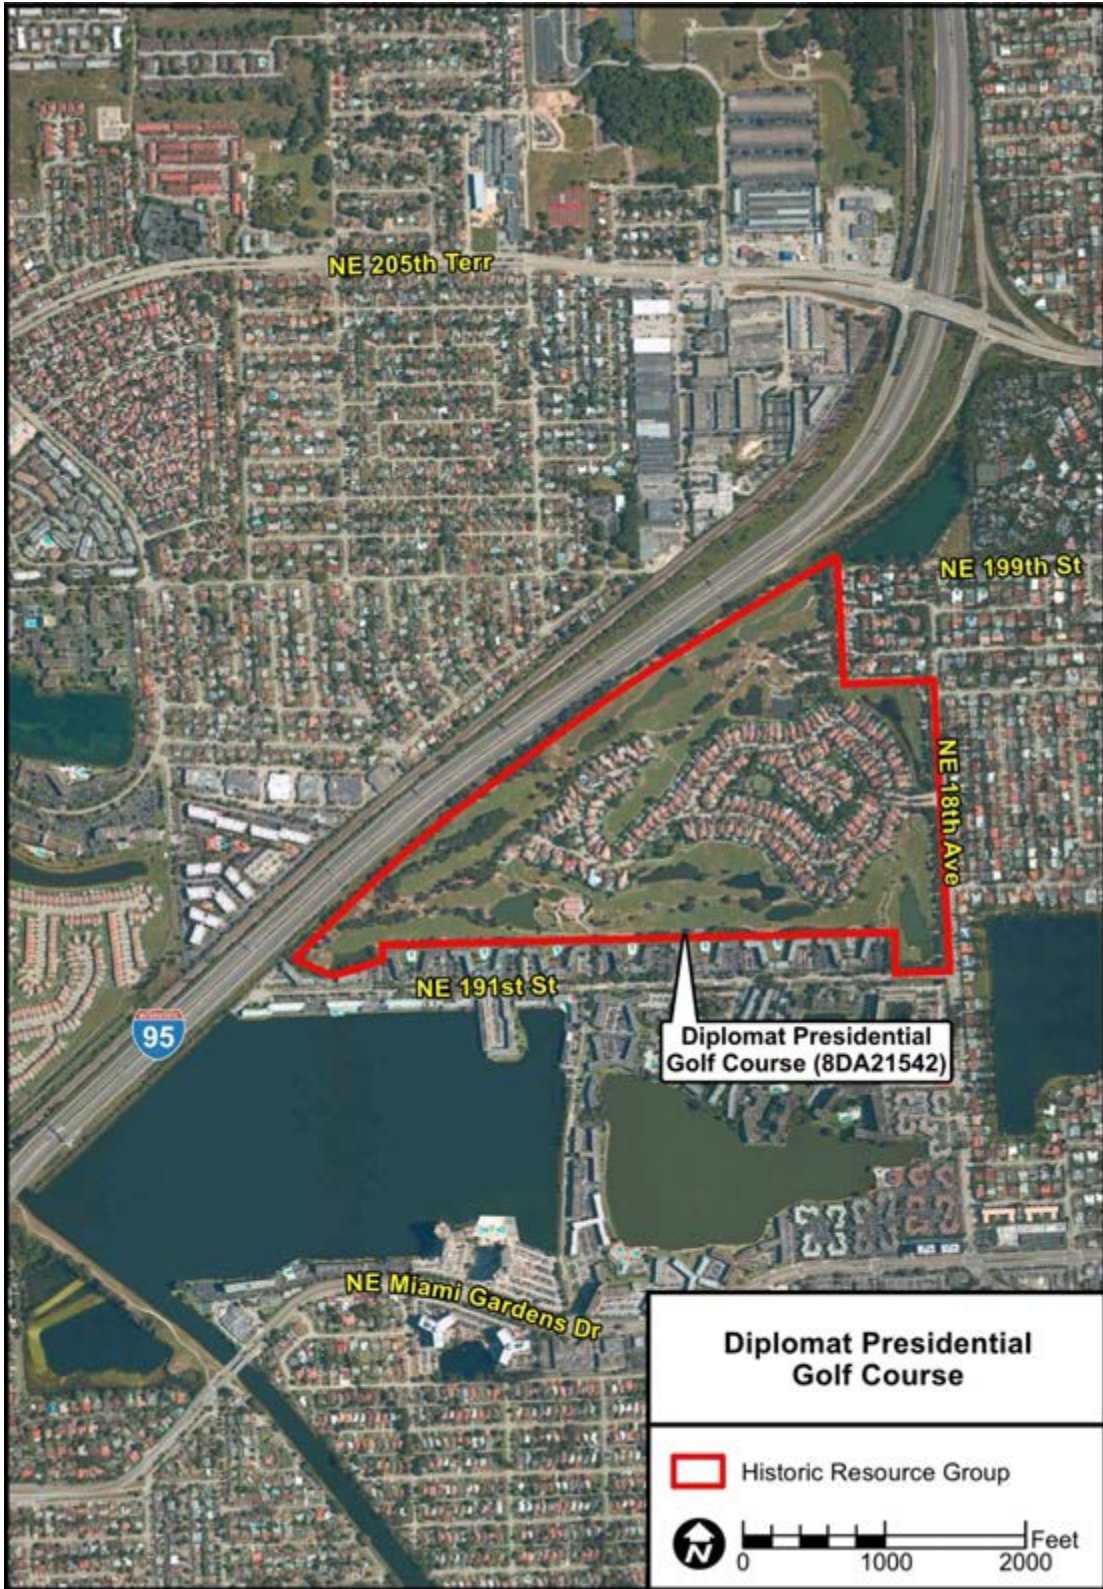
**Figure 11 – 216: Diplomat Presidential Golf Course (19600 NE Presidential Way) (8DA21542) on Modern Aerial, c. 1962, Considered National Register-Ineligible**

The Diplomat Presidential Golf Course within the project APE is located at 19600 Presidential Way in Section 5 of Township 52 South, Range 42 East on the North Miami (1988) USGS quadrangle map, in the City of North Miami Beach, Miami-Dade County, Florida (**Figure 11-216**). The golf course was constructed in 1962 as part of the Diplomat Hotel and Country Club and was designed by Mark Mahannah (Florida Golf Course Seeker 2015). Originally the country club had two golf courses, but only one falls within the current project APE. The other course located on the west side of I-95 has since been developed into a residential neighborhood. The remaining course, located within the APE, is permanently closed and unmaintained.

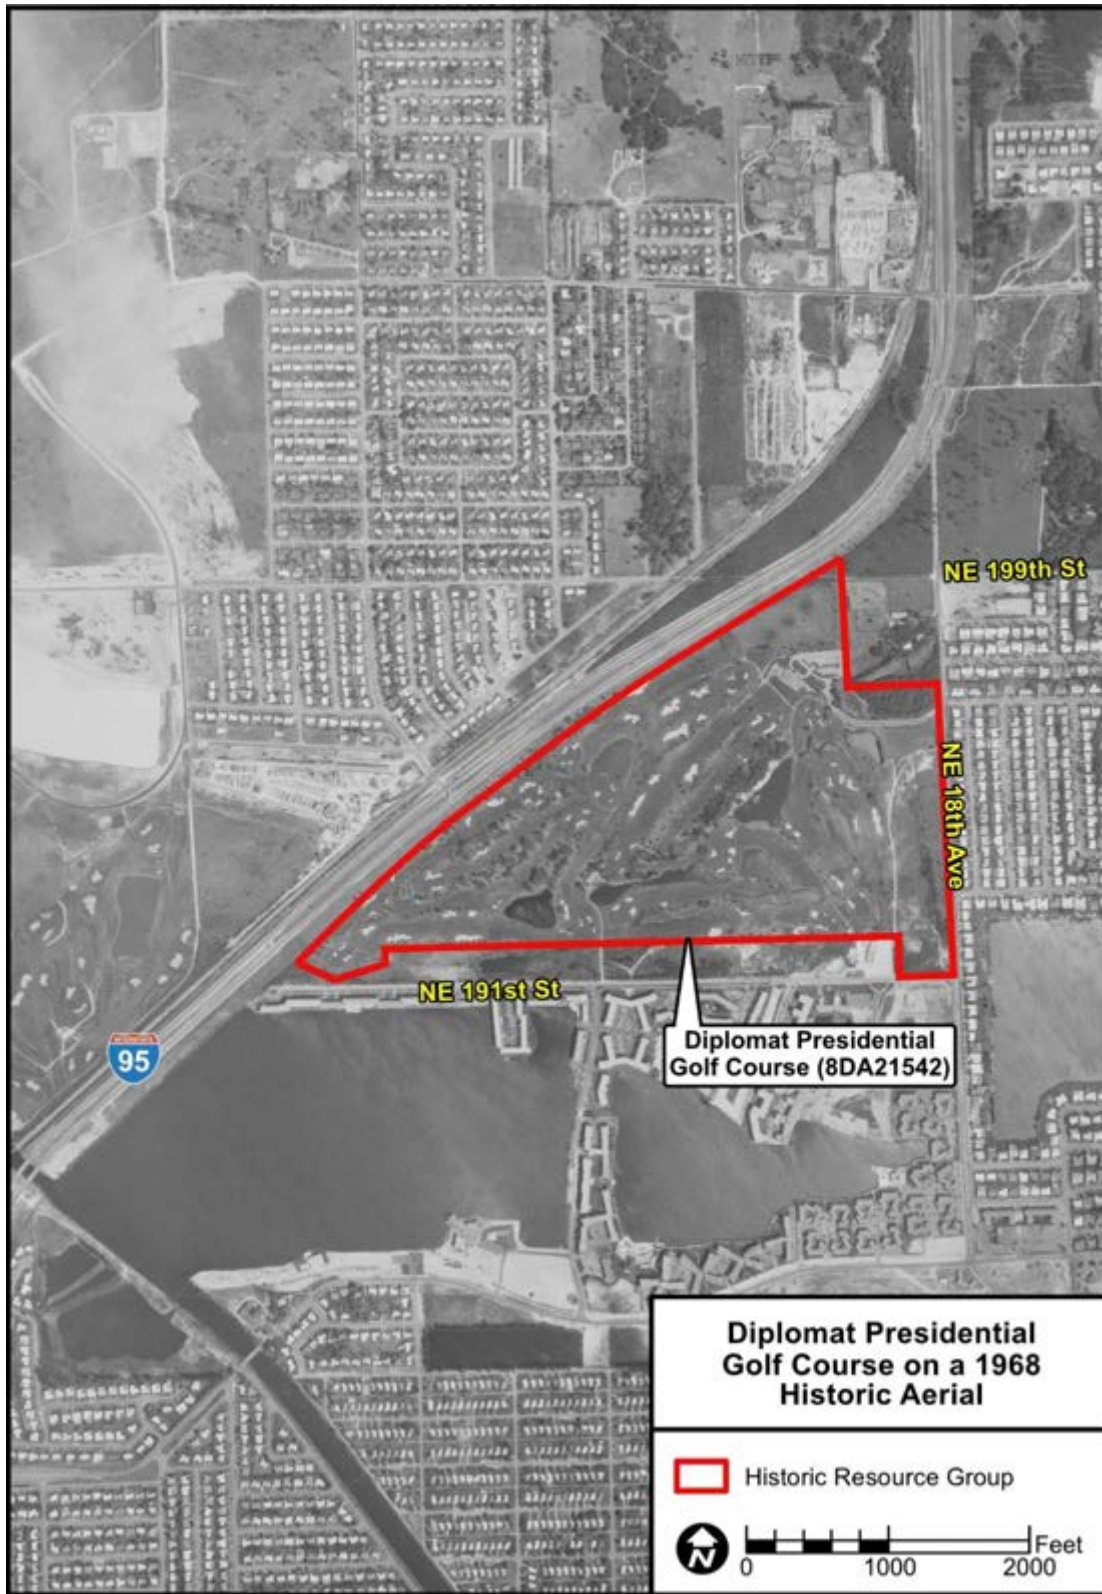
Figure 11 – 217: Diplomat Presidential Golf Course (8DA21542) on 1968 Aerial, c. 1962, Considered National Register-Ineligible

**Figure 11-217** is an aerial of the golf courses (east and a portion of the west) in 1968, showing the original layout designed by Mahannah. In 1998, the golf course was sold and redesigned by Tommy Fazio. The new design incorporated a residential neighborhood at the center of the course. It reopened in 1999. In 2009, the golf course was permanently closed after the owner declared bankruptcy.

The Diplomat Presidential Golf Course is not on the FDHR's *Historic Golf Trail*. Its original design by Mark Mahannah has been altered after being redesigned and modernized in 1998. In addition, the golf course is no longer being used or maintained, further impacting the integrity of the resource. Therefore, the current study considers the Diplomat Presidential Golf Course ineligible for the National Register.

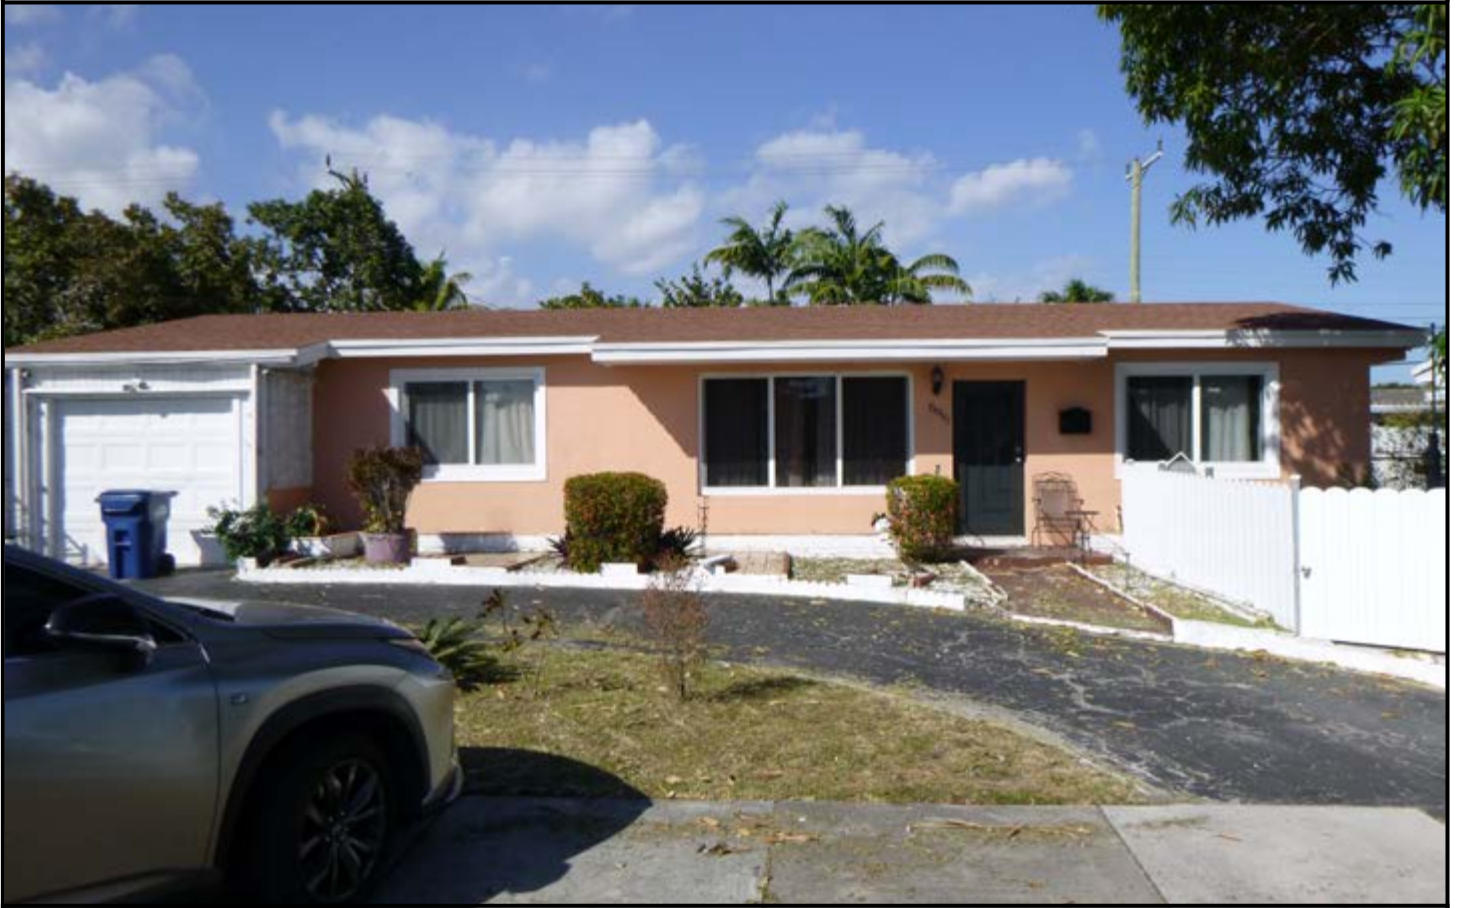
8DA21389

**Narrative Description of Resource**  
 The one-story Ranch style house has a side-gabled roof that extends over porch and garage; exterior is stucco; brick planter spans main facade; house exhibits numerous modifications including door and window replacement and enclosure of carport.

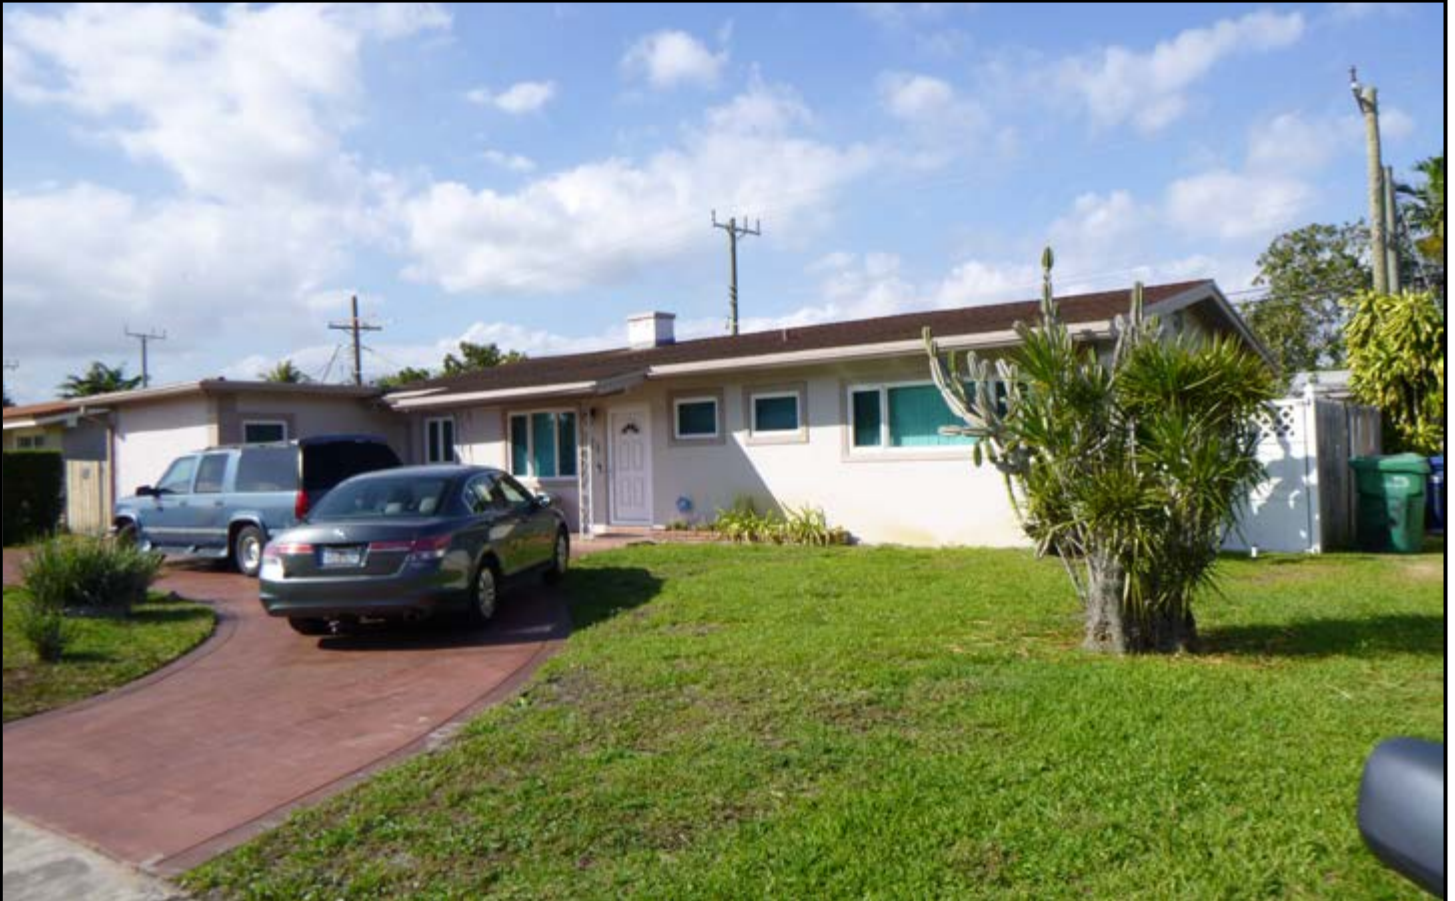
The one-story Ranch style house has a side-gabled roof with a flat roof over front wing; exterior is stucco; porch has ornamental metal roof supports; brick planter to the right of porch; windows have been replaced.

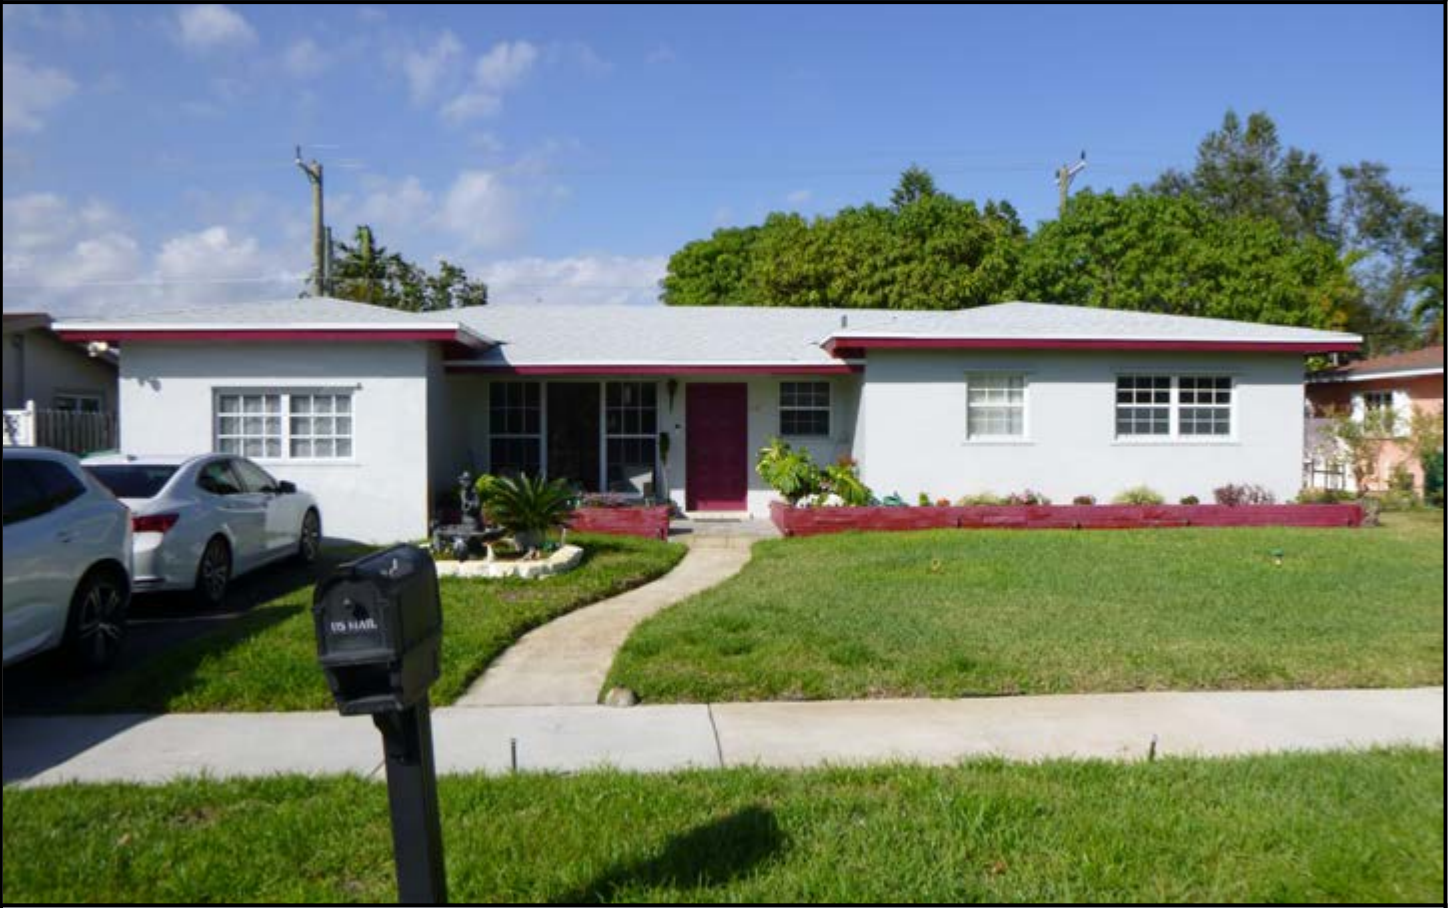
8DA21393

Narrative Description of Resource The one-story Ranch style house has a hip roof crossed by two hip roofs over the side wings; exterior is stucco; built-in planters span most of main facade; majority of the windows have been replaced.

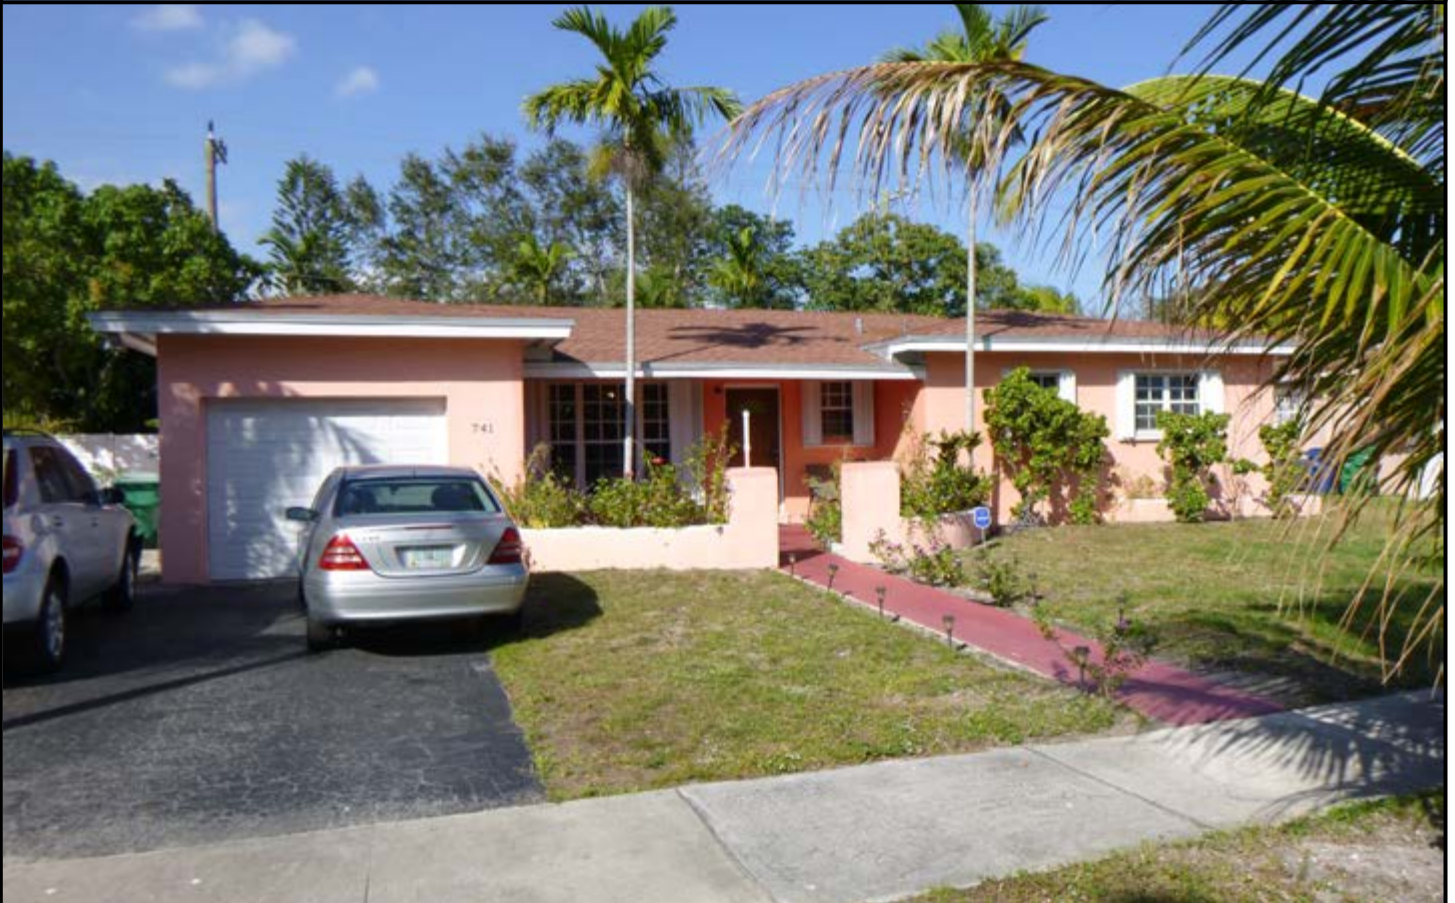
8DA21394

The one-story Ranch style house has a hip roof crossed by two hip roofs over the side wings; exterior is stucco; built-in planters along right facade and in courtyard walls; accordion shutters replaced decorative shutters c.2019.

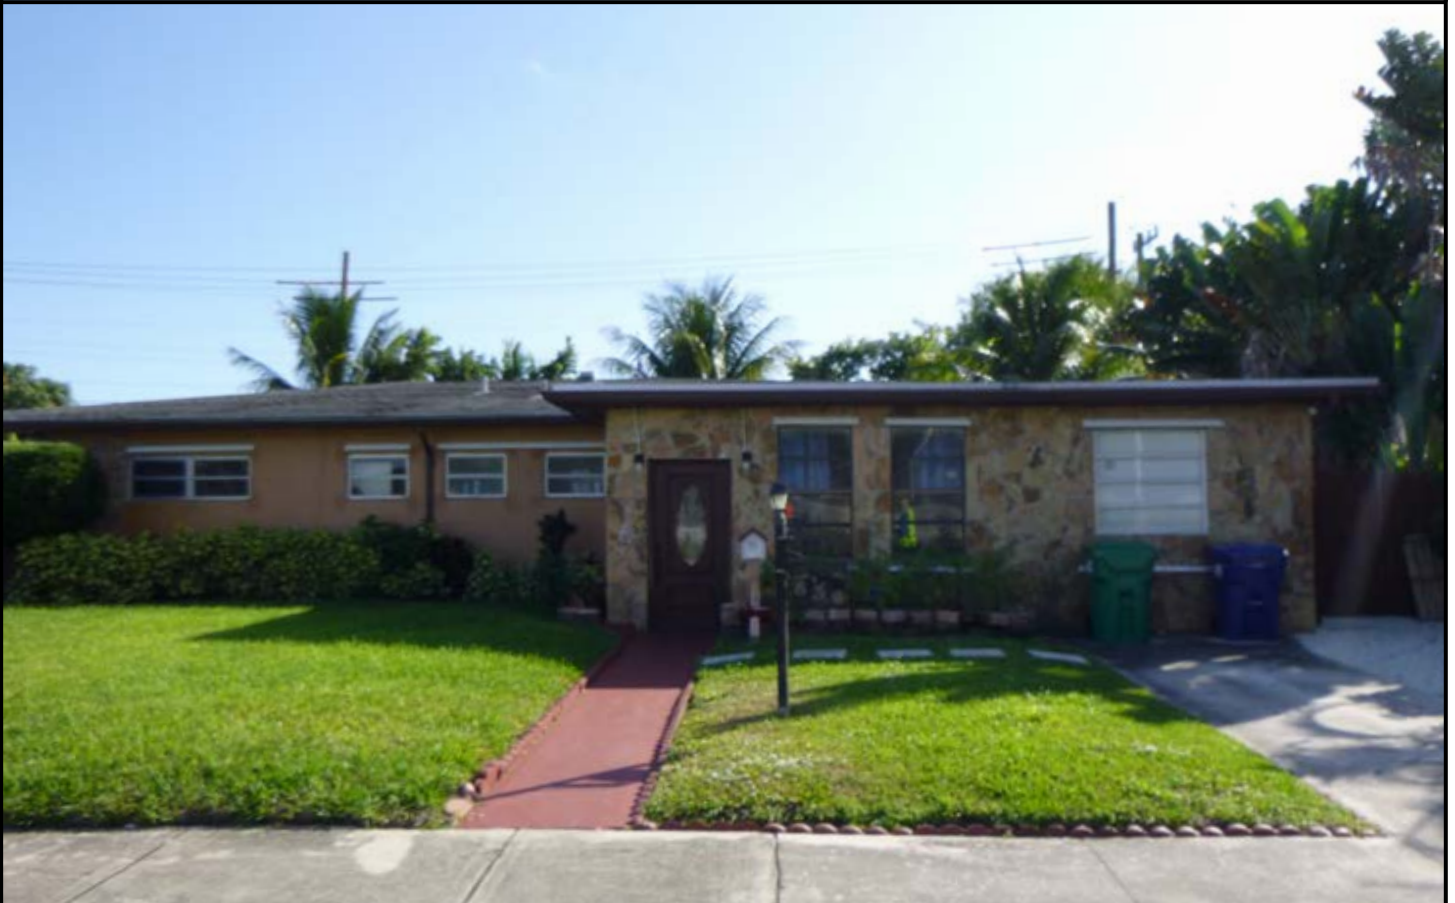
Main Entrance (stylistic details) Located on the left side of the front wing; replacement door.

Narrative Description of Resource The one-story Ranch style house has a shingled hip roof with a flat roof over the front wing; exterior is stone cladding on front wing and stucco on remaining facades; some windows have been replaced.

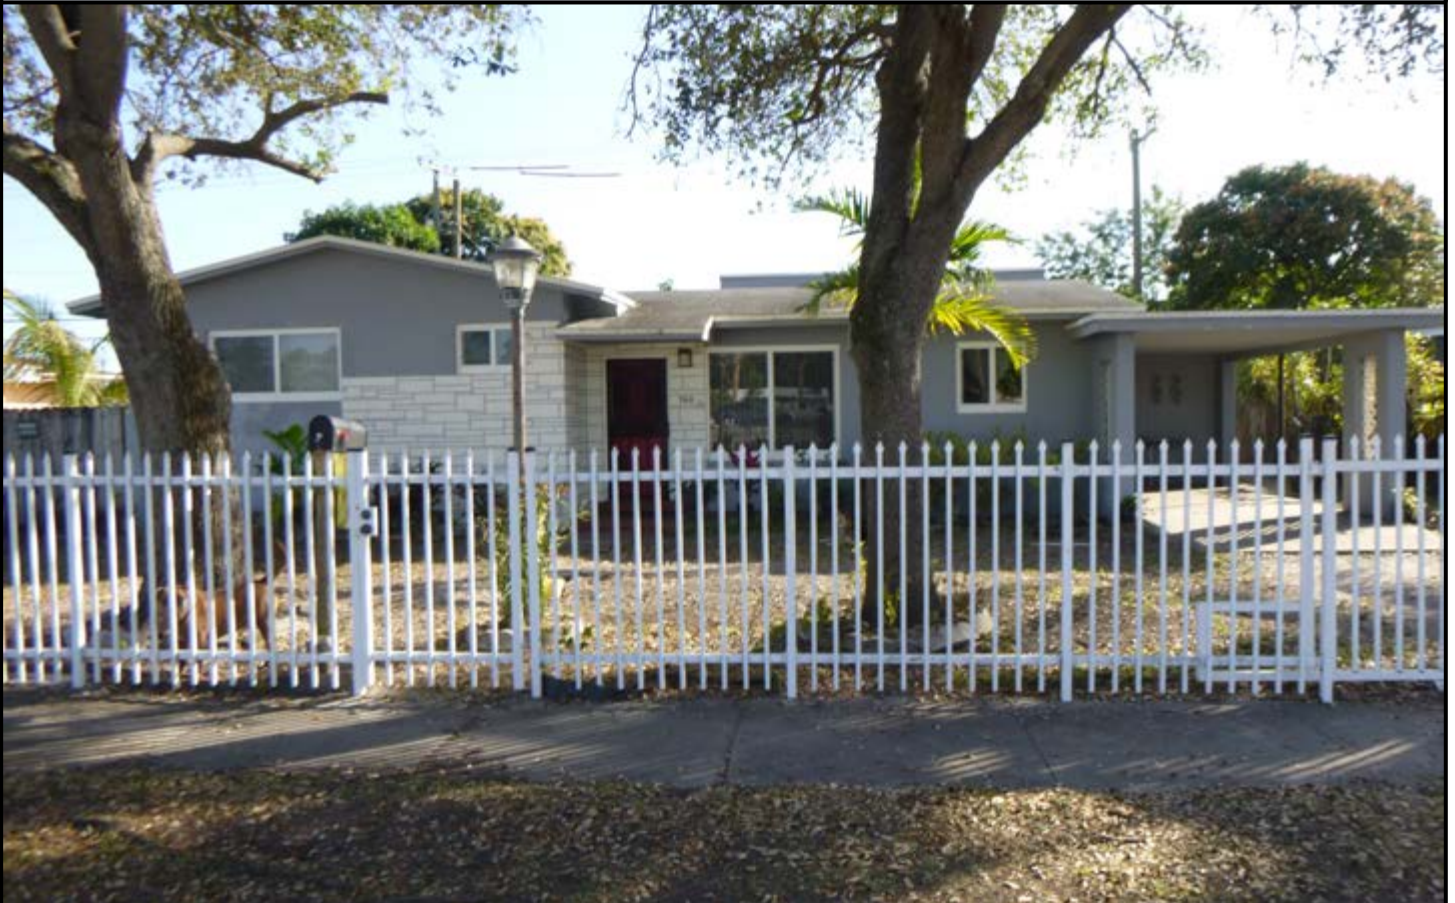
8DA21410

The one-story Ranch style house has a hipped roof with a flat roof over the front wing; exterior is stucco; windows have been replaced.

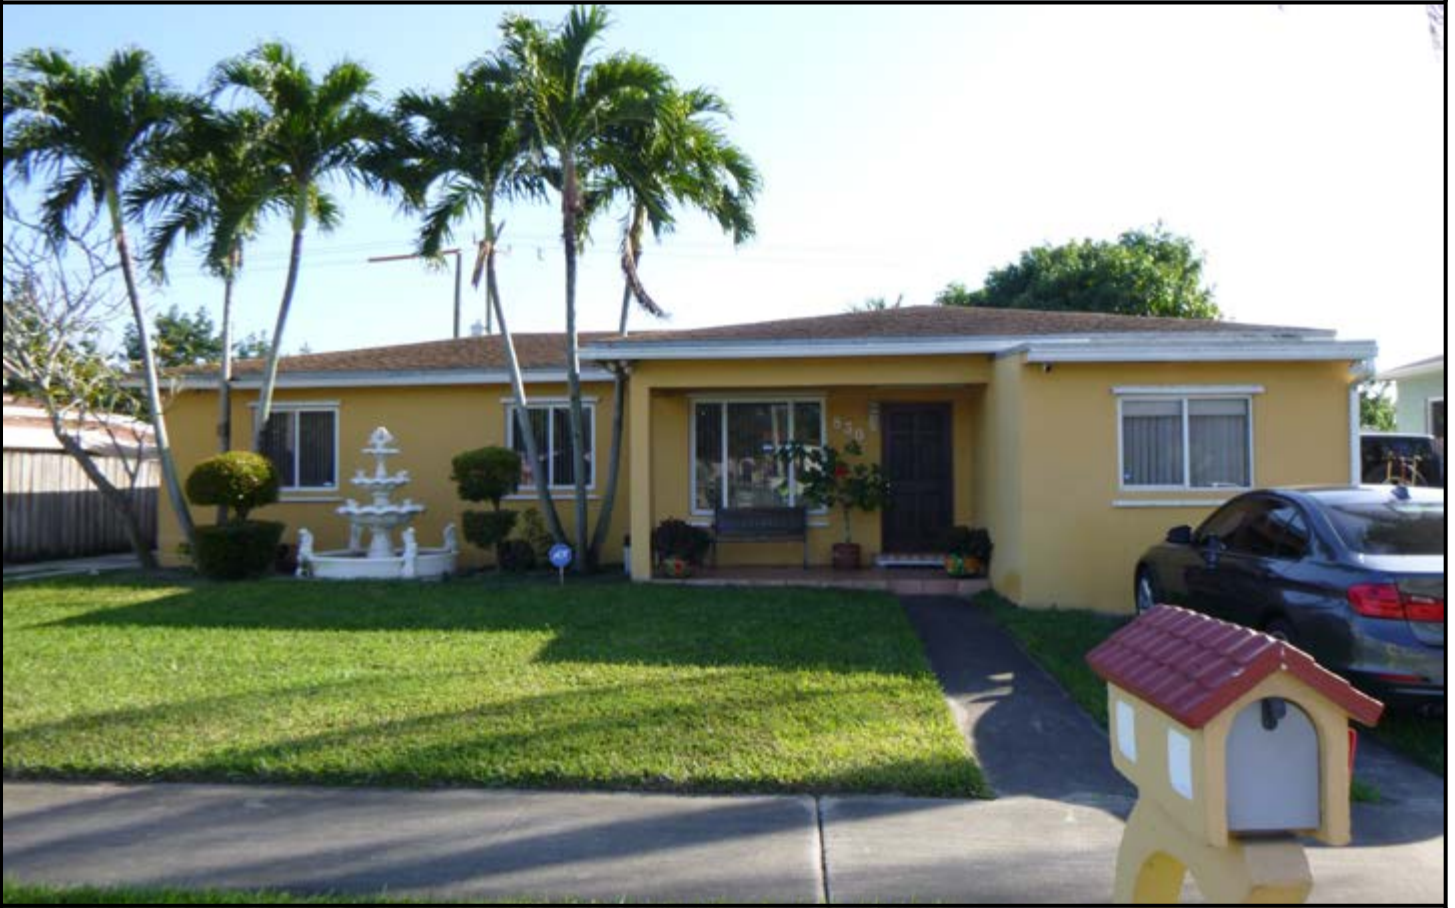
8DA21413

The one-story Ranch style house has a hipped roof with a shed roof over the front wing; exterior is stucco; large front porch; windows have been replaced.

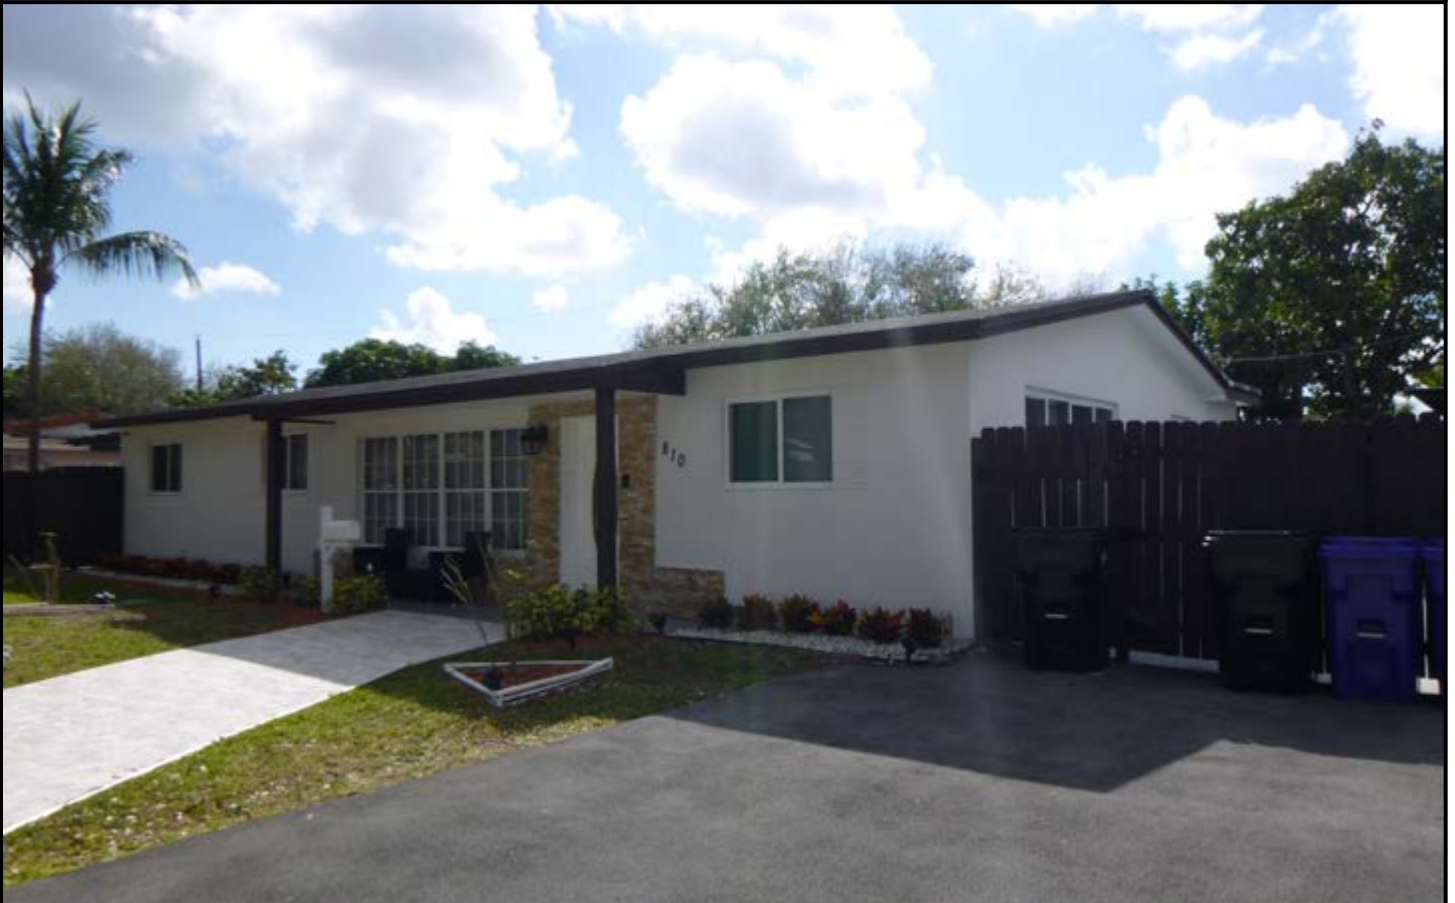
8DA21434

Narrative Description of Resource The one-story Ranch style house has a side-gabled roof crossed by a front-gabled roof over the porch; exterior is stucco with wood siding in upper gable; decorative shutters flank windows; metal grille covers front door; windows have been replaced.

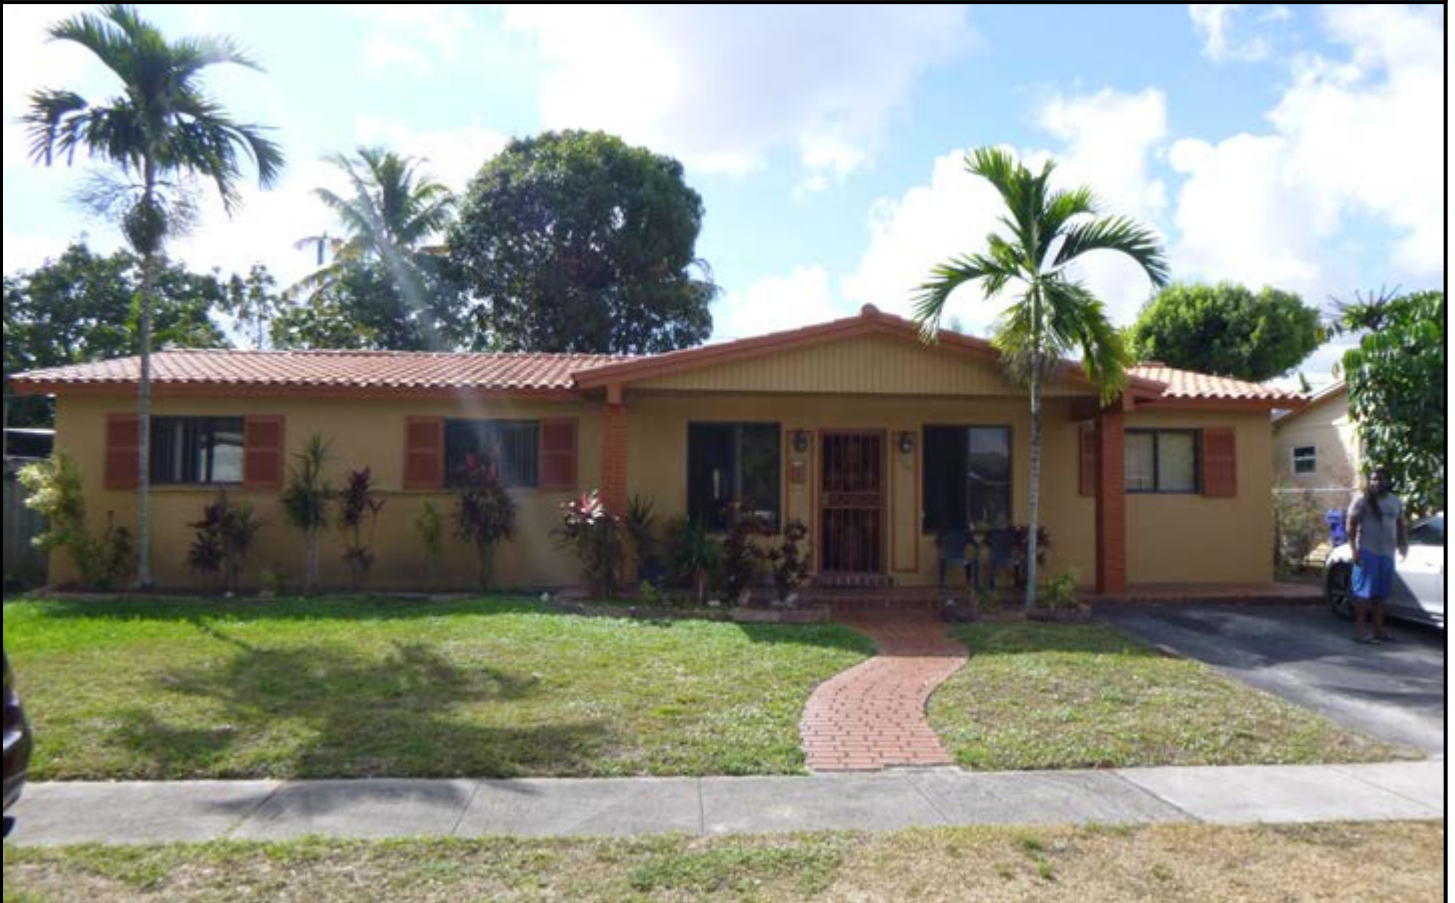
8DA21435

The one-story Ranch style house has a side-gabled roof crossed by a front-gabled roof over the porch; exterior is brick with stucco in upper gable; decorative shutters flank windows; garage has been enclosed; windows have been replaced.

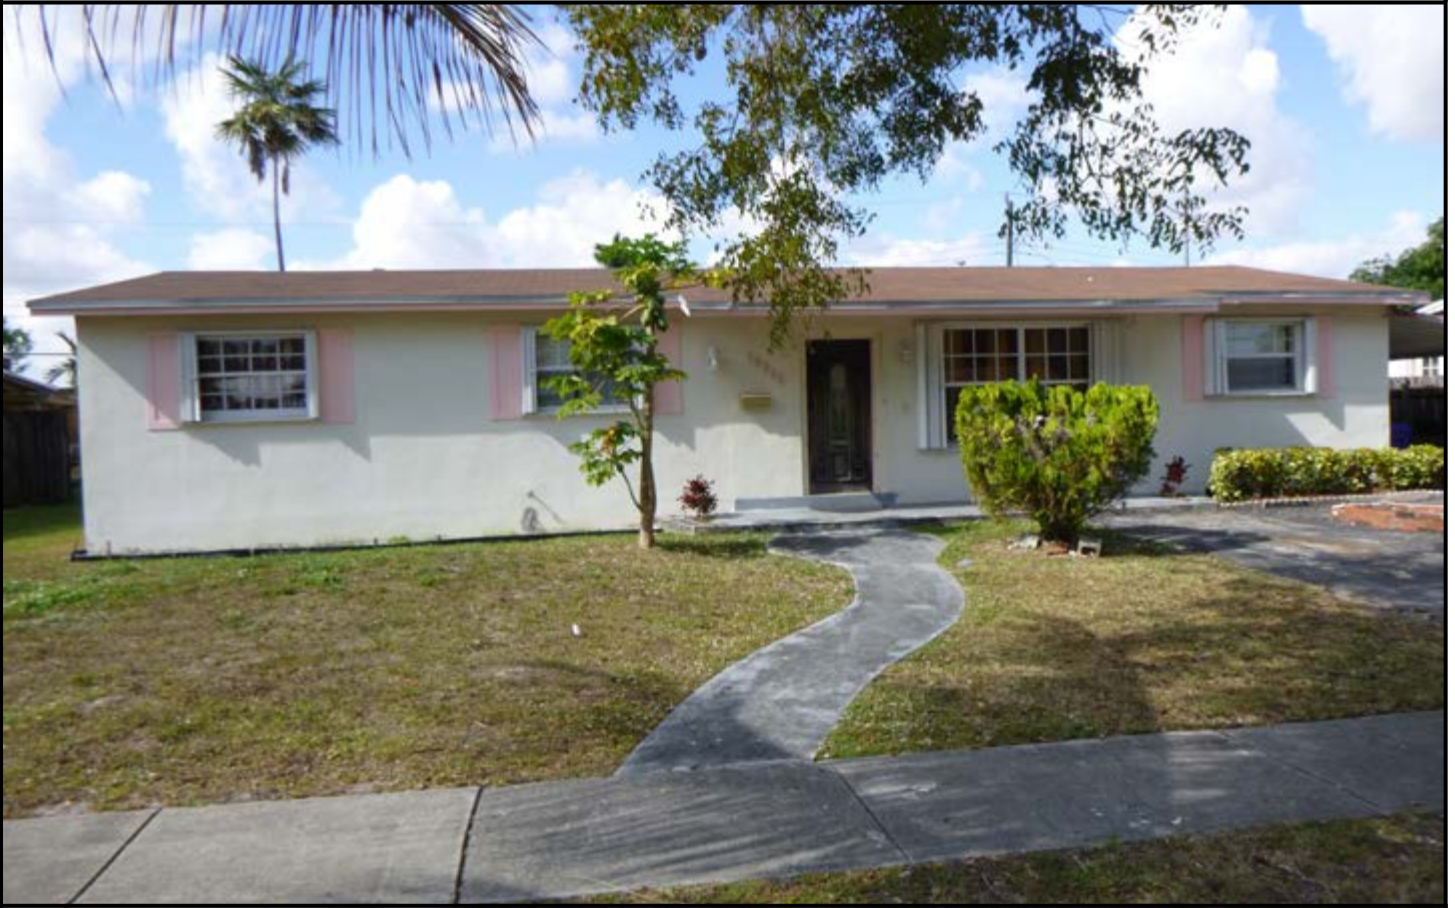
8DA21443

Narrative Description of Resource
The one-story Ranch style house has a side-gabled roof; exterior is stucco; windows have been replaced and are flanked by decorative shutters.

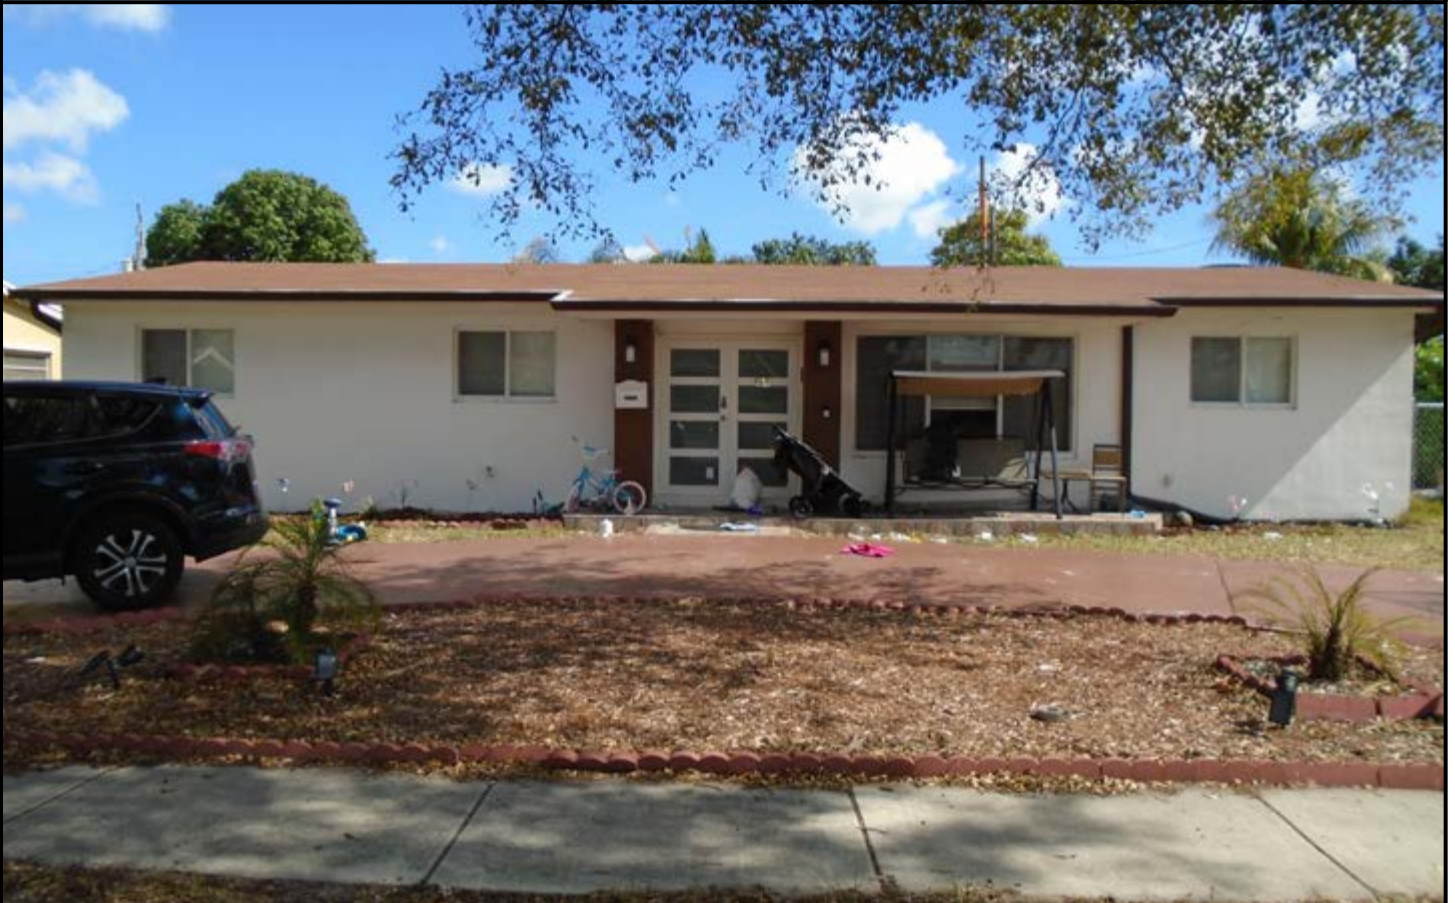
8DA21454

The one-story Ranch style house has a side-gabled roof; exterior is stucco; double front doors and windows have been replaced.

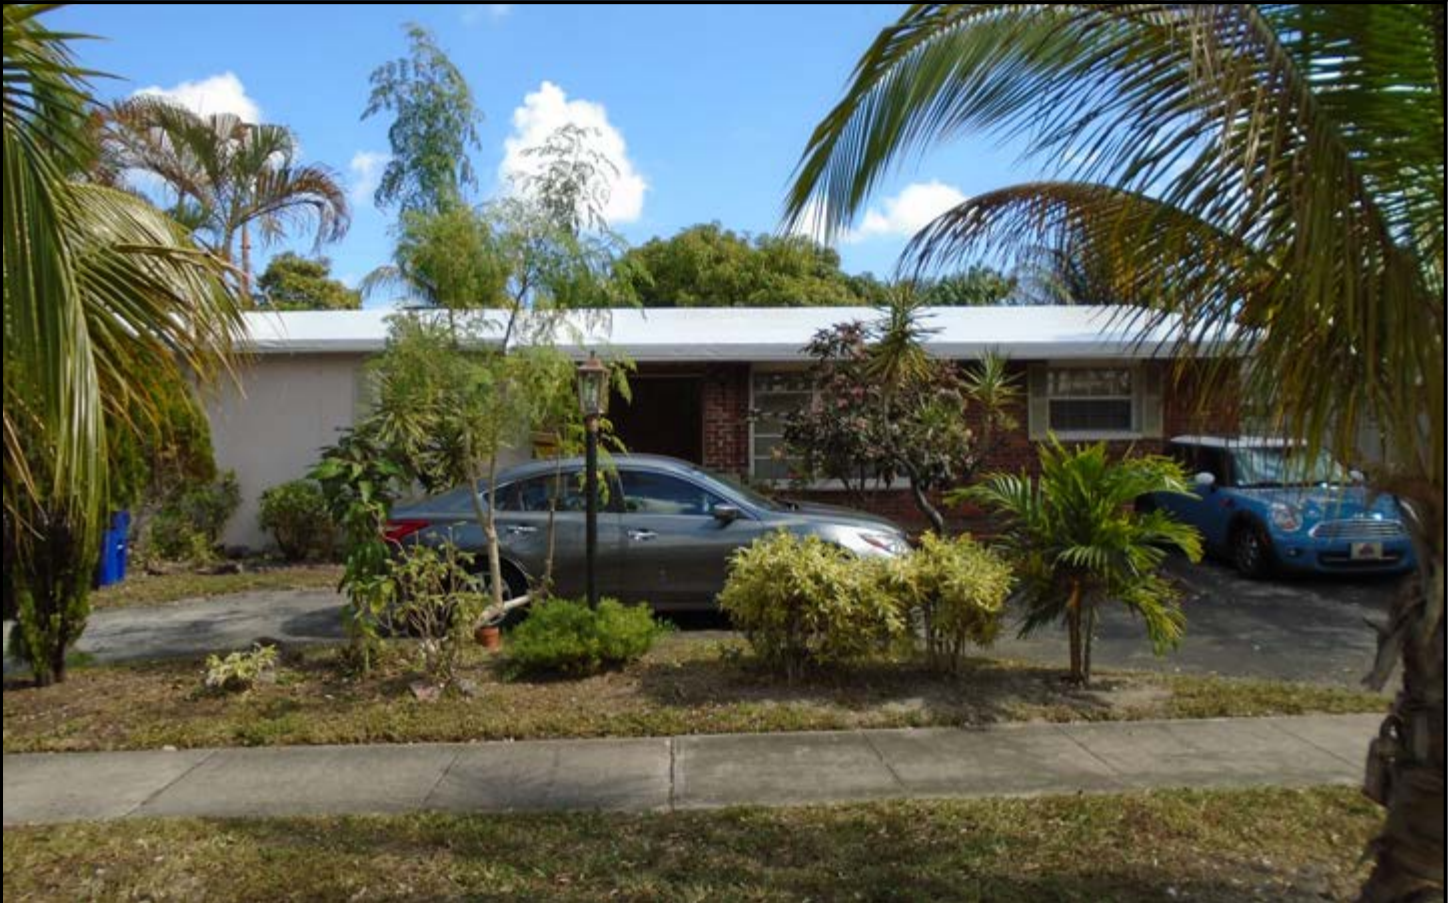
8DA21455

The one-story Ranch style house has a side-gabled roof; exterior is stucco and brick cladding along porch; bay window with awning windows; double front doors and some windows have been replaced.
