# CULTURAL RESOURCE ASSESSMENT SURVEY

I-95/State Road (SR) 9 Project Development and Environment (PD&E) Study  
From South of SR 860/Miami Gardens Drive to North of Broward County Line  
Miami-Dade County, Florida

Financial Management Number: 414964-1-22-01  
Federal Aid Project Number: N/A  
Efficient Transportation Decision Making (ETDM): 14419

## **Cultural Resources Assessment Survey**

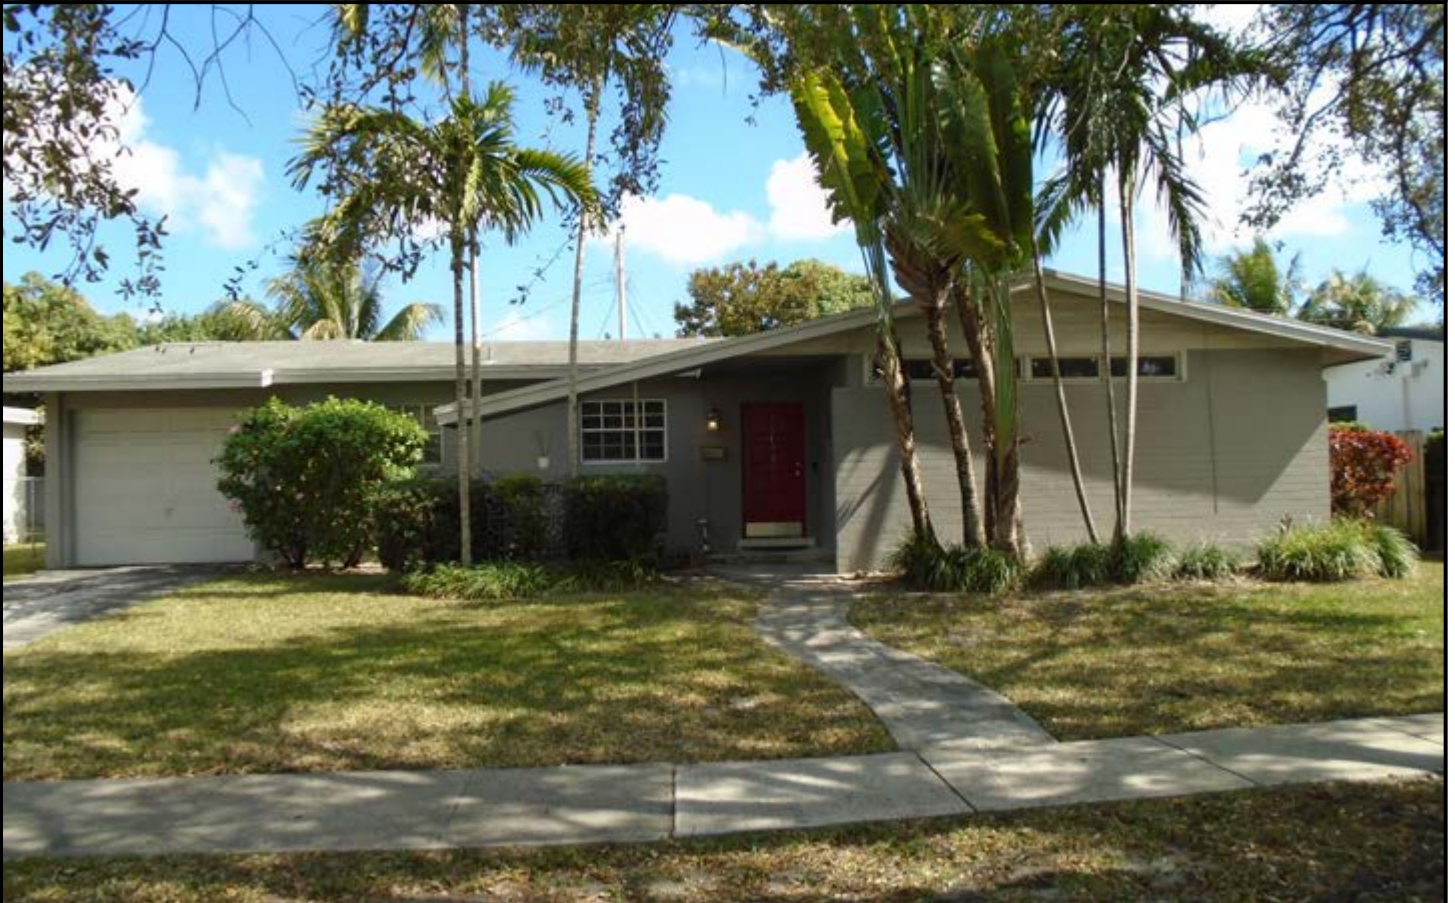
8DA21456

**Narrative Description of Resource**  
 The one-story Contemporary style house has a side-gabled roof crossed by a front-gabled roof; narrow band of roof shelters breezeblock porch privacy wall; exterior is stucco and concrete block with vinyl in upper gable; windows have been replaced.

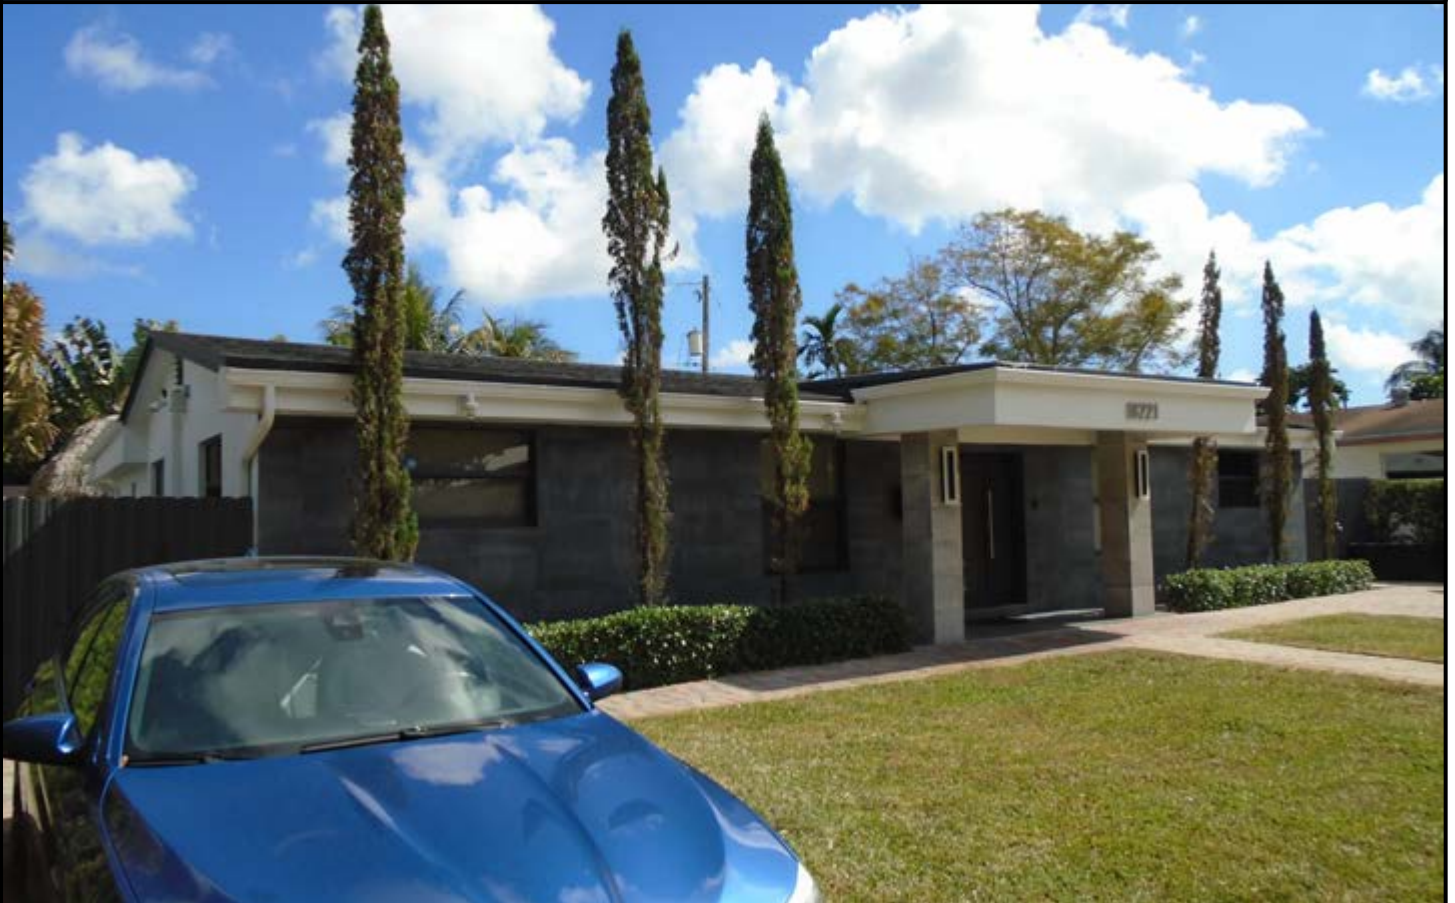
8DA21457

The one-story Ranch style house has a side-gabled roof with a shed roof over the porch; exterior is tile on the main facade and stucco on remaining facades; windows have been replaced.

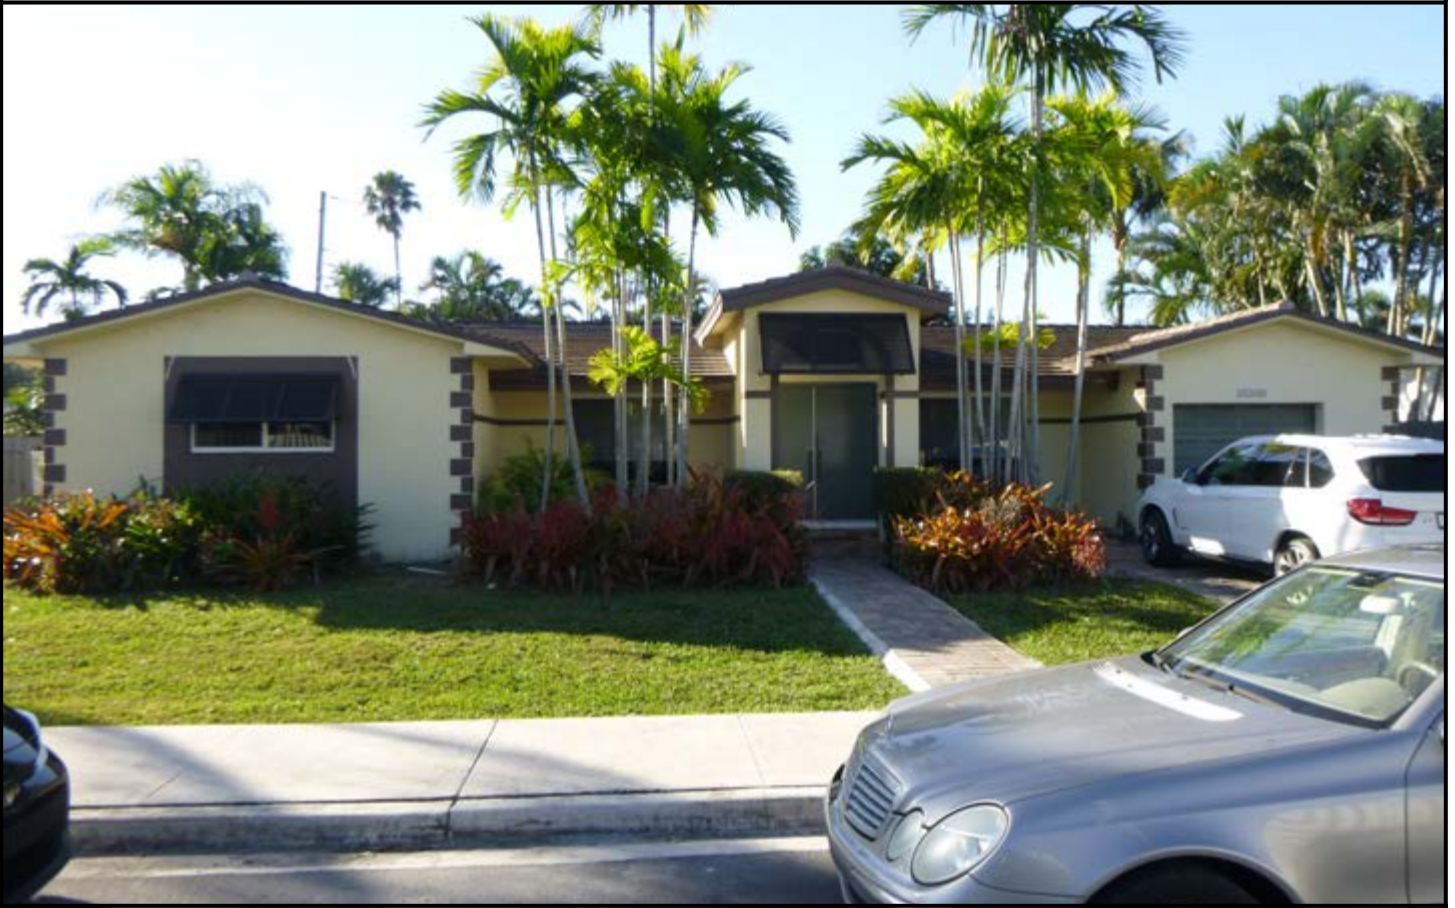
8DA21473

The one-story Ranch style house has a side-gabled roof crossed by three front-gabled wings; exterior is stucco; quoins at corners of front wings; louvered awning shutters shade windows, windows replaced c.2014-2020.

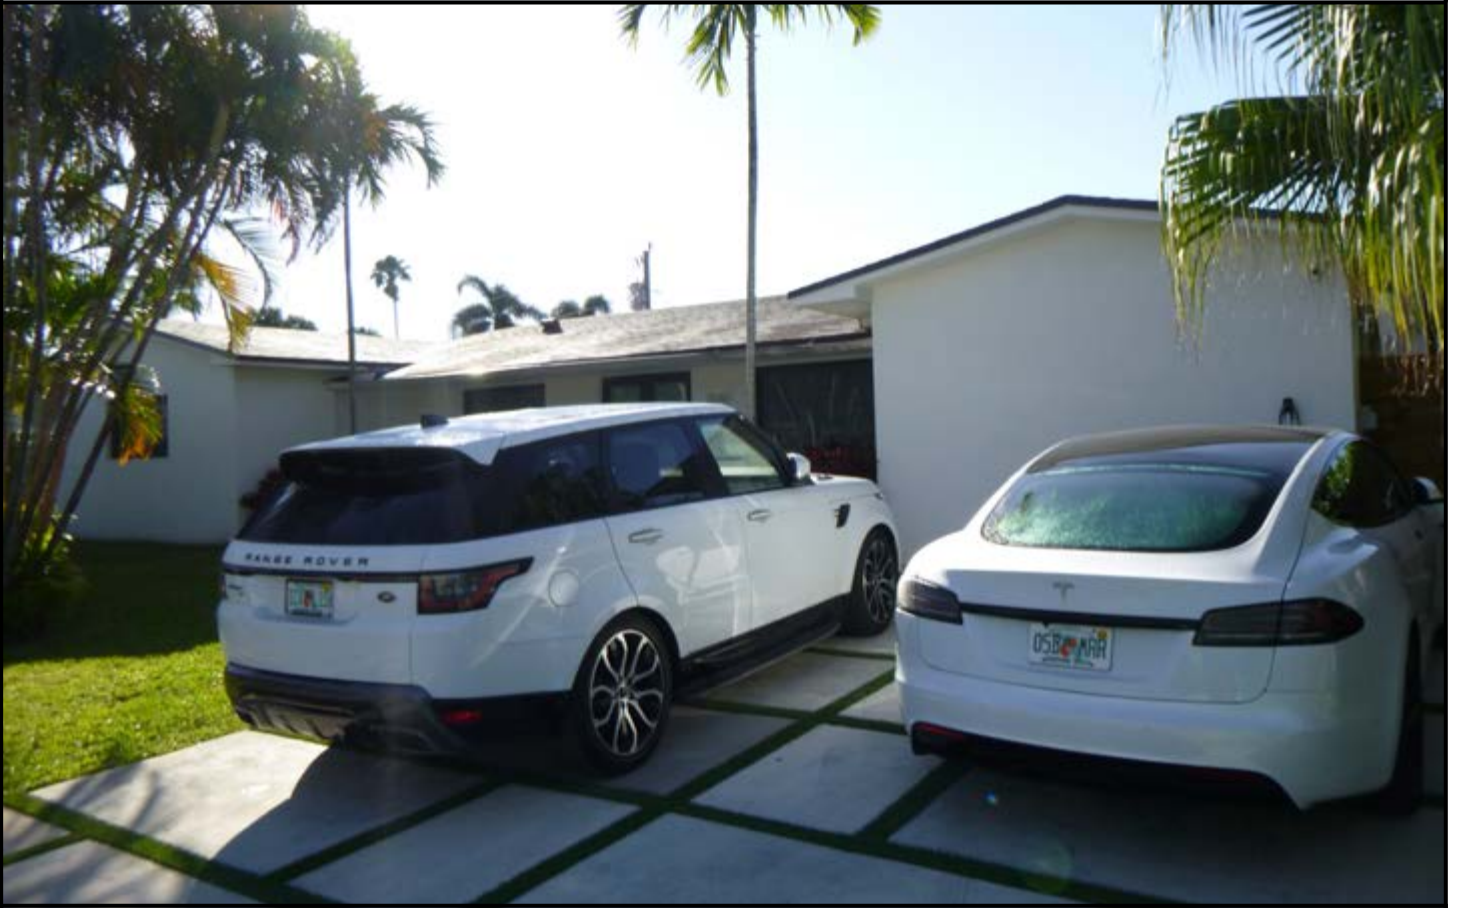
8DA21475

The one-story Ranch style house has a side-gabled roof crossed by two front-gabled wings; exterior is stucco; windows replaced c.2014-2020; stone cladding, planters, and breezeblock wall were removed between 2014-2020.

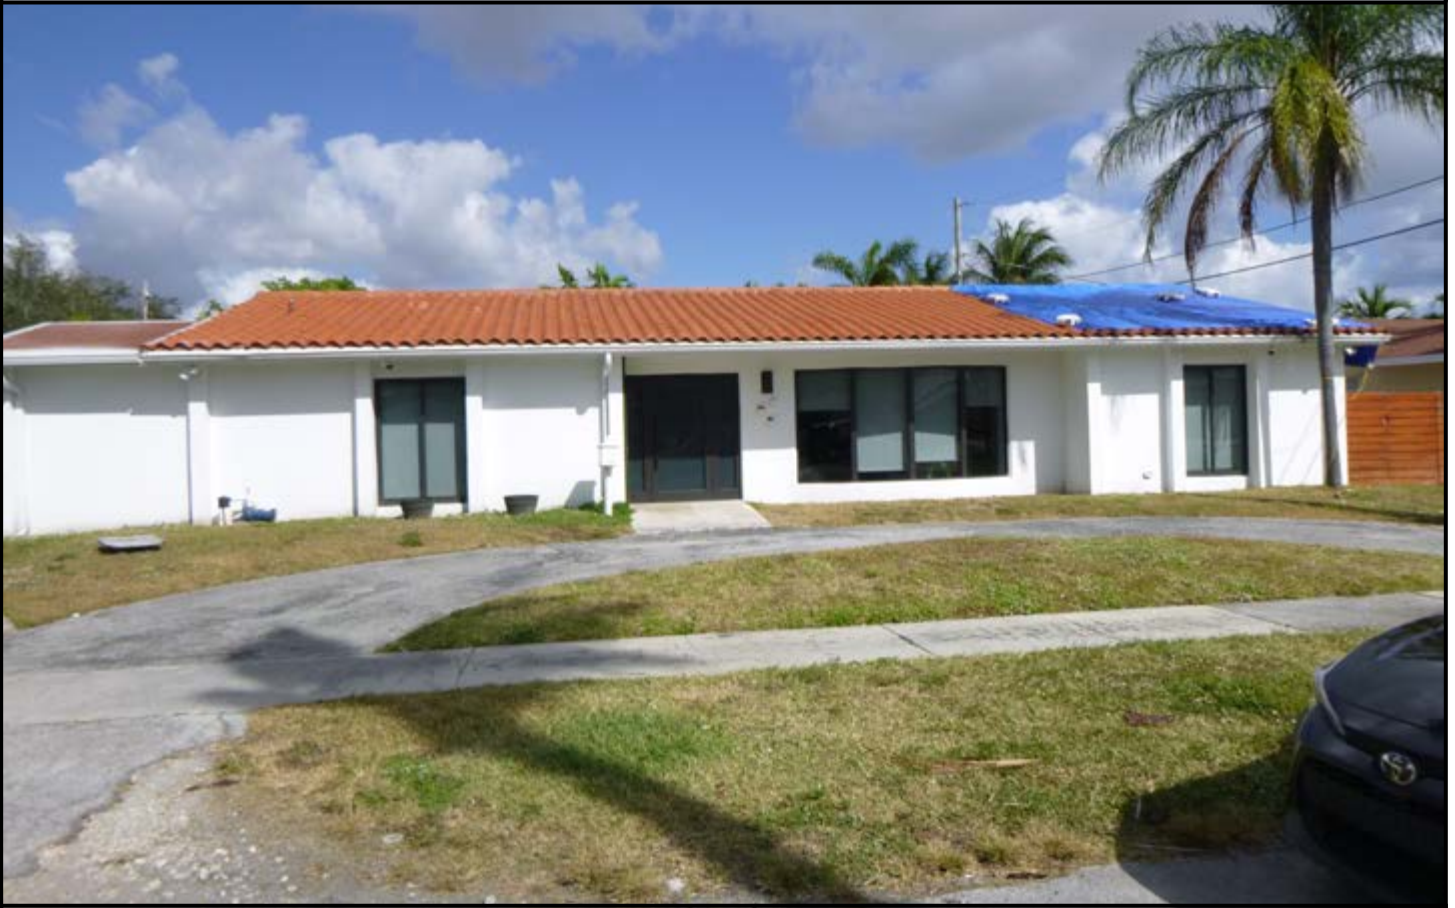
8DA21503

Narrative Description of Resource The Ranch style house has a side-gabled roof crossed by two front-gabled wings; exterior is stucco with modern wood siding flanking front door; windows have been replaced.

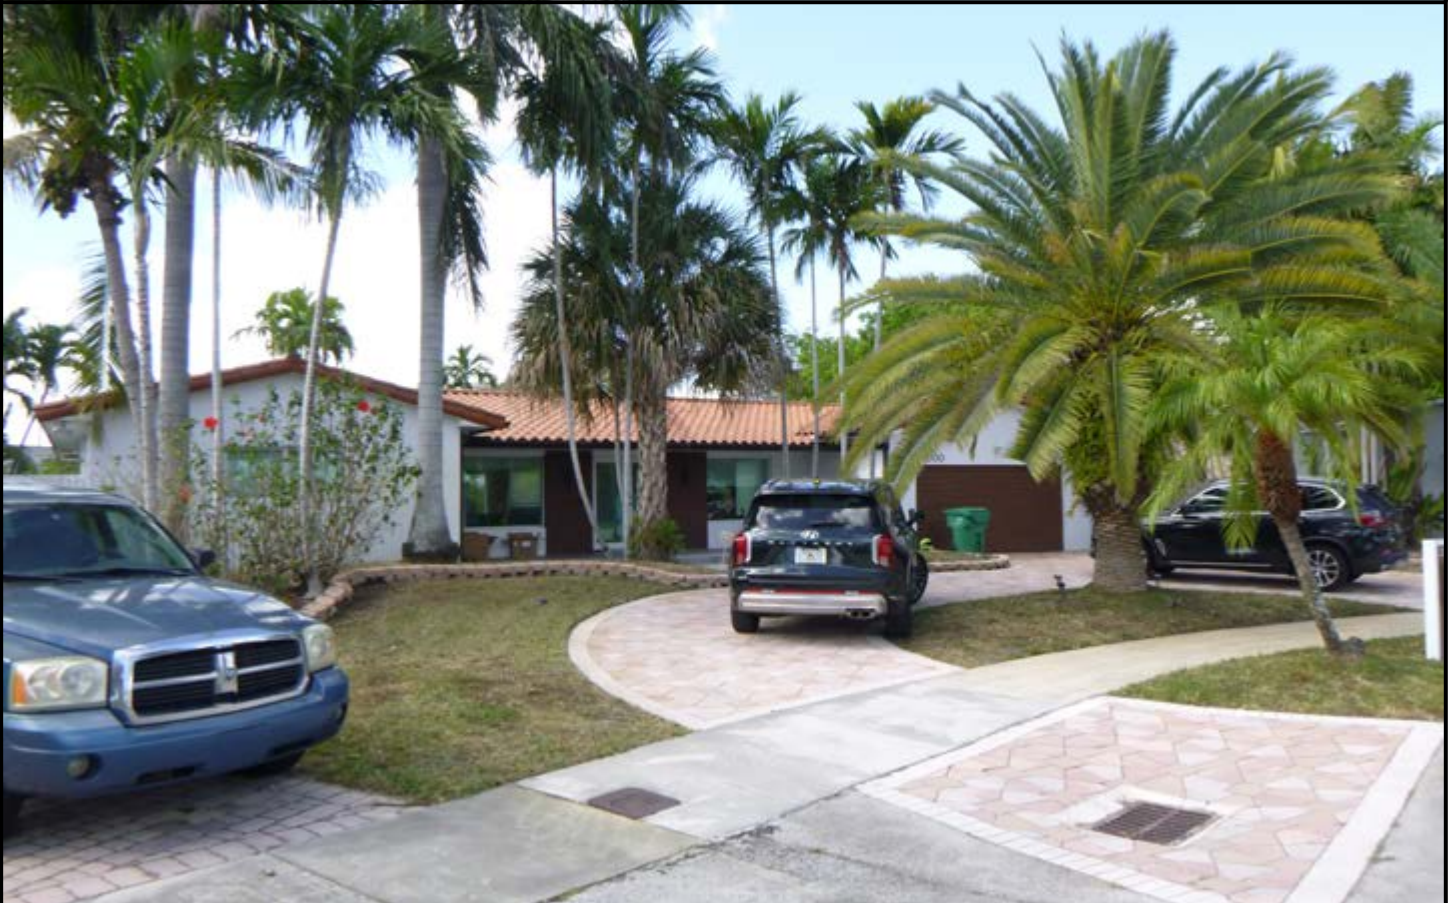
8DA21504

The Ranch style house has a side-gabled roof crossed by two front-gabled wings; exterior is stucco; front door has been replaced.

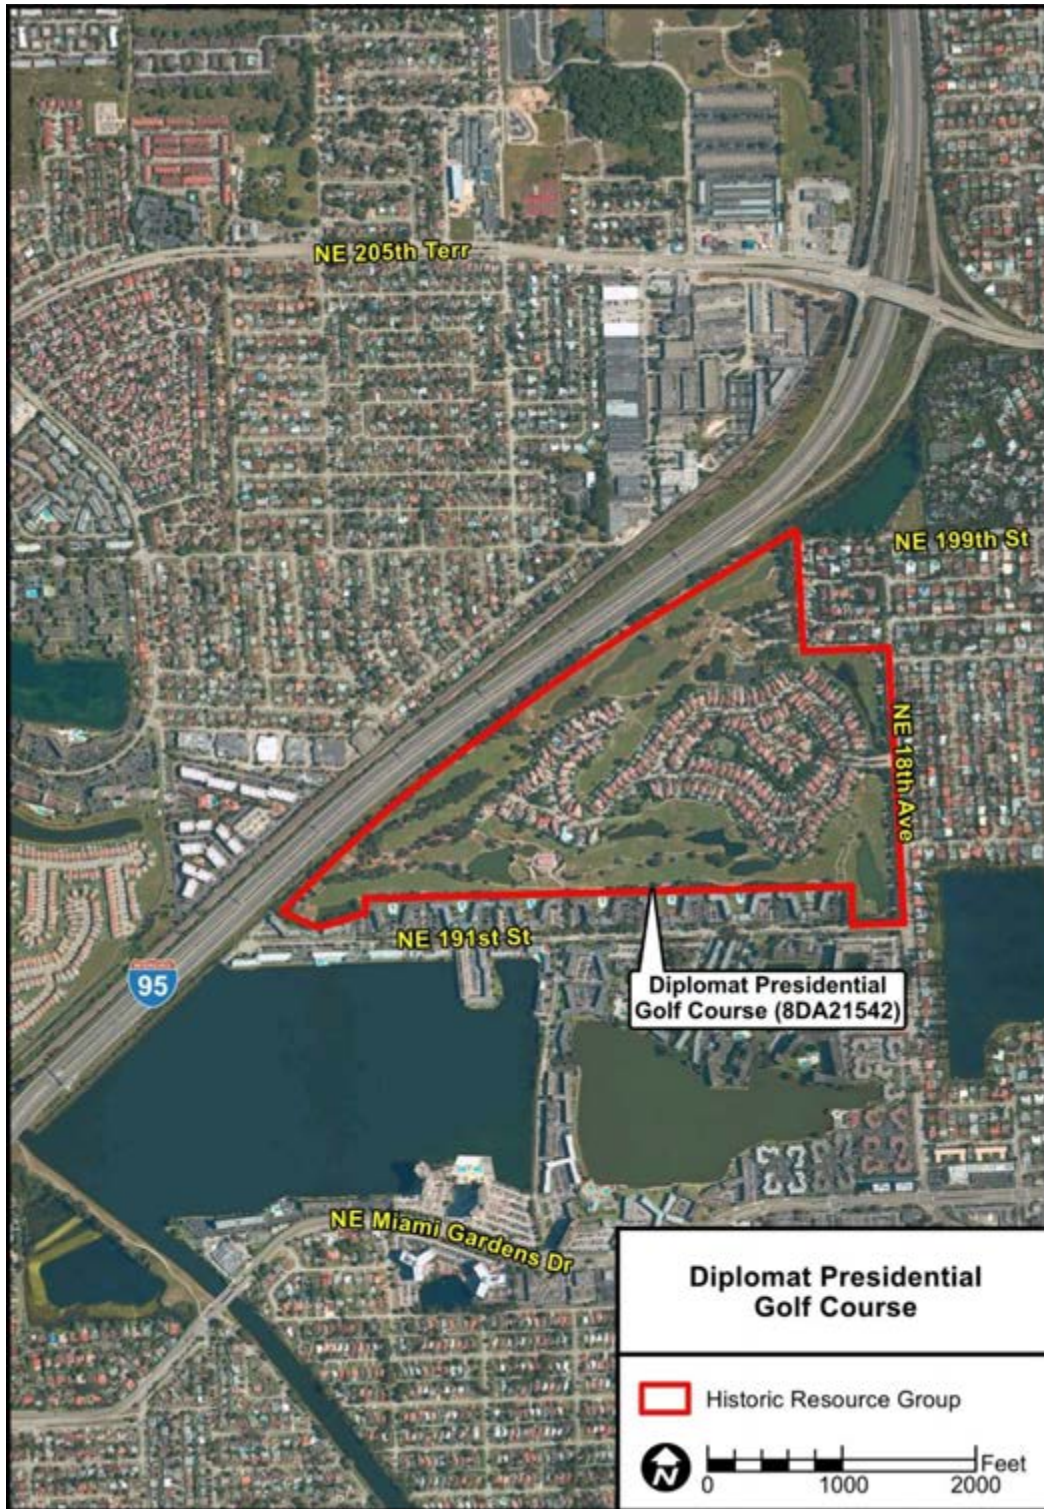
The Diplomat Presidential Golf Course within the project APE is located at 19600 Presidential Way in Section 5 of Township 52 South, Range 42 East on the North Miami (1988) USGS quadrangle map, in the City of North Miami Beach, Miami-Dade County, Florida (Figure 1). The golf course was constructed in 1962 as part of the Diplomat Hotel and Country Club and was designed by Mark Mahannah (Florida Golf Course Seeker 2015). Originally the country club had two golf courses, but only one falls within the current project APE. The other course located on the west side of I-95 has since been developed into a residential neighborhood. The remaining course, located within the APE, is permanently closed and unmaintained.

Figure 1: Current Aerial (2023) of the Diplomat Presidential Golf Course (8DA21542). The golf course permanently closed in 2009. Aerial Courtesy of Google Maps.

The Diplomat Presidential Golf Course is not on the Florida Division of Historical Resources' *Historic Golf Trail*. Its original design by Mark Mahannah has been altered after being redesigned and modernized in 1998. In addition, the golf course is no longer being used or maintained, further impacting the integrity of the resource. Therefore, the current study considers the Diplomat Presidential Golf Course ineligible for the National Register.

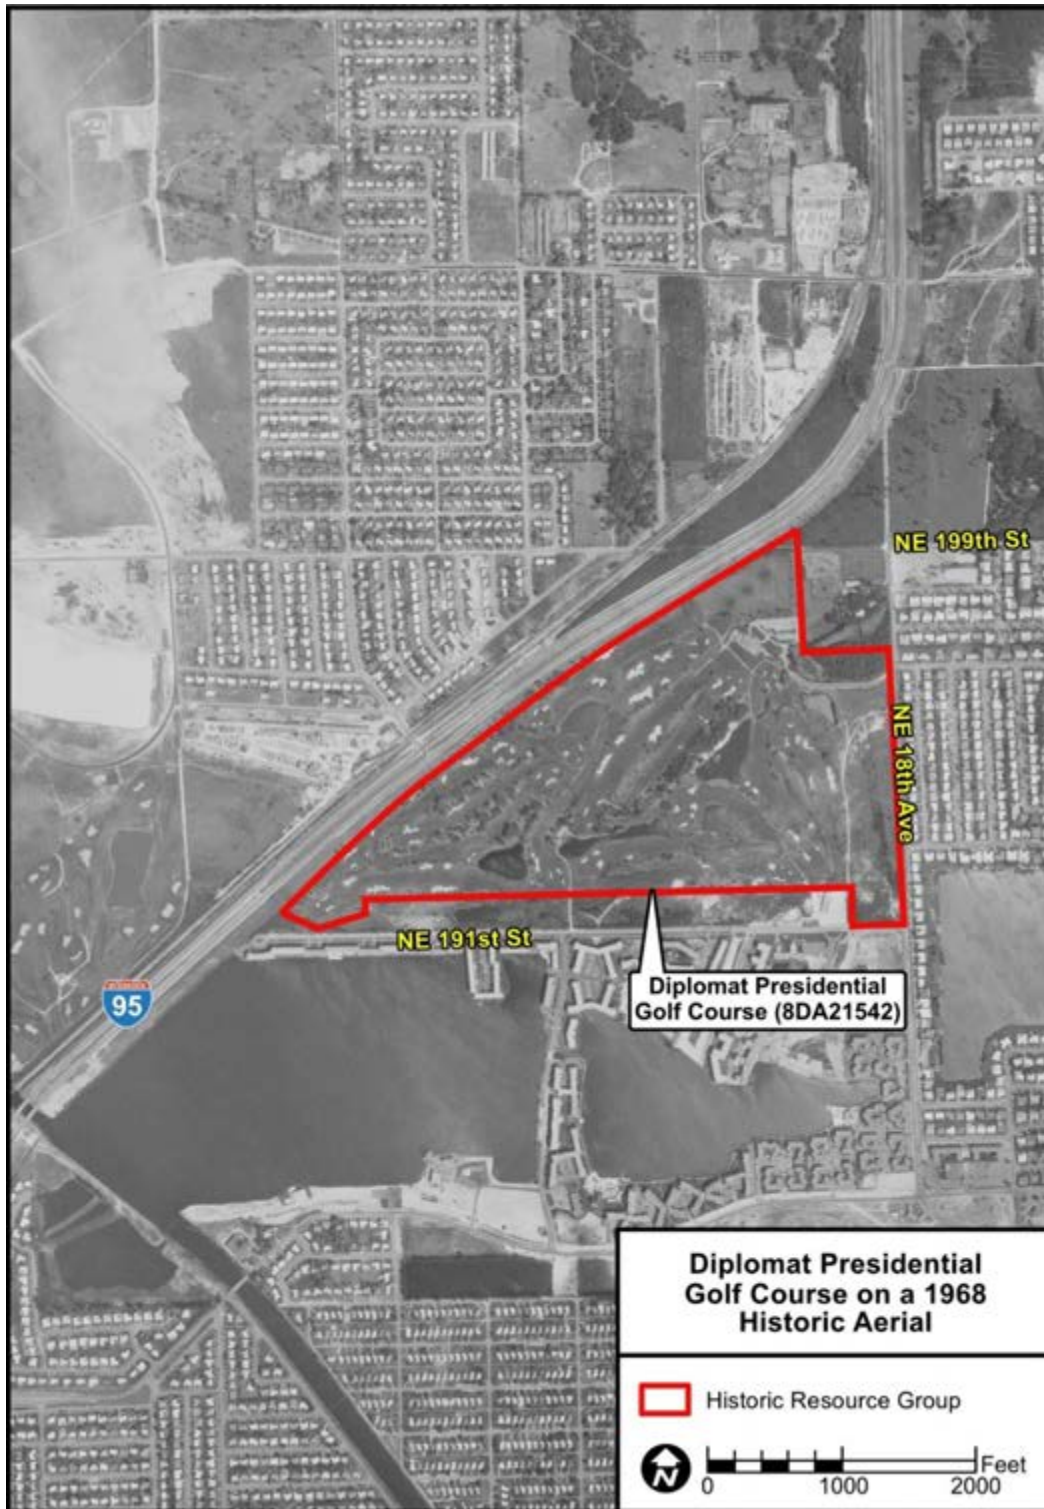
Figure 2 is an aerial of the golf courses (east and a portion of the west) in 1968, showing the original layout designed by Mahannah. In 1998, the golf course was sold and redesigned by Tommy Fazio. The new design incorporated a residential neighborhood at the center of the course. It reopened in 1999. In 2009, the golf course was permanently closed after the owner declared bankruptcy.

Figure 2: A 1968 aerial showing the Diplomat Presidential Golf Course. A portion of a different Diplomat Hotel and Country Club golf course can be seen to the west.

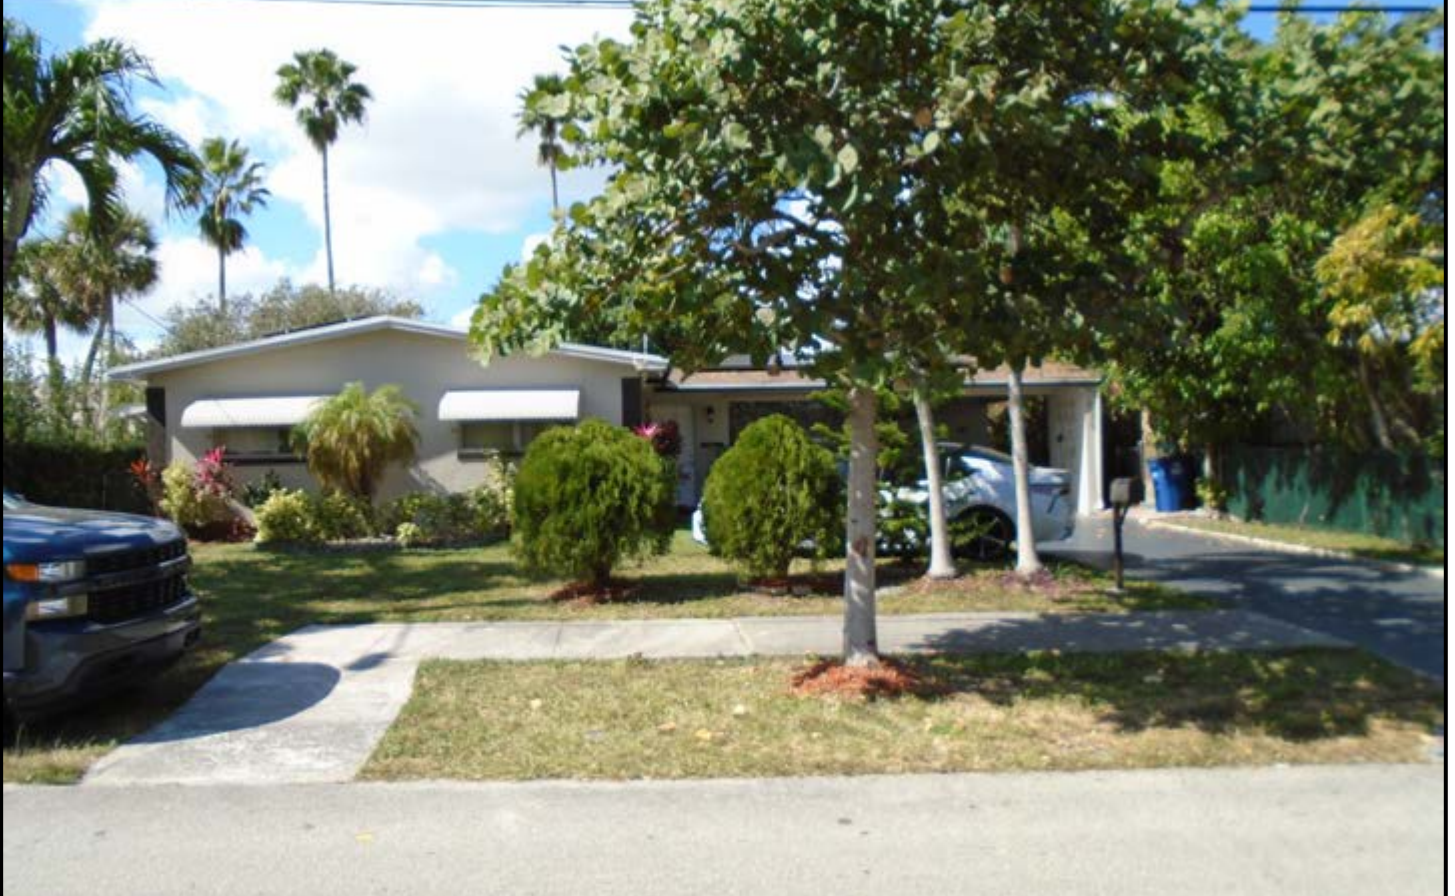
8BD8581

Condition (overall resource condition):  excellent  good  fair  deteriorated  ruinous

The one-story Ranch style house has a side-gabled roof crossed by a front-gabled roof; exterior is stucco with brick cladding along porch and stone cladding at corners; metal awnings shade windows; front door has been replaced.

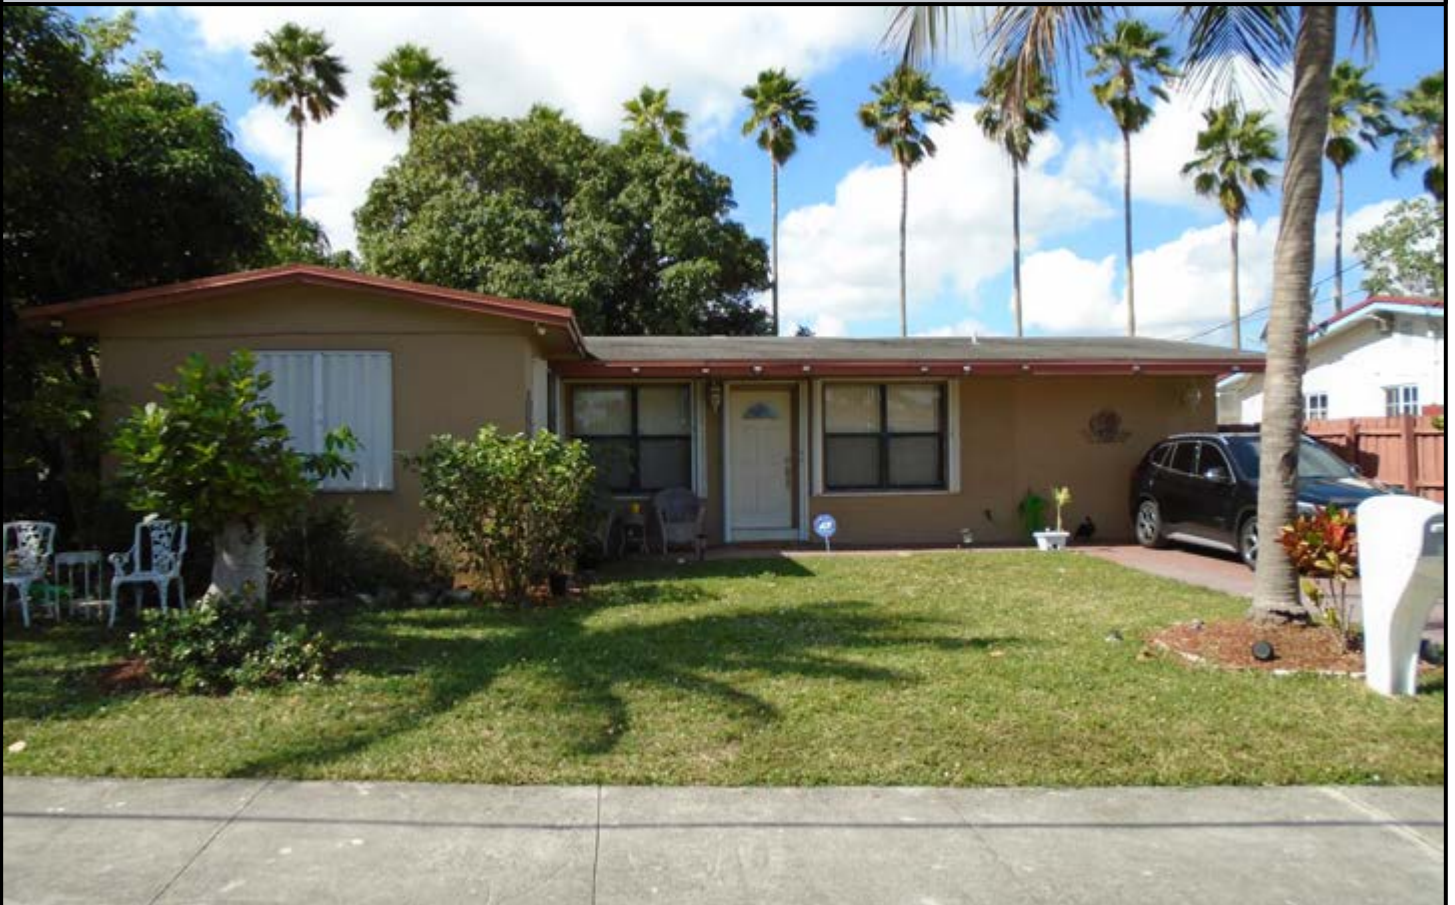
8BD8582

Condition (overall resource condition):  excellent  good  fair  deteriorated  ruinous

The one-story Ranch style house has a side-gabled roof crossed by a front-gabled roof; exterior is stucco with brick cladding along porch; accordion shutters flank windows; windows and door have been replaced, garage has been enclosed.

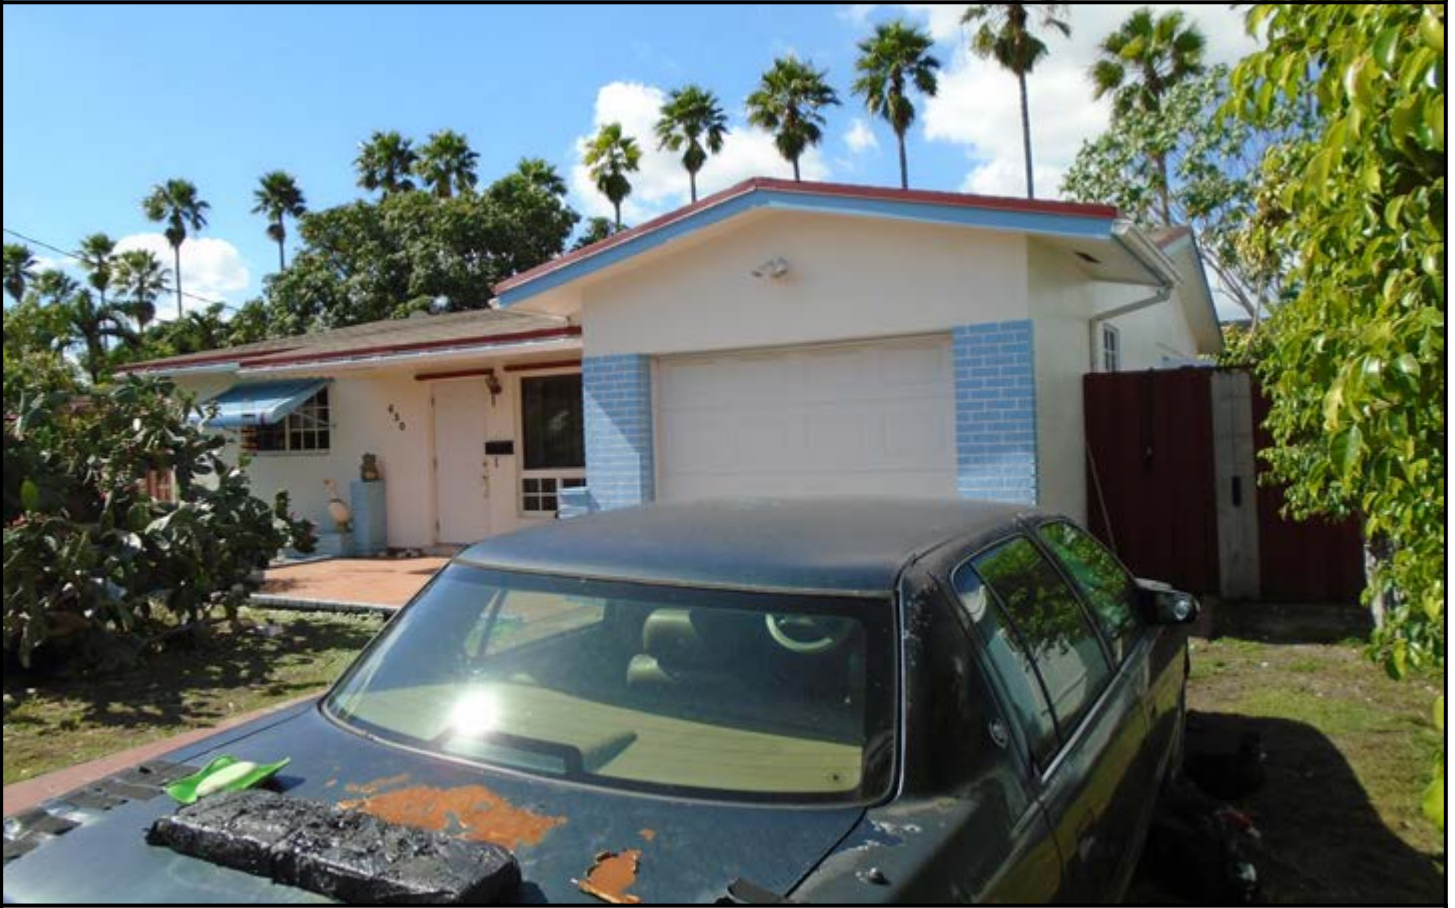
8BD8583

Condition (overall resource condition):  excellent  good  fair  deteriorated  ruinous

The one-story Ranch style house has a side-gabled roof crossed by a front-gabled roof; exterior is stucco with brick cladding along garage and matching brick planters; metal awnings shade windows; windows have been replaced.

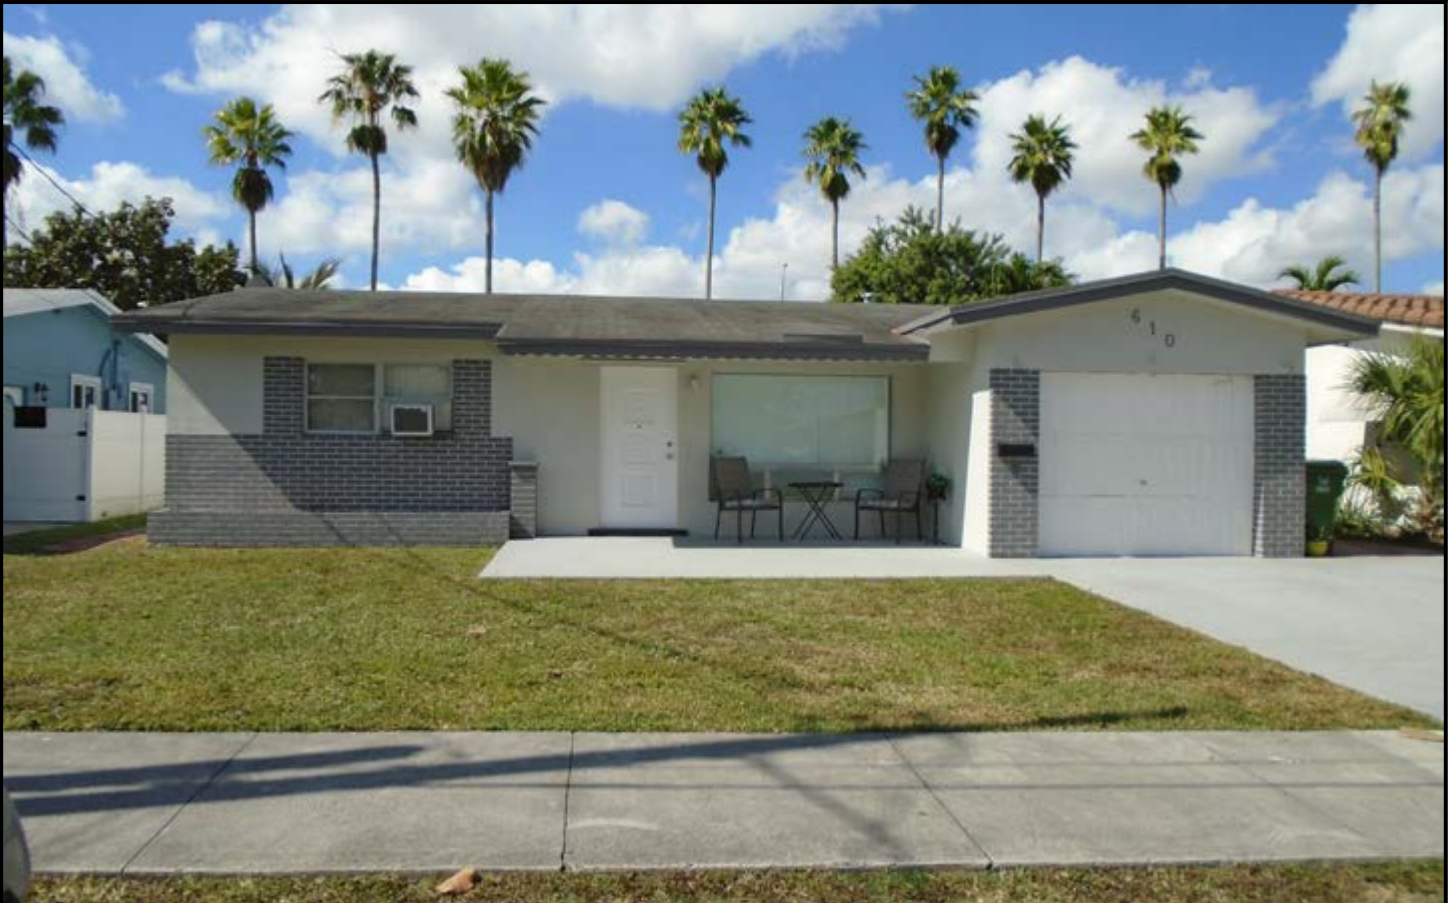
8BD8585

Condition (overall resource condition):  excellent  good  fair  deteriorated  ruinous

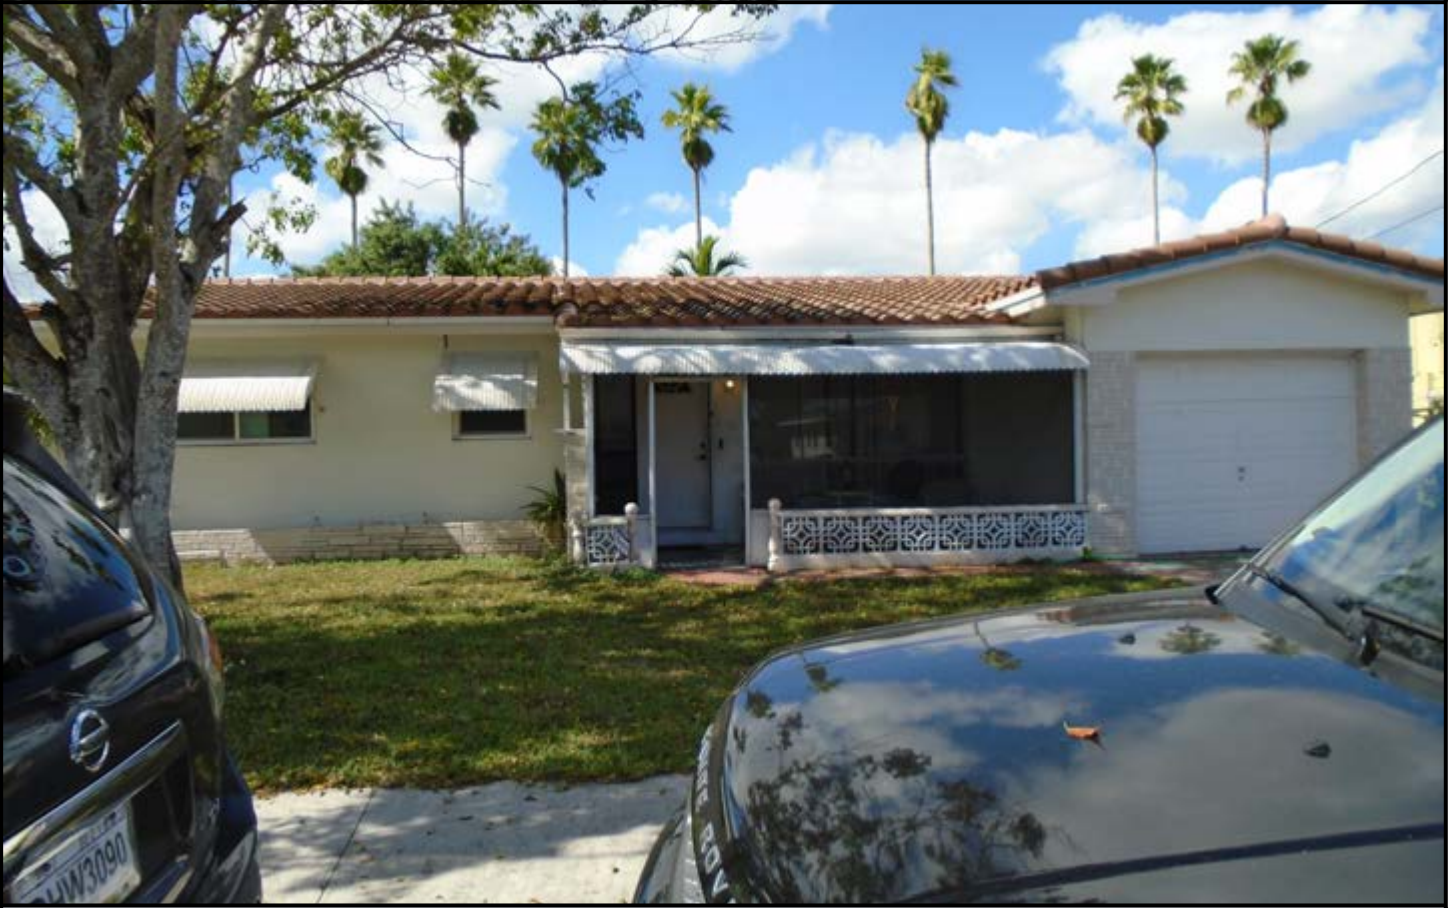
8BD8586

Windows (types, materials, etc.)
Awning; jalousie; picture; some replacement sliding windows.

Condition (overall resource condition):  excellent  good  fair  deteriorated  ruinous

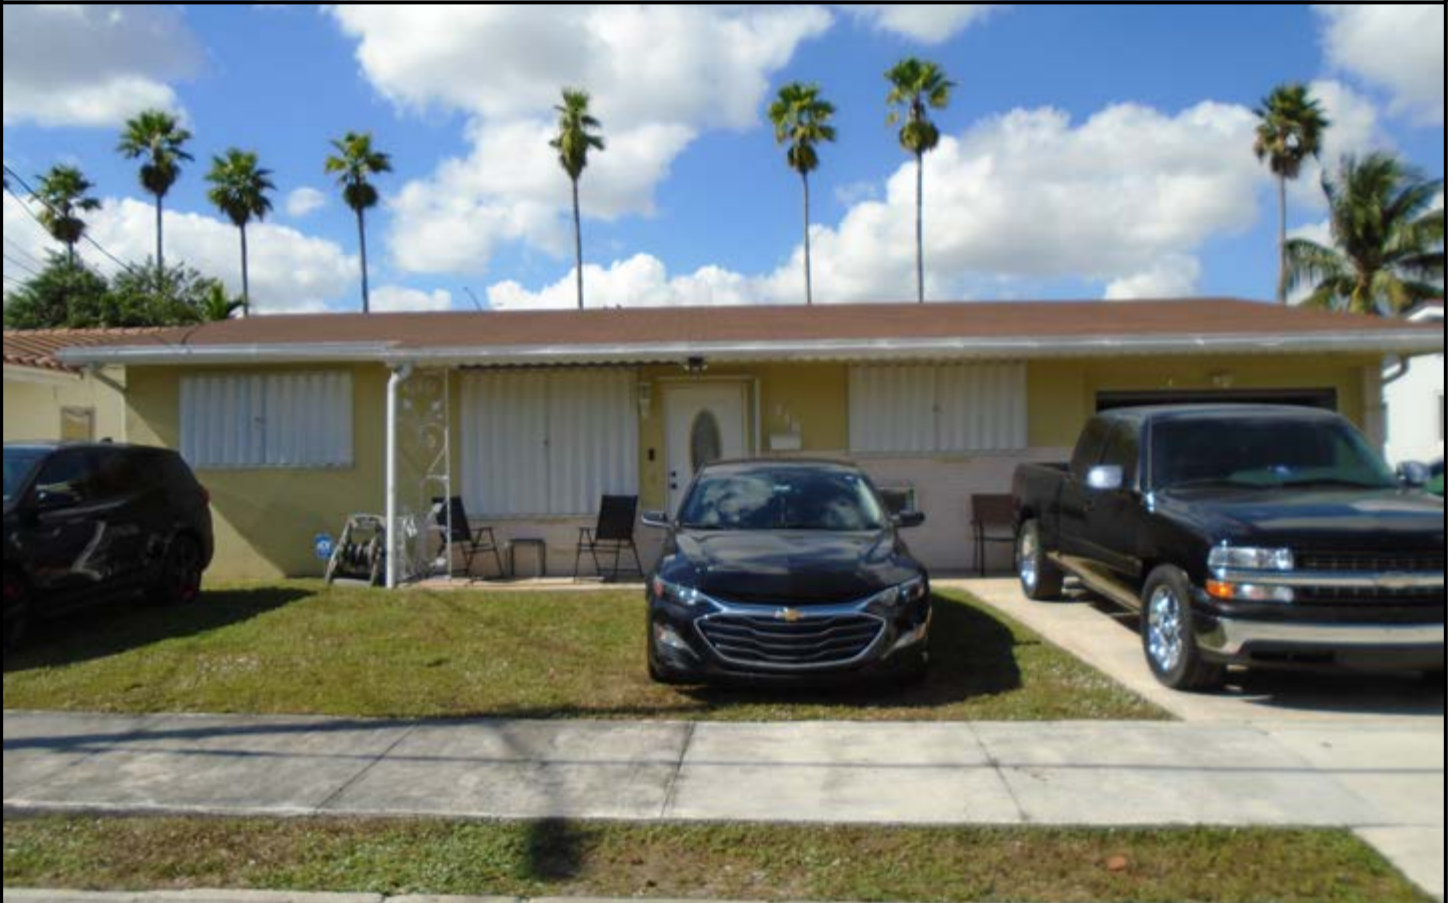
8BD8587

Windows (types, materials, etc.)
Obscured by accordion shutters; oval light in replacement door.

Condition (overall resource condition):  excellent  good  fair  deteriorated  ruinous

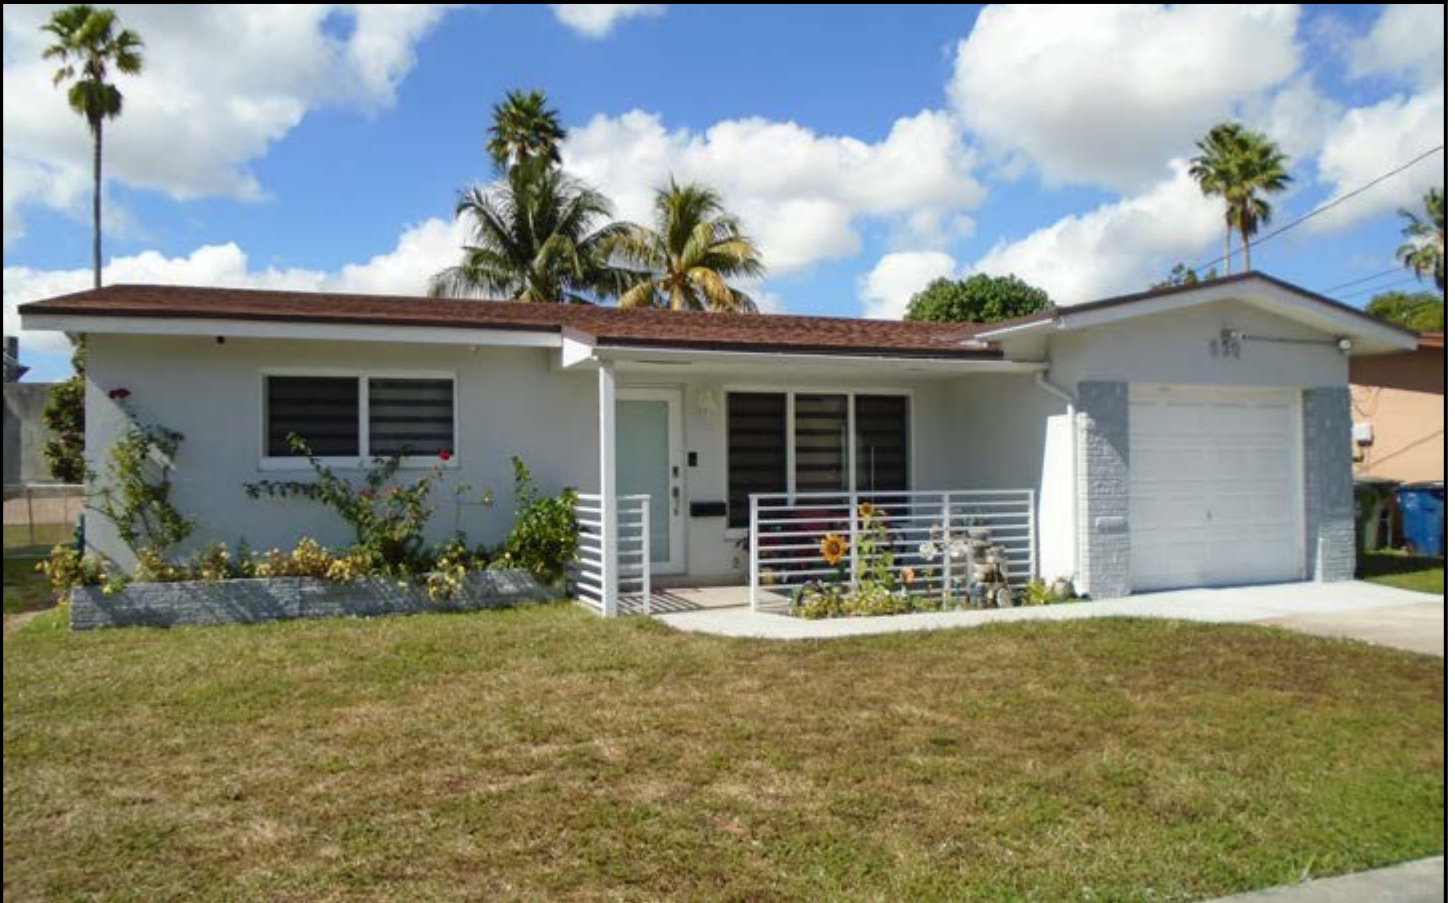
8BD8588

Windows (types, materials, etc.)
Replacement sliding; glass door.

Condition (overall resource condition):  excellent  good  fair  deteriorated  ruinous

The one-story Ranch style house has a side-gabled roof crossed by a front-gabled roof; exterior is stucco with brick cladding along the garage; matching brick planter spans left side of main facade; windows, door, and porch railing have been replaced.

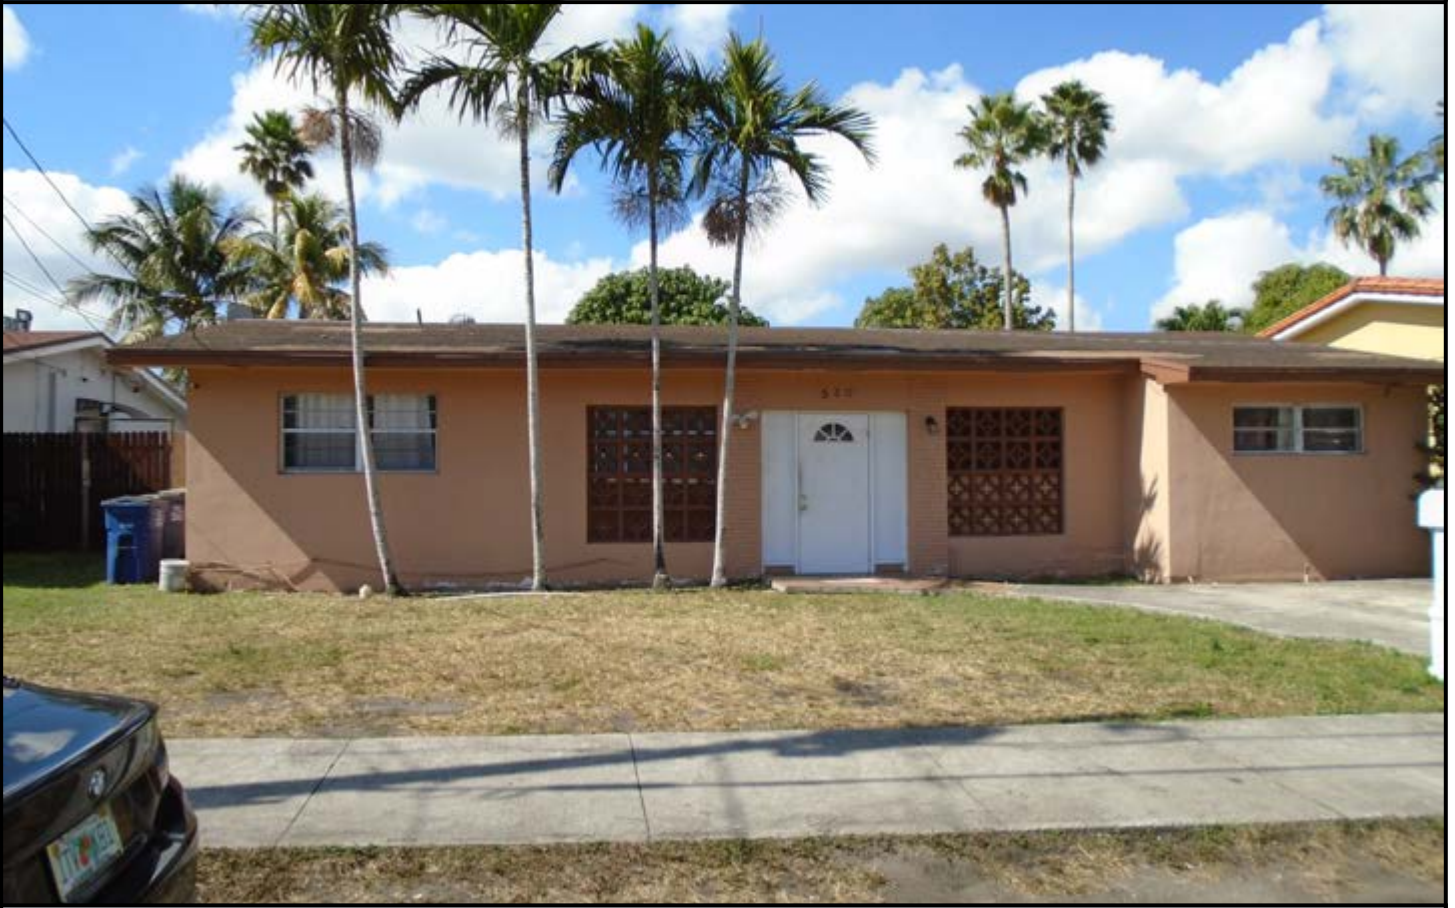
8BD8589

Open entry porch is located at center of main facade; sheltered by overhang of main side-gabled roof; replacement door flanked by two panels; doorway flanked by brick cladding.

Condition (overall resource condition):  excellent  good  fair  deteriorated  ruinous
