# CULTURAL RESOURCE ASSESSMENT SURVEY

I-95/State Road (SR) 9 Project Development and Environment (PD&E) Study  
From South of SR 860/Miami Gardens Drive to North of Broward County Line  
Miami-Dade County, Florida

Financial Management Number: 414964-1-22-01  
Federal Aid Project Number: N/A  
Efficient Transportation Decision Making (ETDM): 14419

## **Cultural Resources Assessment Survey**

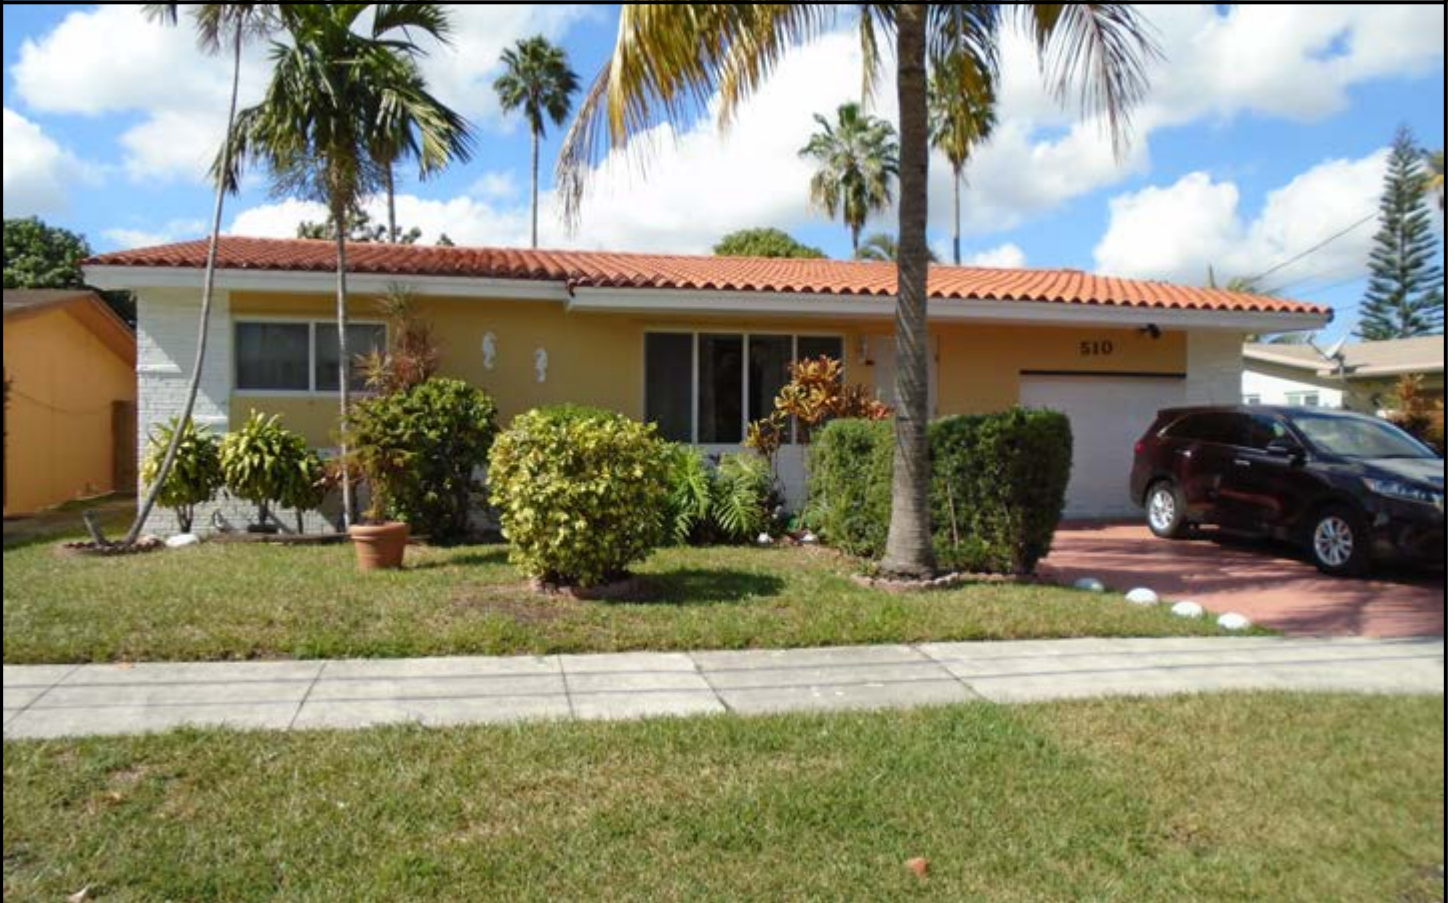
8BD8590

Condition (overall resource condition):  excellent  good  fair  deteriorated  ruinous

The one-story Ranch style house has a side-gabled roof; exterior is stucco with brick cladding at corners and on lower main facade; windows have been replaced.

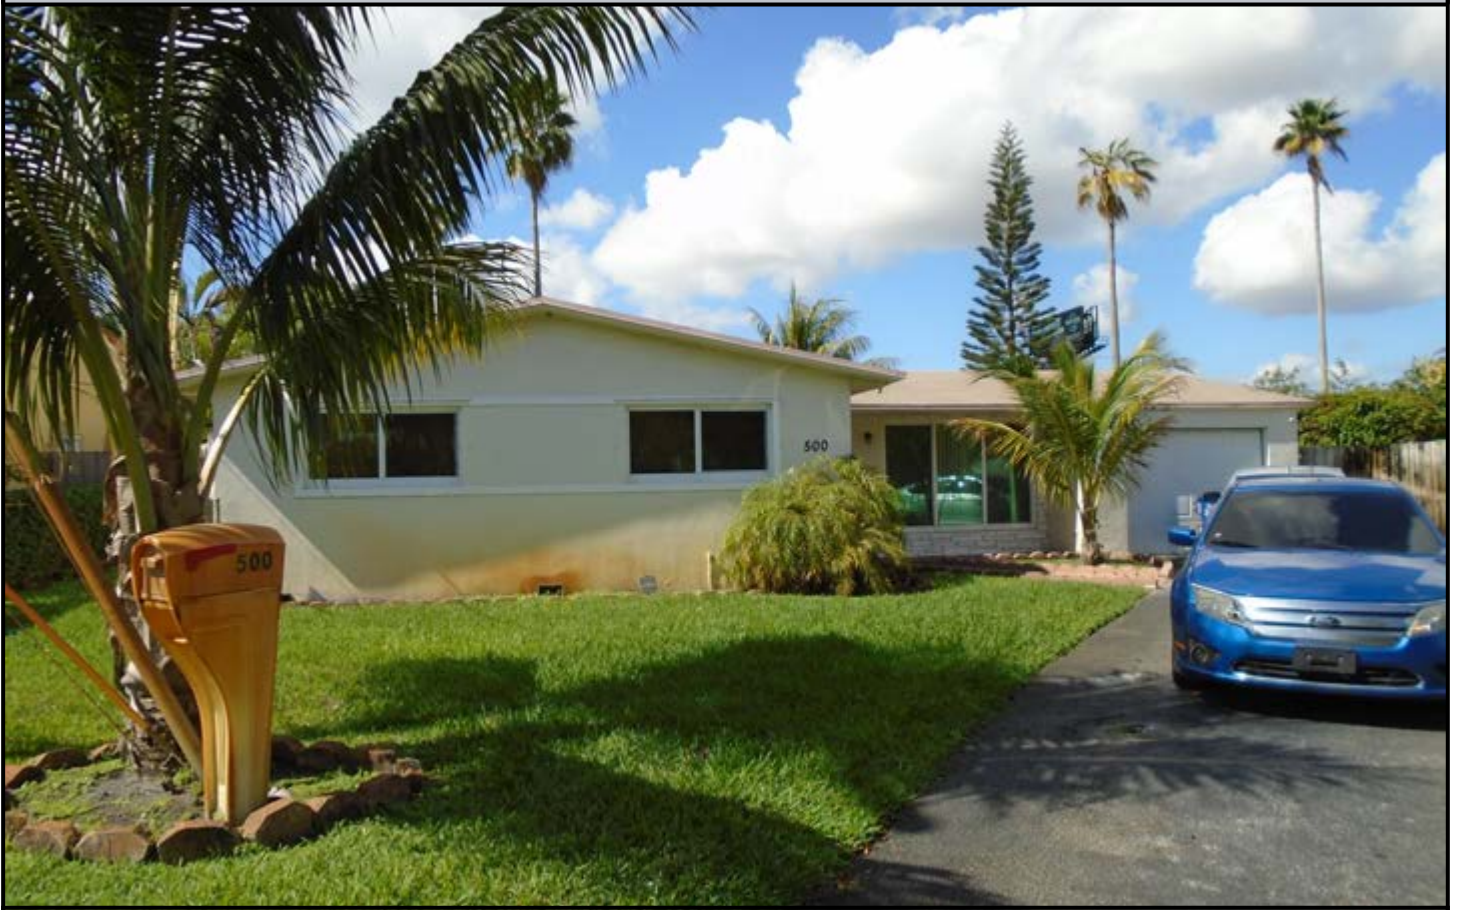
8BD8591

Condition (overall resource condition): excellent good fair deteriorated ruinous

The one-story Ranch style house has a side-gabled roof crossed by a front-gabled roof; exterior is stucco with stone cladding along lower porch facade; porch is recessed; windows have been replaced.

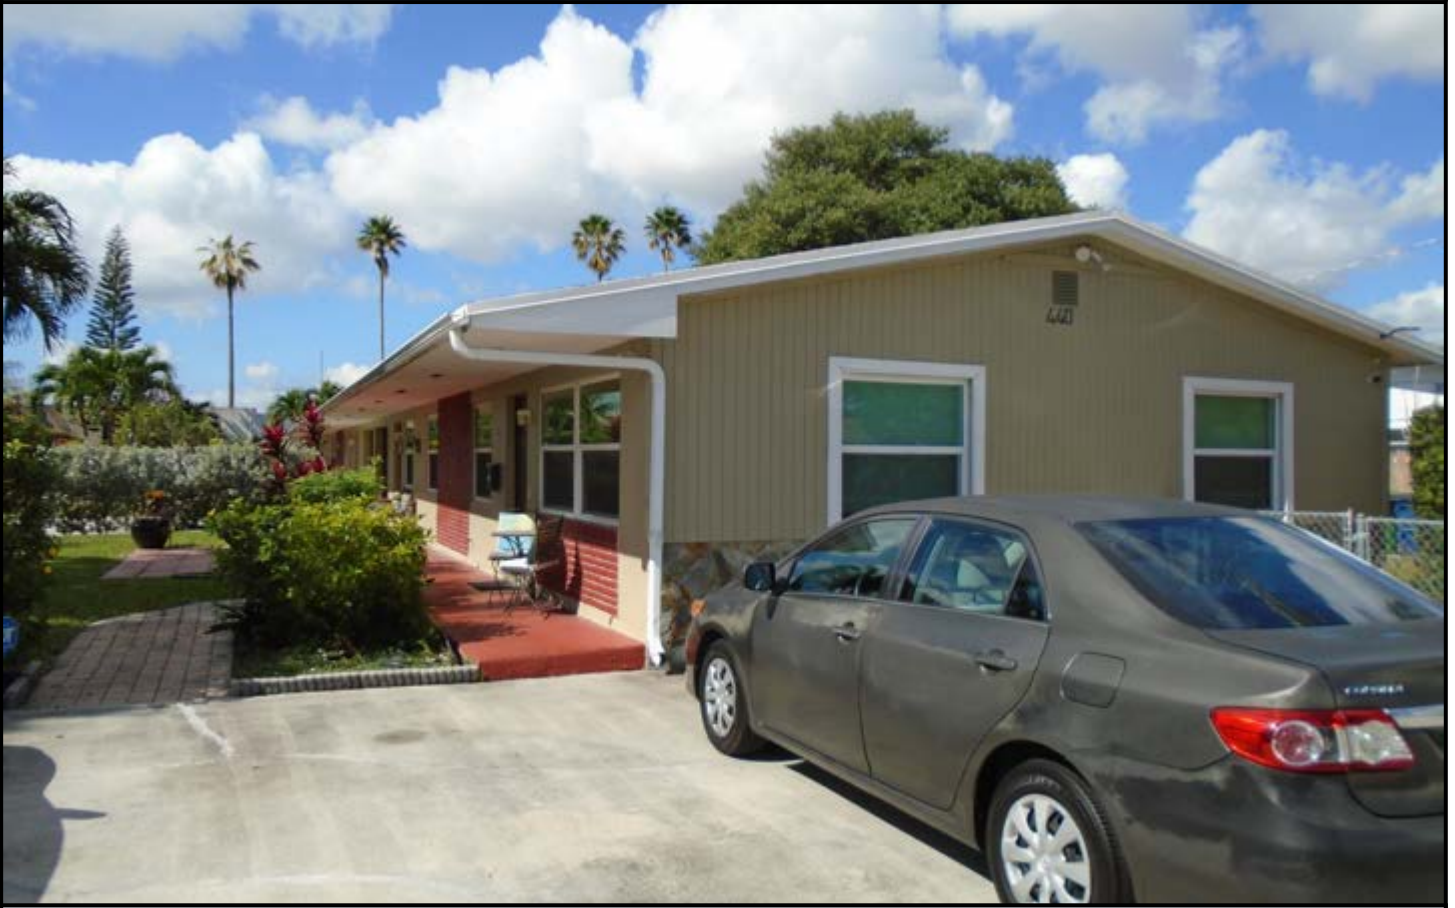
8BD8592

Windows (types, materials, etc.)
Replacement 1/1 SHS.

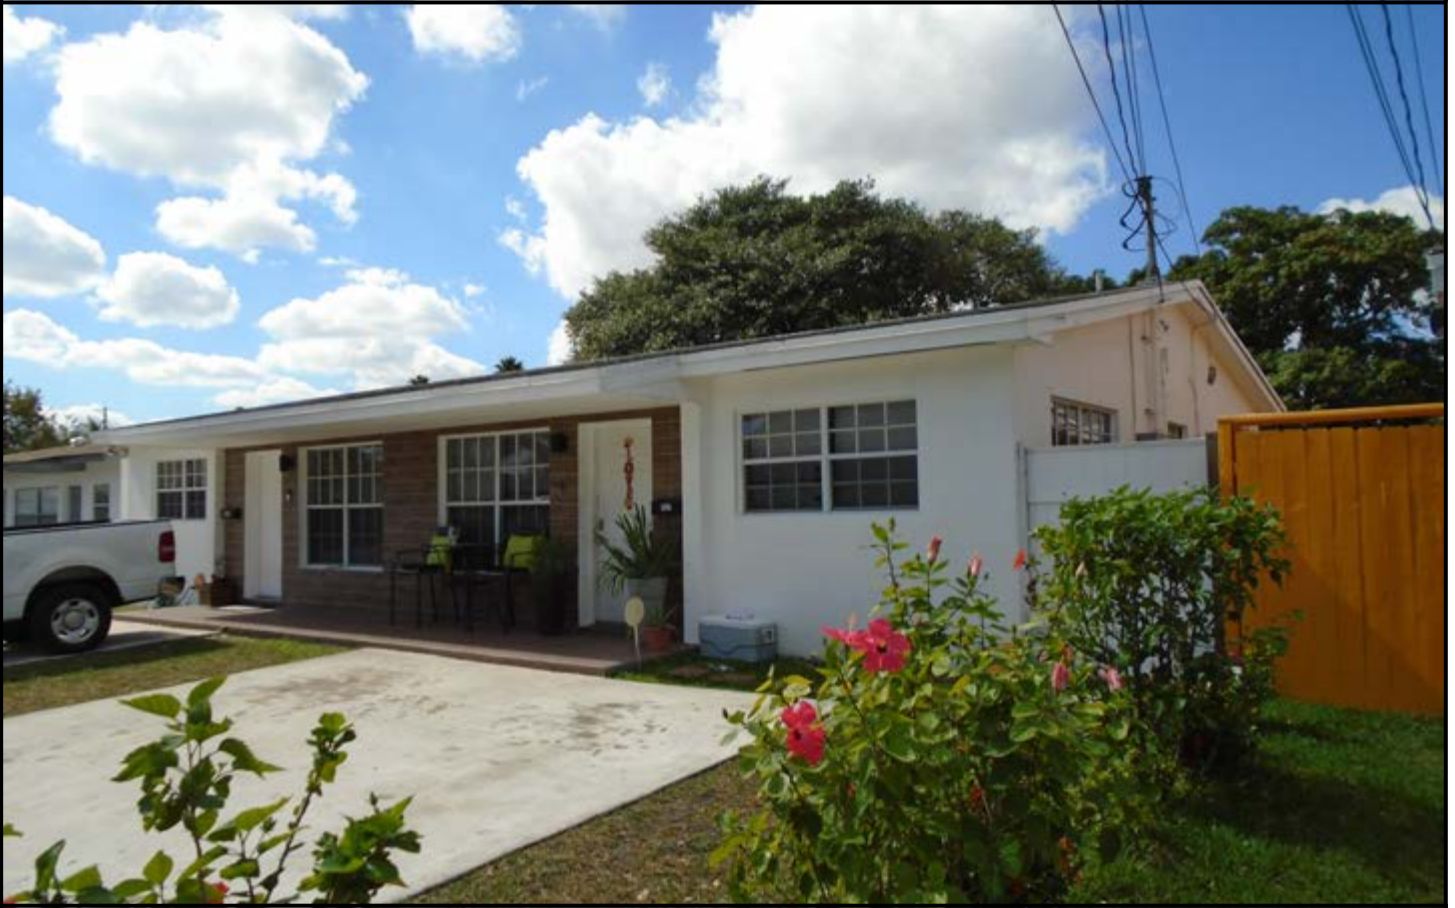
8BD8594

Windows (types, materials, etc.)
Replacement 6/6 SHS.

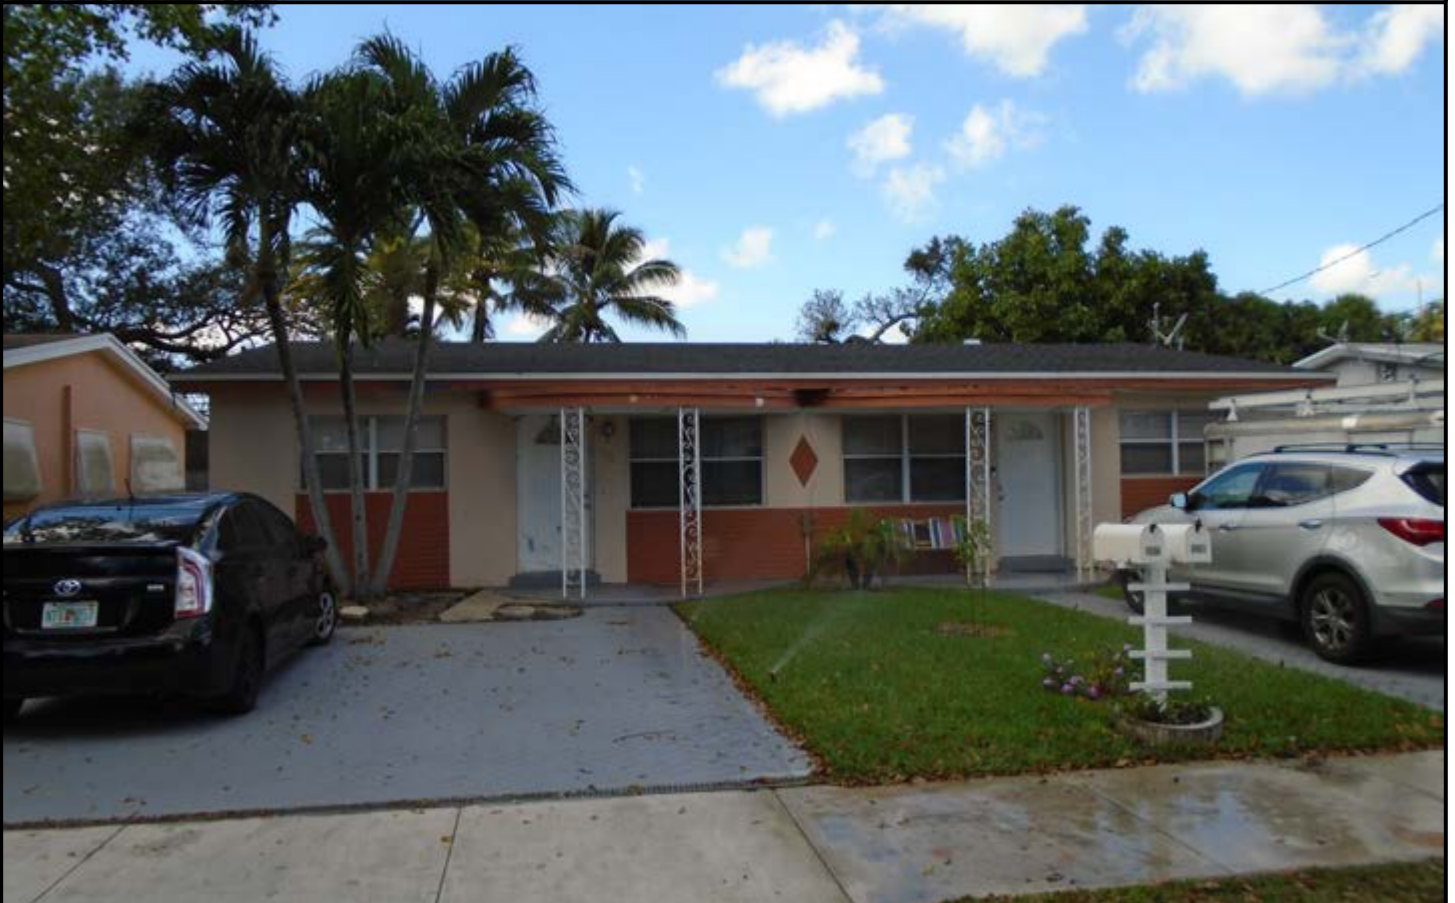
8BD8600

Narrative Description of Resource
The one-story Masonry Vernacular style duplex has a side-gabled roof with flat semi-circular roofs over porches; exterior is stucco with brick cladding on lower facade; main facade is symmetrical; windows have been replaced.

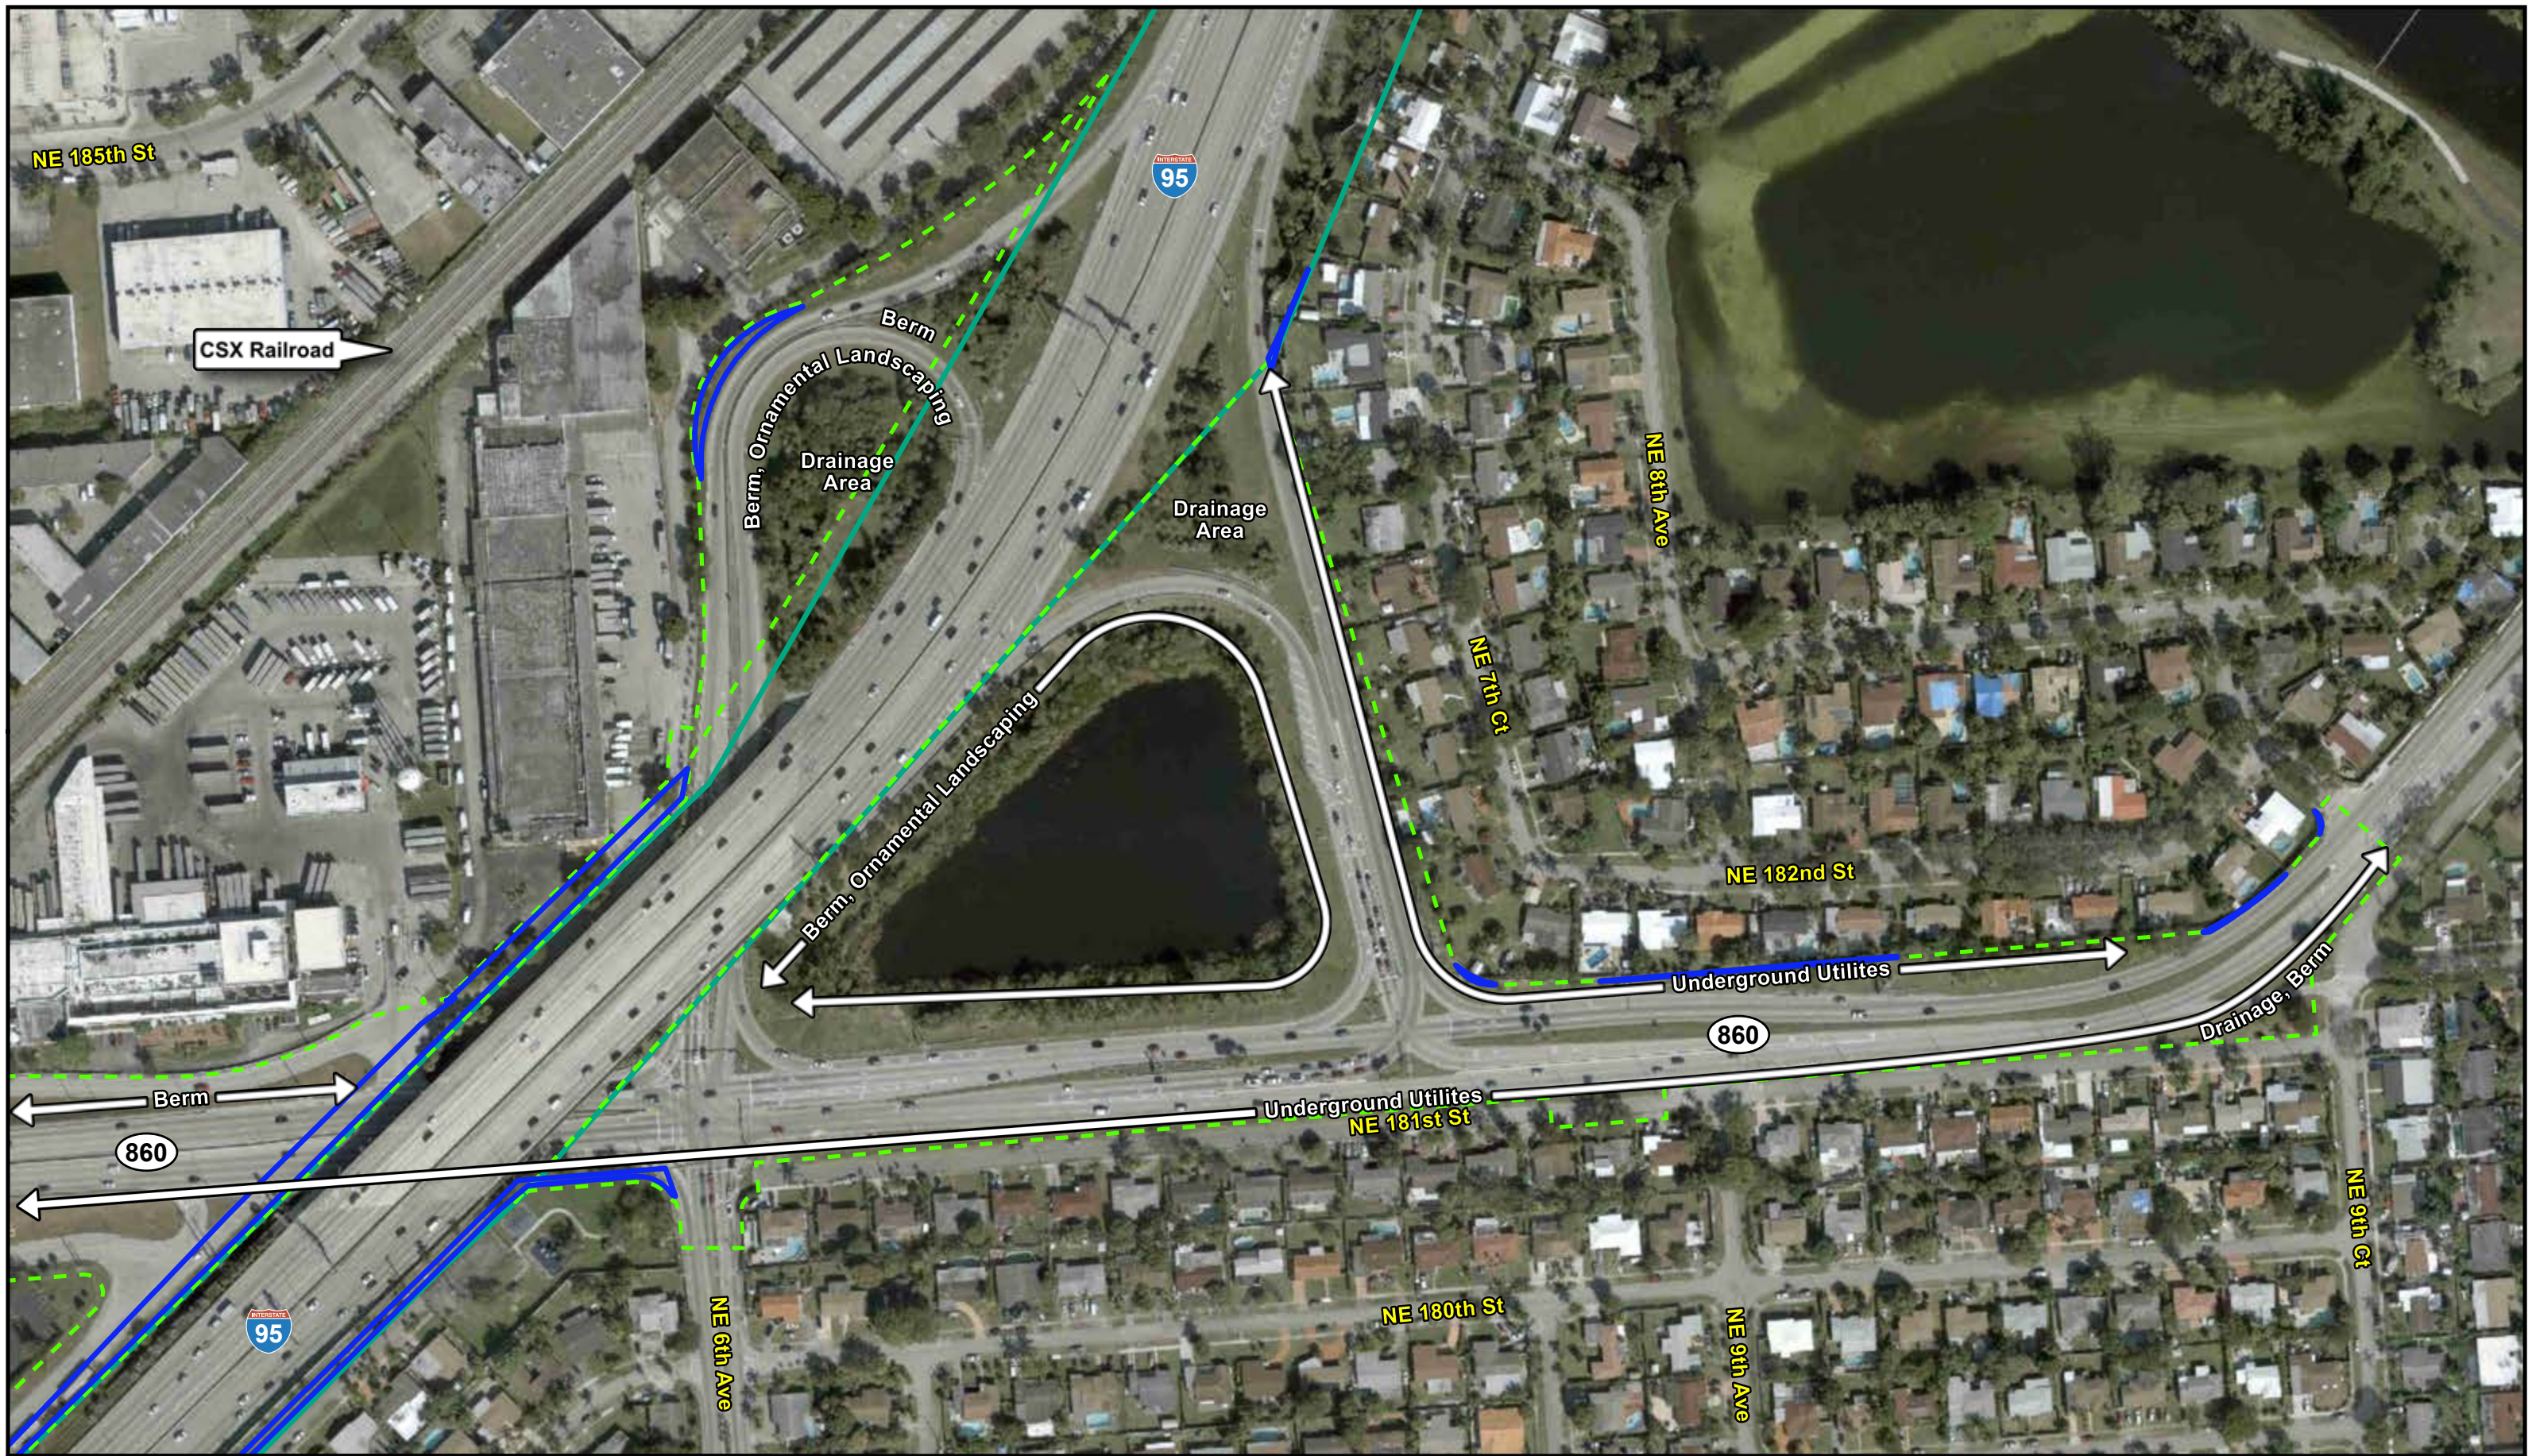
**Map 2**

**Field Conditions within the Archaeological APE**

*I-95 from South of Miami Gardens Drive to North of Broward County Line*
