Re: Updated Determination of Effects Associated with the Cultural Resource Assessment Survey for the SR 826/Palmetto Expressway From South of NW 36th Street (MP 8.355) to North of NW 154th Street (MP 17.950) Project Development & Environment Study, Miami-Dade County, Florida
Financial Management Numbers: 447165-1-22-01, 441830-1-22-01, 441831-1-22-01
Federal Aid Project Number: N/A
ETDM Number: 14455

December 2020

Cultural Resource Assessment Survey

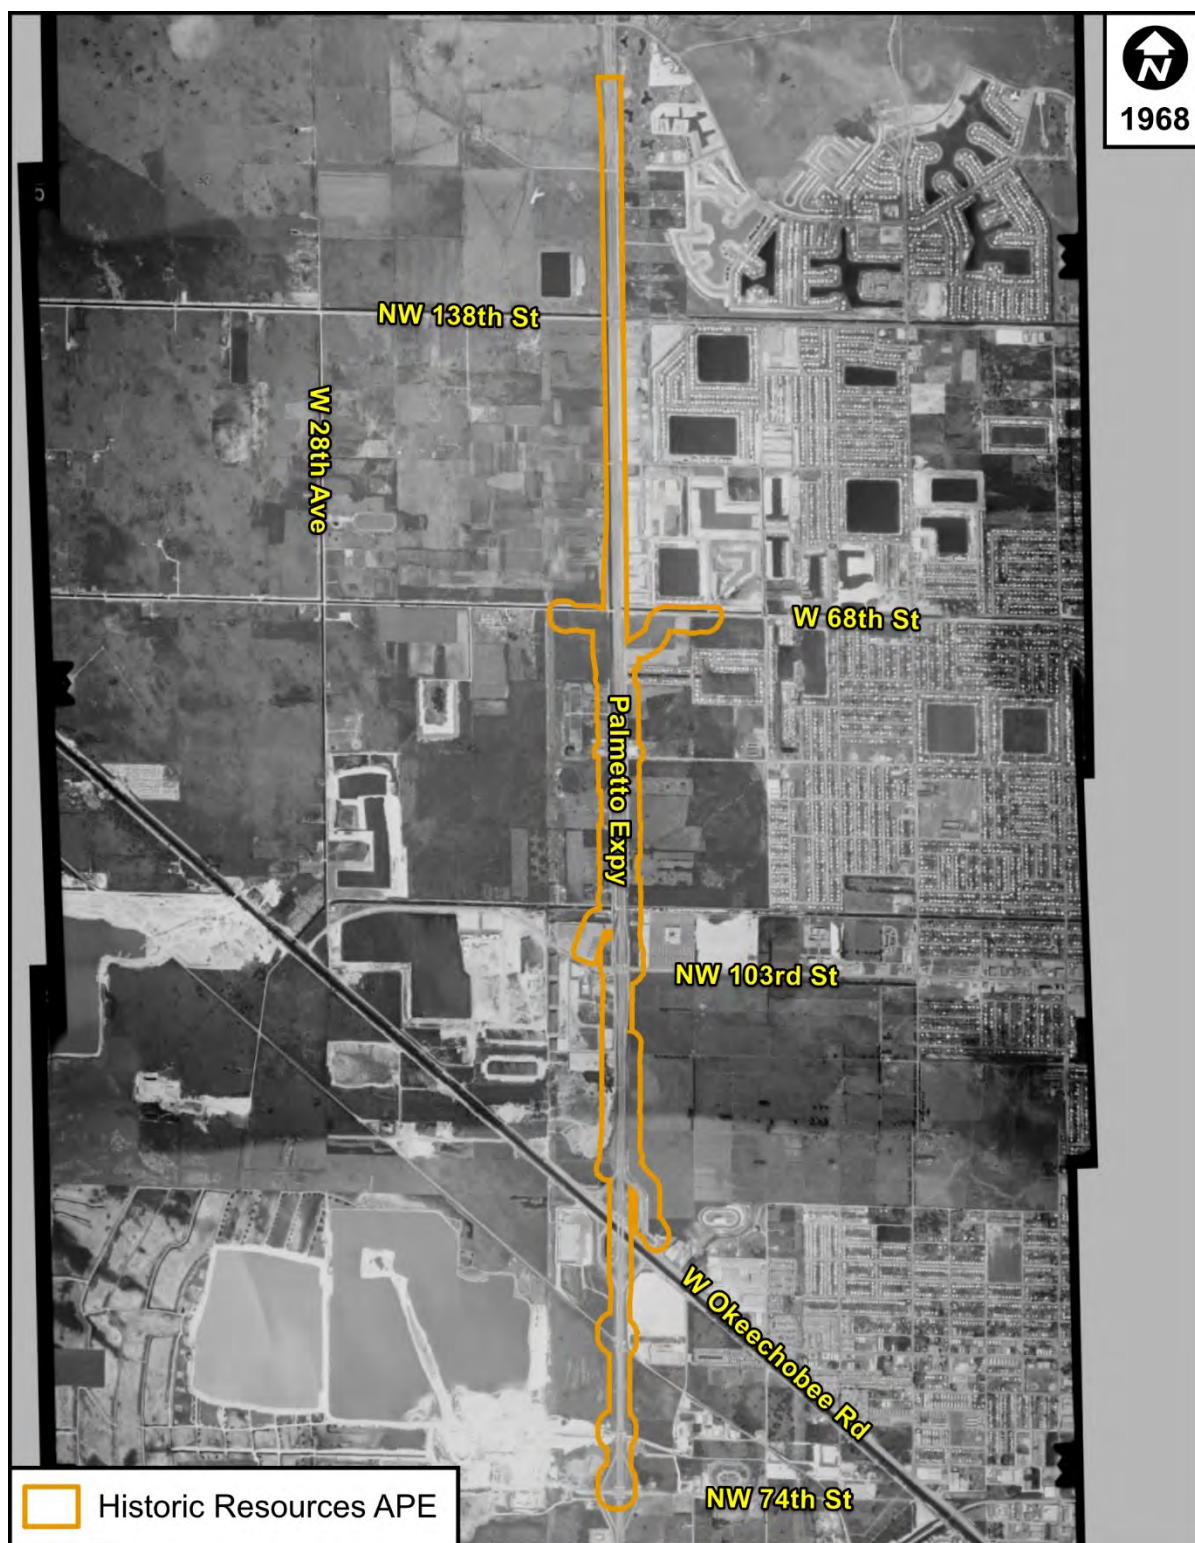
Figure 15: A 1968 historic aerial photograph of the project APE

The 1951 historic aerial photograph depicts a largely rural area surrounding the historic resources APE, with signs of development, including street grid pattern and structures, focused southwest of the project APE (Figure 14). The Miami International Airport, constructed in 1949, is located out of frame and was constructed near hubs of the FEC Railway (8DA10107) and Seaboard Air Line (CSX) Railroad (8DA10753). The rail lines were critical to the development of Miami, and Florida on a larger scale, and were used for passenger travel as well as industrial and manufacturing shipments with some spur lines crossing the future route of SR 826. By 1968, rapid development can be observed near the historic resources APE, most notably east of the project area (Figure 15). In 1961, SR 826 was constructed, and connected I-95 in eastern Miami-Dade County to western and southern portions of the county which had remained largely undeveloped. Several of the residential developments of Hialeah and Miami Lakes can be observed at the north end of the APE. The southern end of the APE intersects Medley and Hialeah Gardens, with the development of industrial and warehouse complexes on both sides of SR 826.

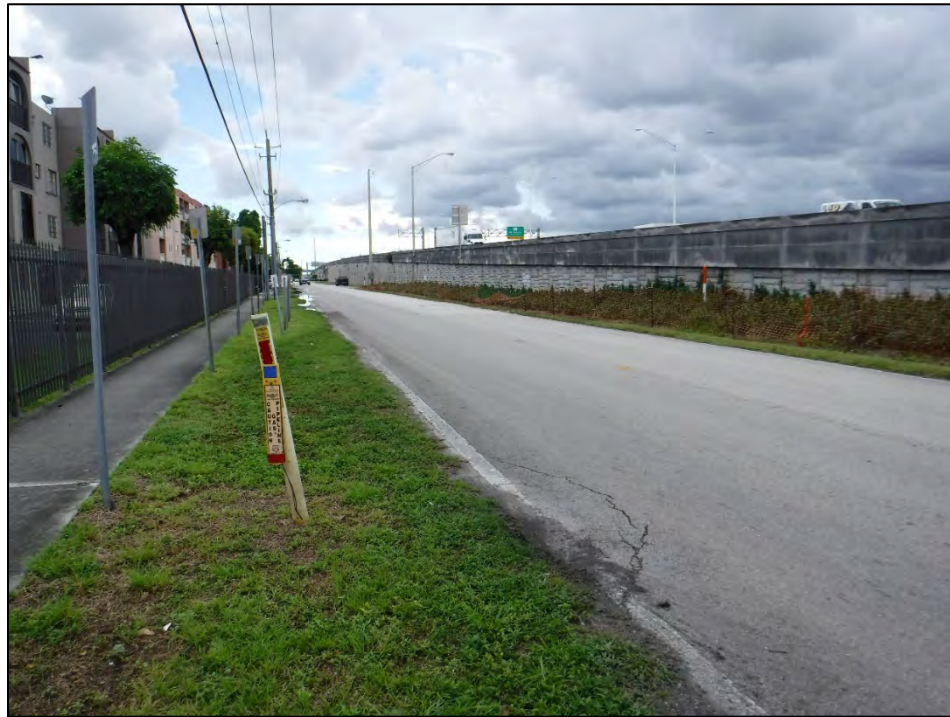
Figure 18: Pavement, Landscaping, Sidewalks, Gas Pipeline, and Fiber Optic Cable within the Portion of the APE in the Recorded Limits of 8DA75, Facing South

Two previously recorded archaeological sites (8DA40 and 8DA75) were identified within the archaeological APE during the background research for the current survey. No locally designated archaeological sites or zones are located within one mile of the project corridor. No subsurface testing was feasible within the archaeological APE due to the presence of existing pavement, ditches and berms, access drives, planted vegetation, concrete sidewalk, and numerous features indicative of buried utilities, including gas pipeline, water lines, sanitary and storm sewer, fiber optic cable, electric, lighting, signalization, and ITS. The pedestrian survey did not identify any evidence of archaeological sites or environmental factors indicative of increased archaeological site potential. Representative photographs of the current condition of the archaeological APE are included in Figures 18-21.

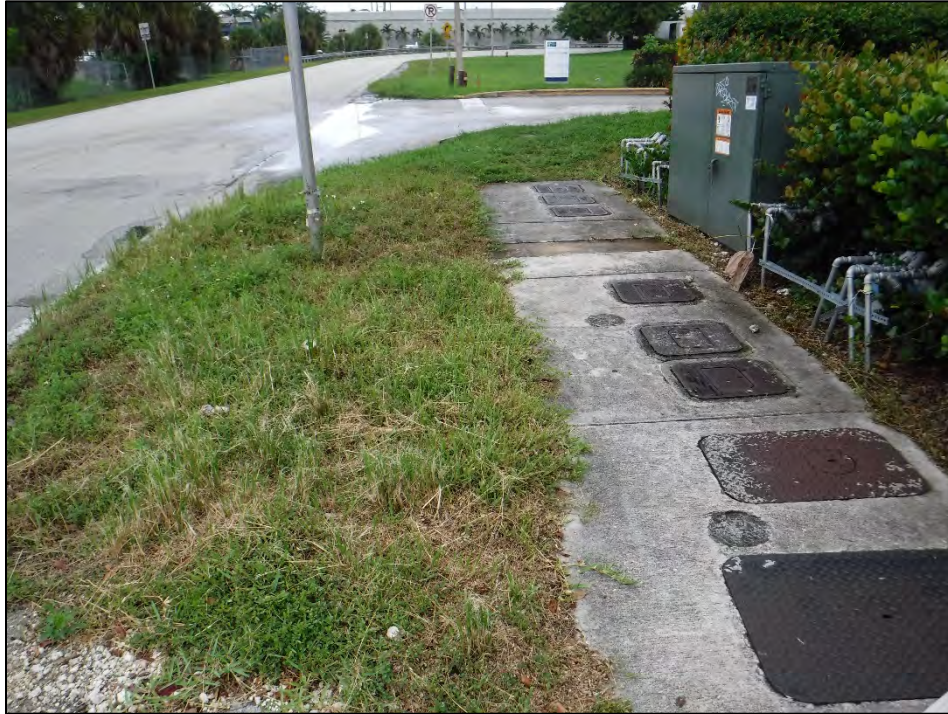
Figure 19: Pavement, Buried Utilities, and Land Modification within the Northern Expanded APE along W 68th Street between 21st Court and W 20th Avenue, Facing East

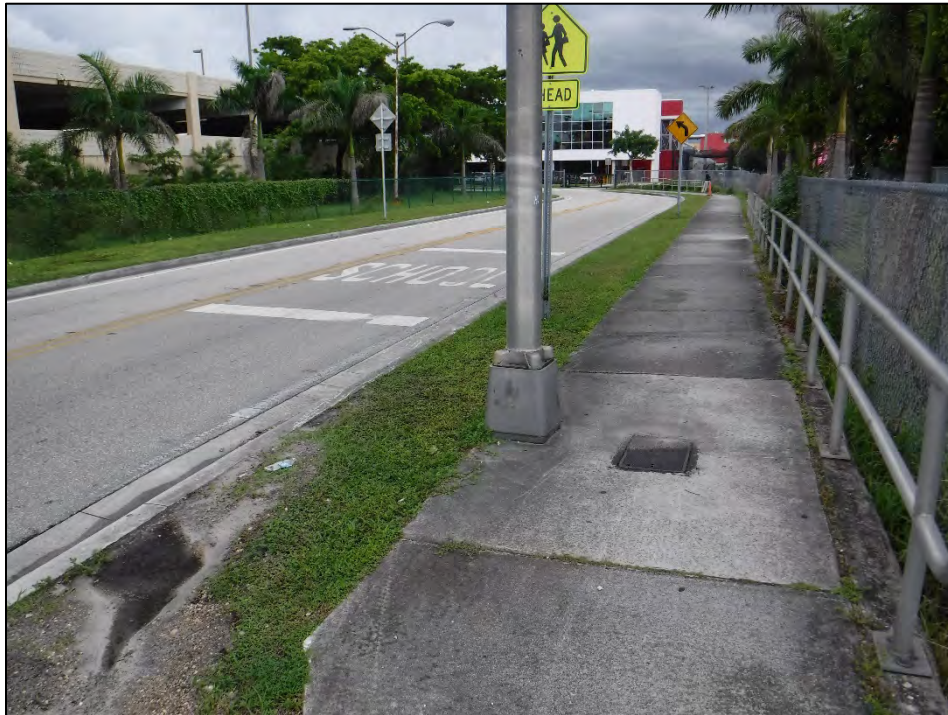
Figure 20: Pavement, Concrete Sidewalk, and Underground Utilities within the Southern Expanded APE along SW 77th Court, Facing West

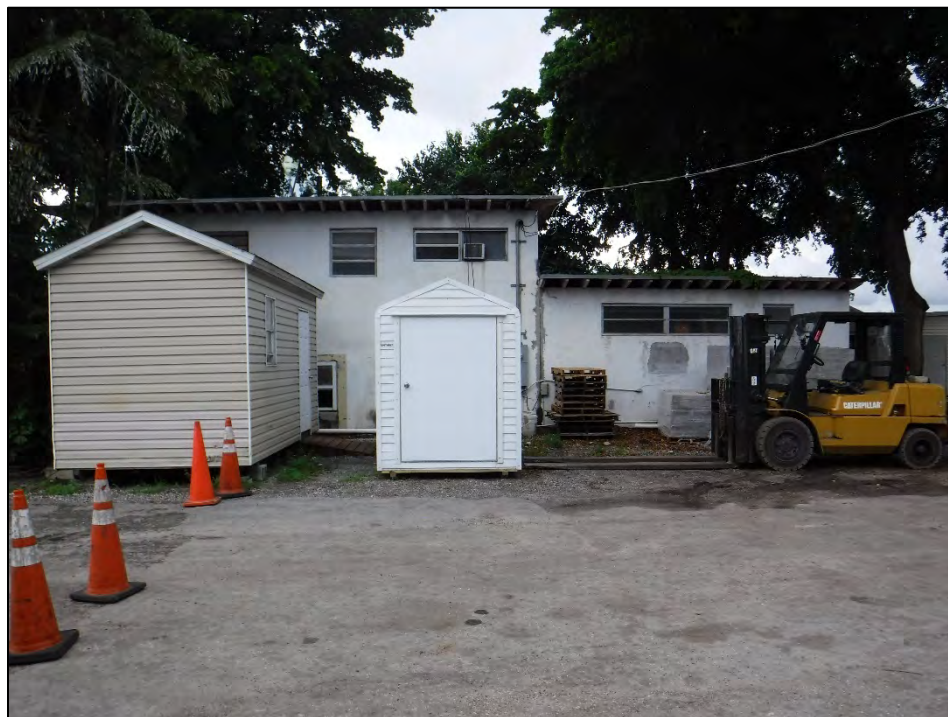
Figure 24: The Shed Depot (8DA12383), c. 1957, located at 9600 NW 77th Avenue, considered National Register-ineligible, facing South

The Shed Depot (8DA12383), located at 9600 NW 77th Avenue, is a c. 1957 Frame Vernacular commercial building. The two story structure features a wood frame structural system with stucco exterior walls and a flat roof of built-up material. The only visible distinguishing architectural feature is rafter tails extending at the roof line. The majority of the visible windows appear to date to the time of the construction and are aluminum awning two-light or three-light windows, some of which are paired. One visible window is a circa 1990 vinyl one-over-one single-hung-sash window. The main entrance to the structure was not visible to surveyors and no additions or porches were observed. The 8DA12383 likely retains its original plan, location, and exhibits few alterations. The structure does not possess any known associations with significant people or events and is a common architectural style found throughout South Florida. Therefore, 8DA12383 is considered ineligible for listing in the National Register either individually or as part of a historic district.

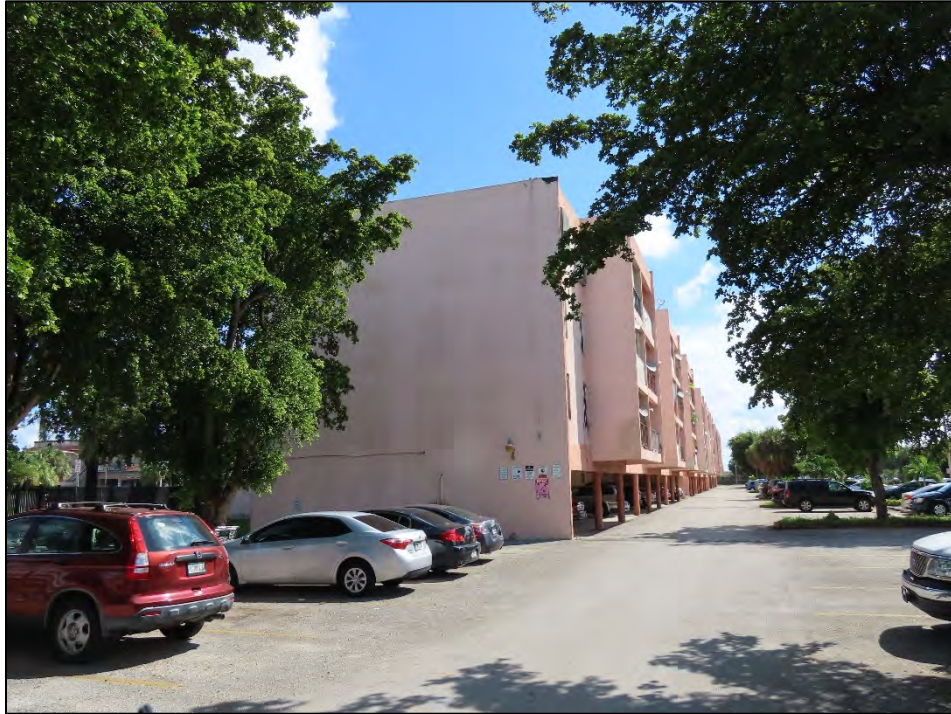
Figure 57: Los Arboles Condominiums Building 1 (8DA19141), c. 1973, located at 1900 W 68th Street, considered National Register-ineligible, facing East

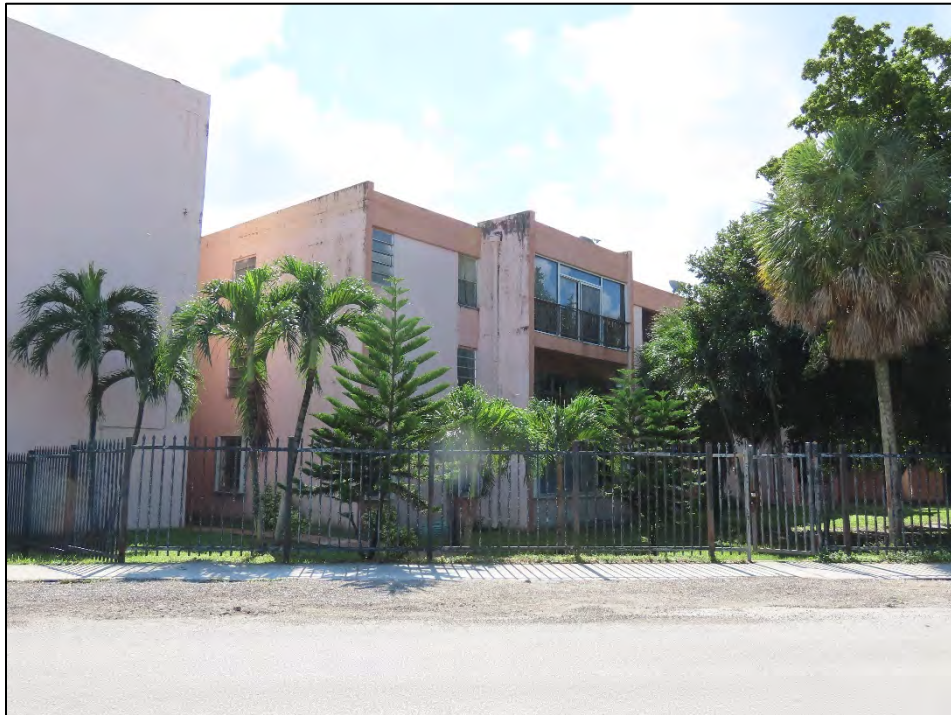
Figure 58: Los Arboles Condominiums Building 2 (8DA19142), c. 1973, located at 1900 W 68th Street, considered National Register-ineligible, facing East

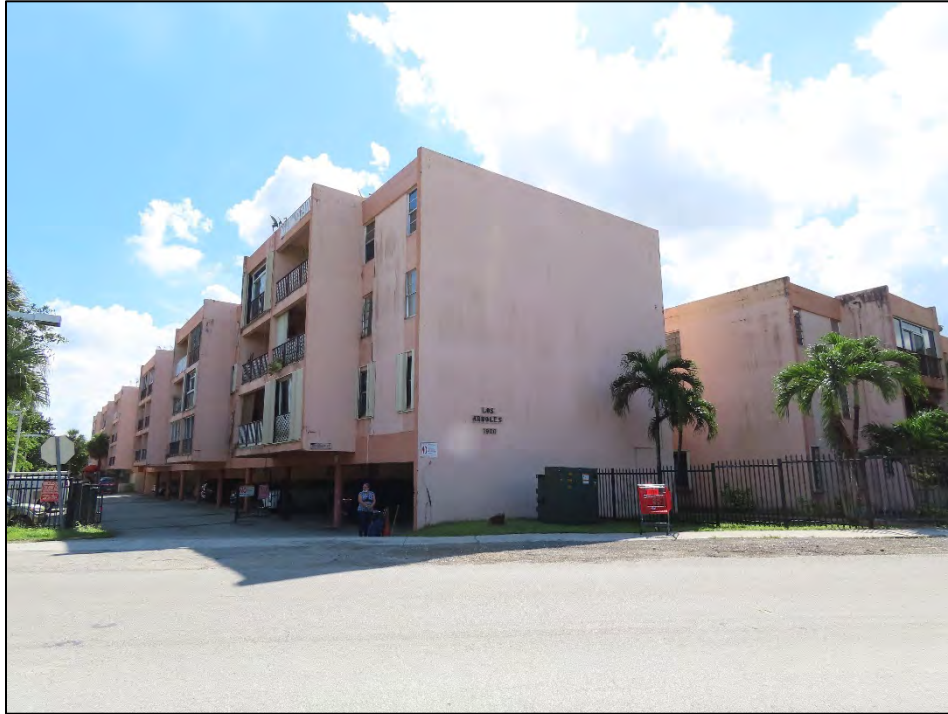
Figure 59: Los Arboles Condominiums Building 3 (8DA19143), c. 1973, located at 1900 W 68th Street, considered National Register-ineligible, facing East

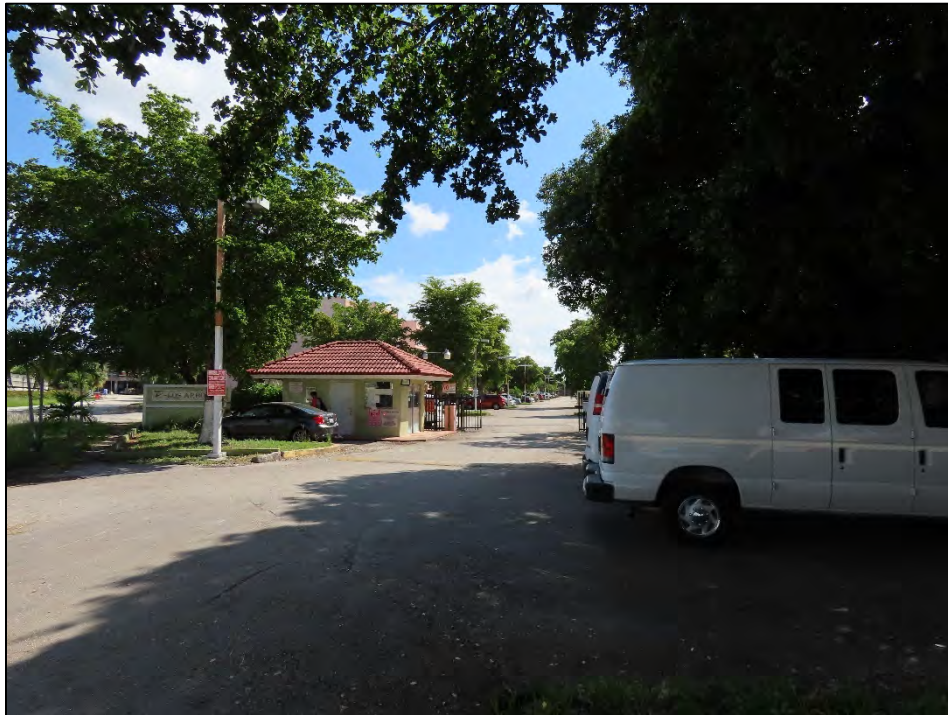
Figure 60: Los Arboles Condominiums Resource Group (8DA19150), c. 1973, located at 1900 W 68th Street, considered National Register-ineligible, facing East

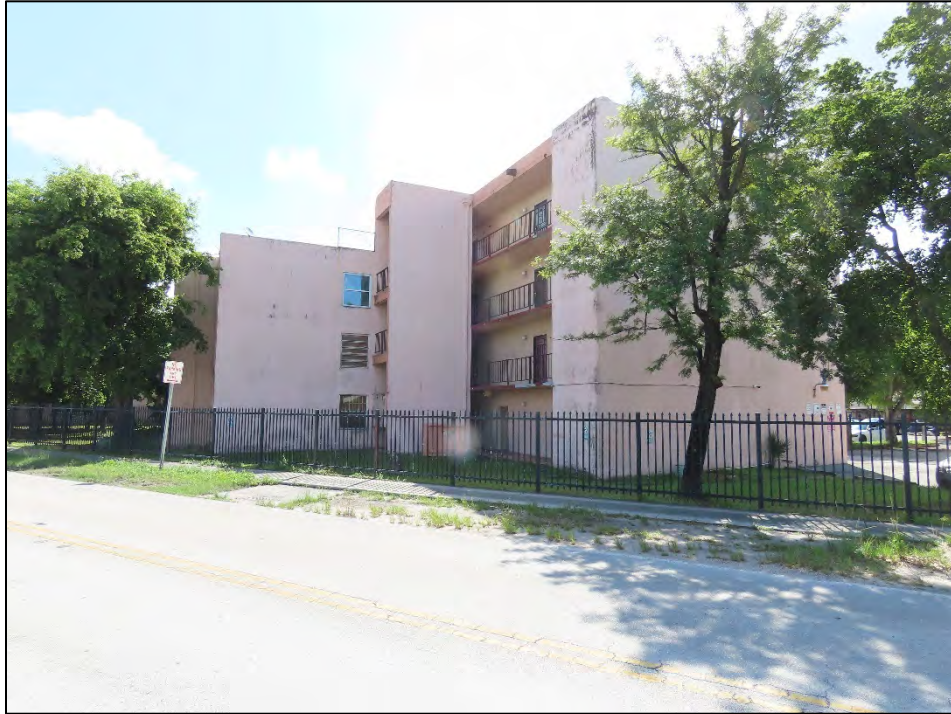
Figure 61: Los Arboles Condominiums Resource Group (8DA19150), c. 1973, located at 1900 W 68th Street, considered National Register-ineligible, facing East

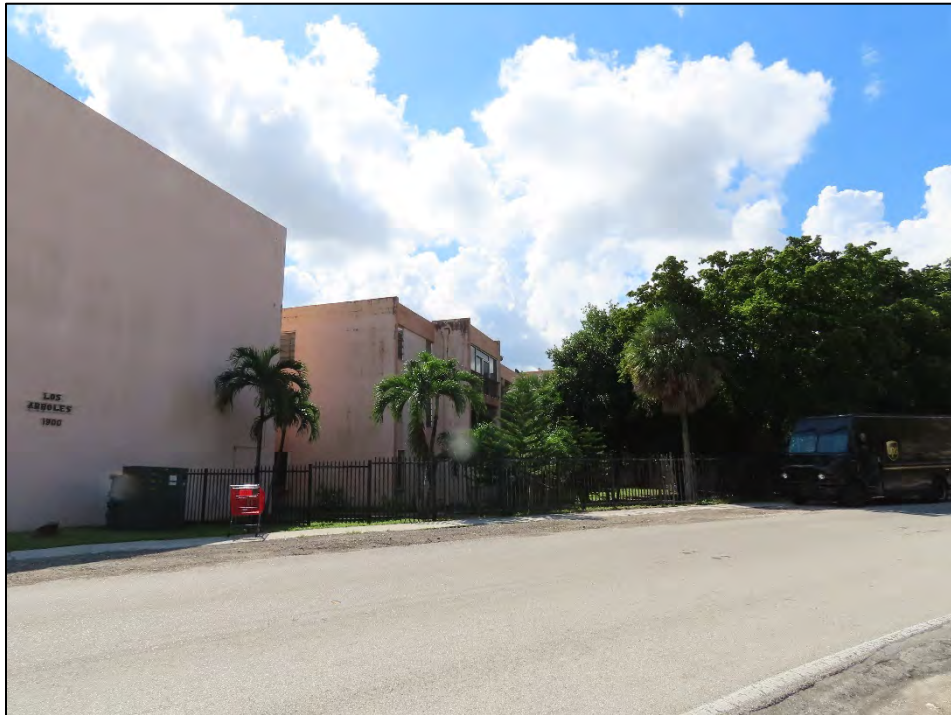
Figure 62: Los Arboles Condominiums Resource Group (8DA19150), c. 1973, located at 1900 W 68th Street, considered National Register-ineligible, facing Southeast

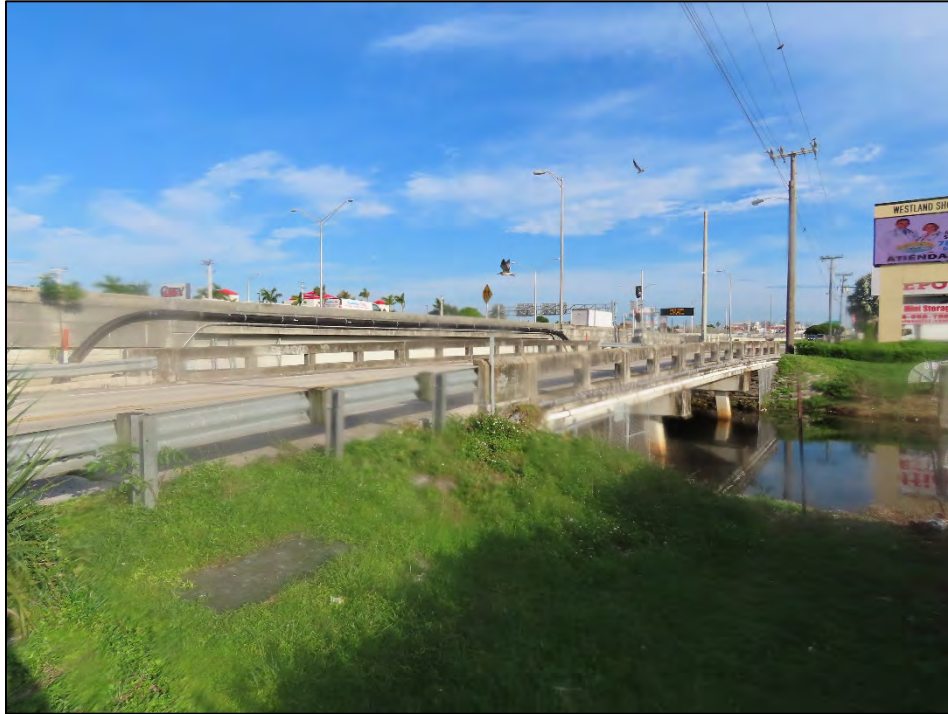
Figure 63: FDOT Bridge No. 870570 (8DA19154), c. 1968, carries vehicular traffic on W 20th Avenue over the Little River Canal (8DA6352)

FDOT Bridge No. 870570 (8DA19154), c. 1968, carries vehicular traffic on W 20th Avenue over the Little River Canal (8DA6352). The bridge is a three span reinforced concrete slab bridge with a pedestrian sidewalk on the east side. FDOT Bridge No. 870580 (8DA19155), c. 1973, carries eastbound vehicular traffic on NW 122nd Street over the SR 826 Canal (8DA11681). The bridge is a one span reinforced concrete slab bridge with four vehicle travel lanes. FDOT Bridge 870467 (8DA19156), c. 1974 carries northbound SR 826 over NW 138th Street. The bridge is a two span prestressed concrete multi-beam bridge with four vehicle travel lanes. Photographs of the three bridges are included as Figures 63-65.

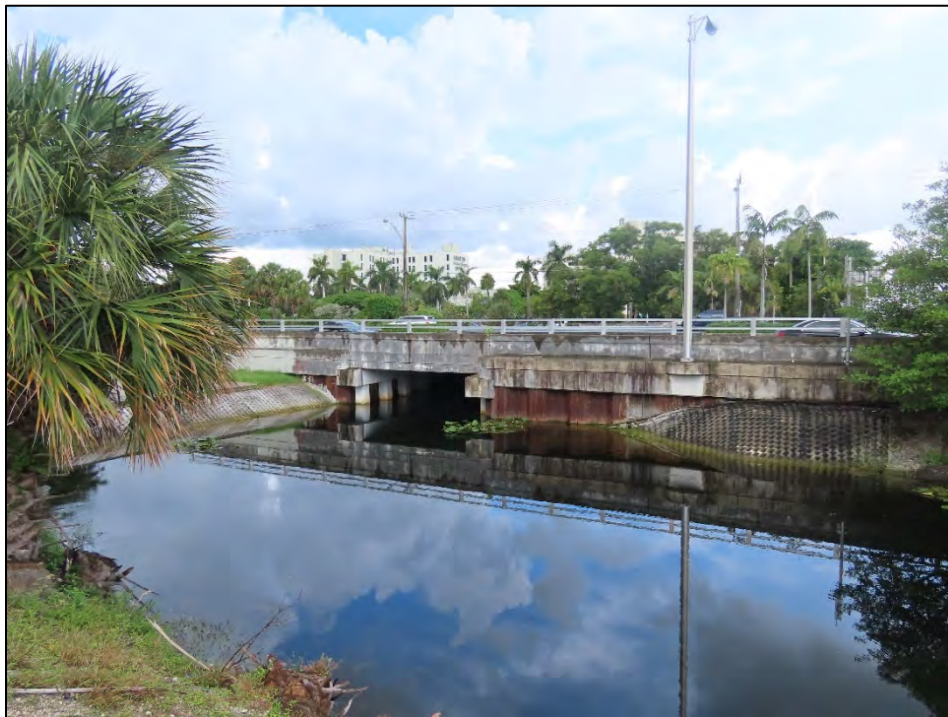
Figure 64: FDOT Bridge No. 870580 (8DA19155), c. 1973, carries eastbound vehicular traffic on NW 122nd Street over the SR 826 Canal (8DA11681)

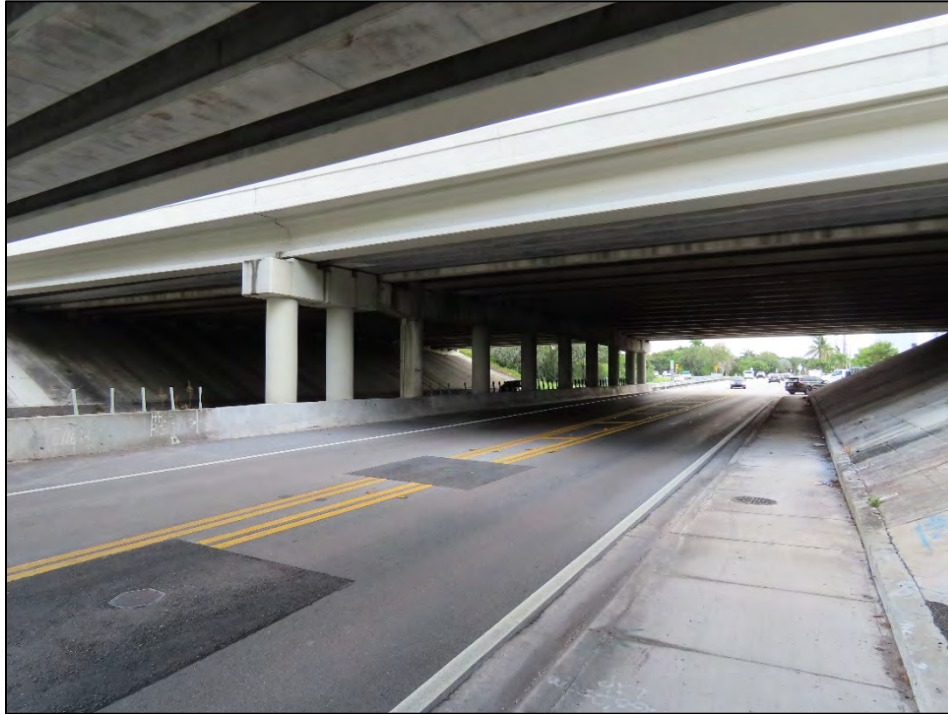
Figure 65: FDOT Bridge 870467 (8DA19156), c. 1974, carries northbound SR 826 over NW 138th Street

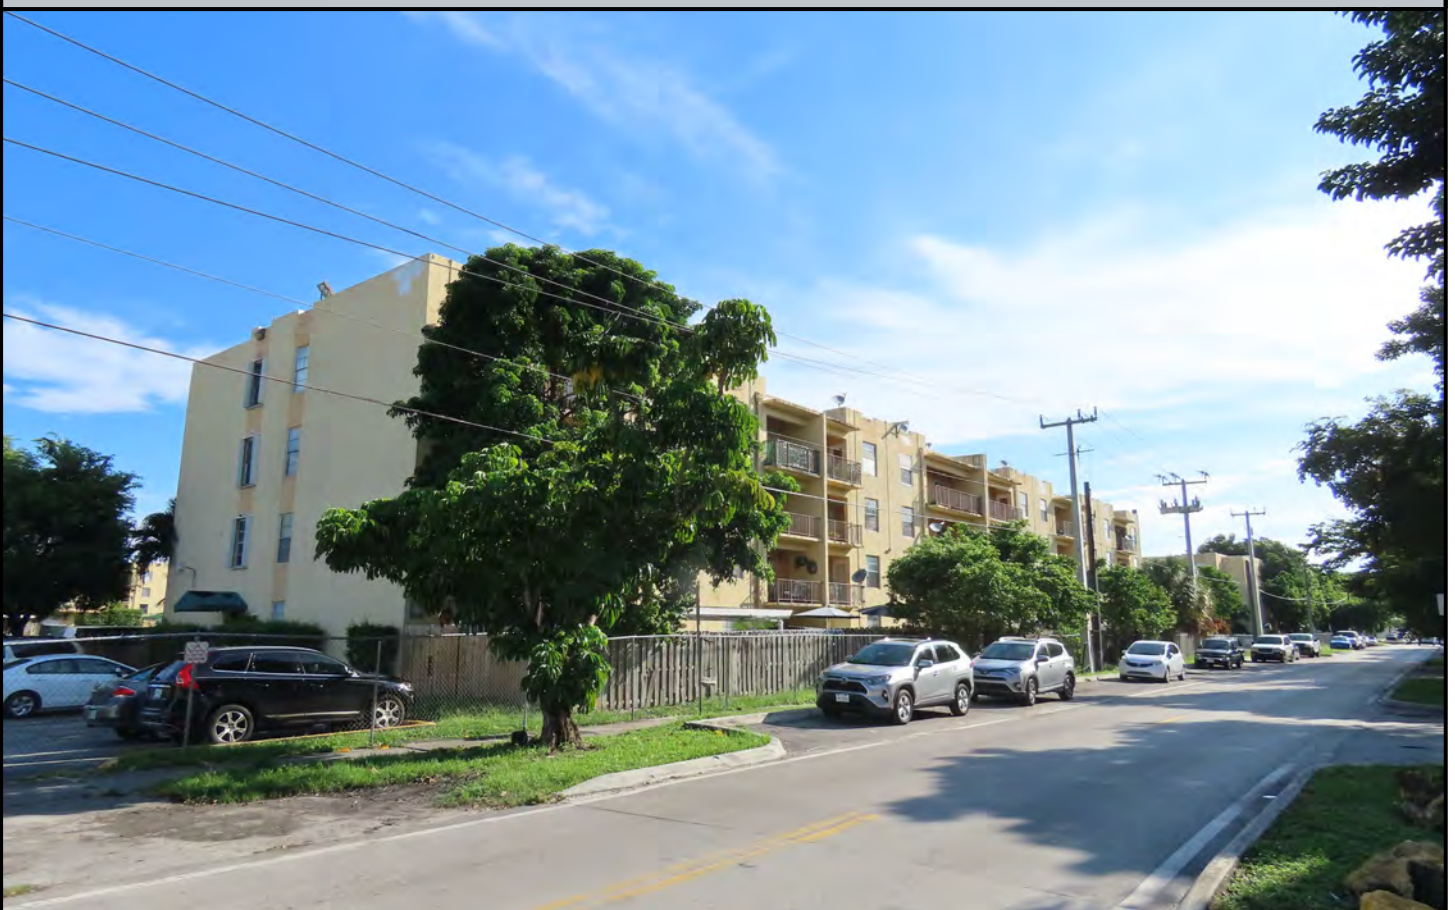
8DA19131

This Masonry Vernacular condominium bldg exhibits a common style found in South Florida, features alts including replaced windows and material, and lacks historical associations. Therefore, it is considered ineligible for listing in the National Register

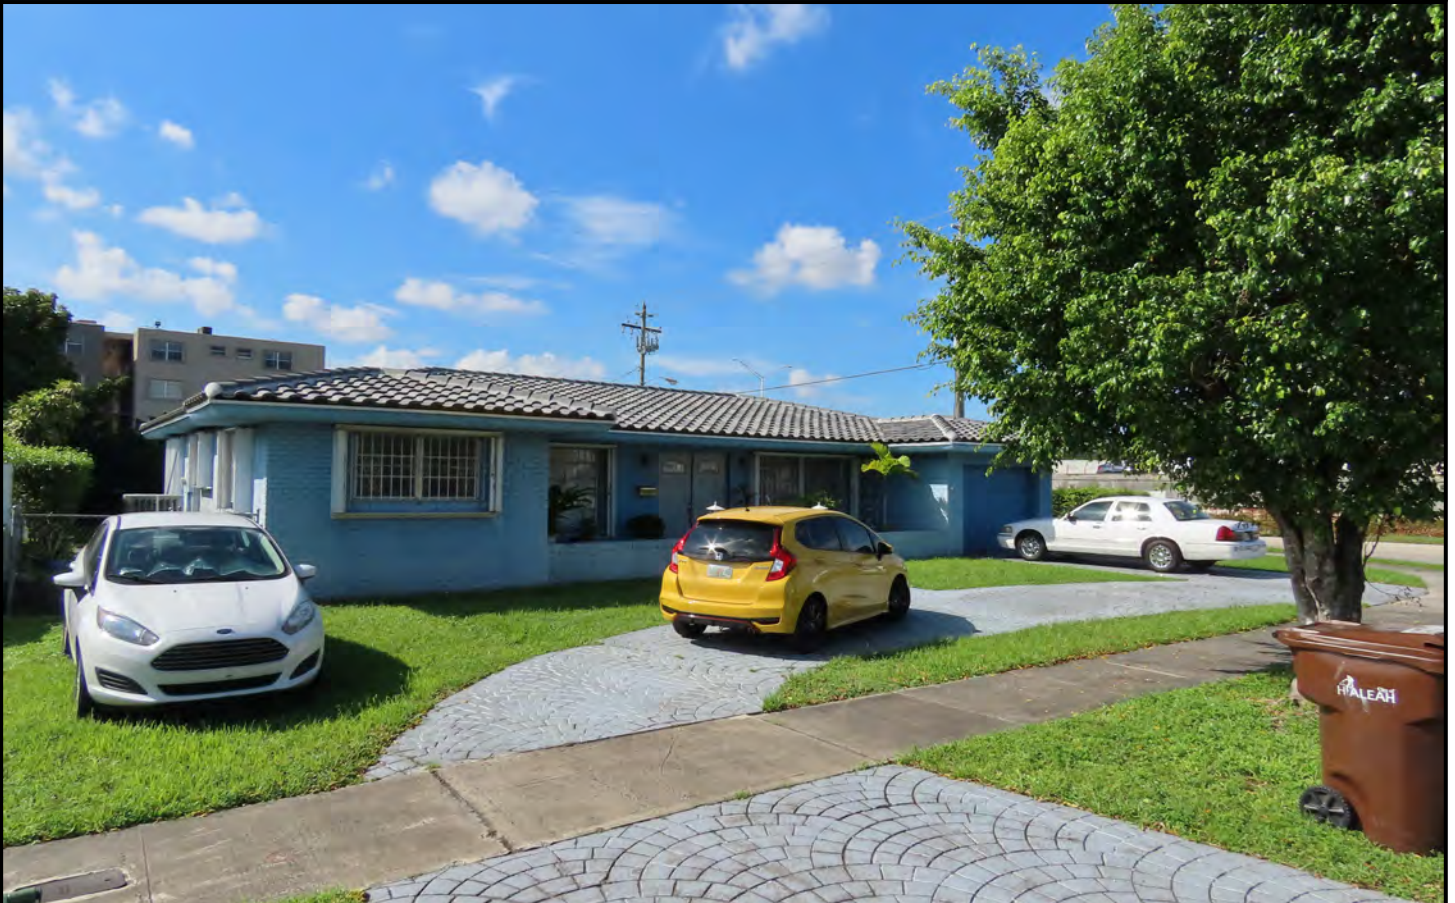
8DA19137

This Masonry Vernacular residence exhibits a common style found in South Florida, features alts including replaced doors and material, and lacks historical associations. Therefore, it is considered ineligible for listing in the National Register

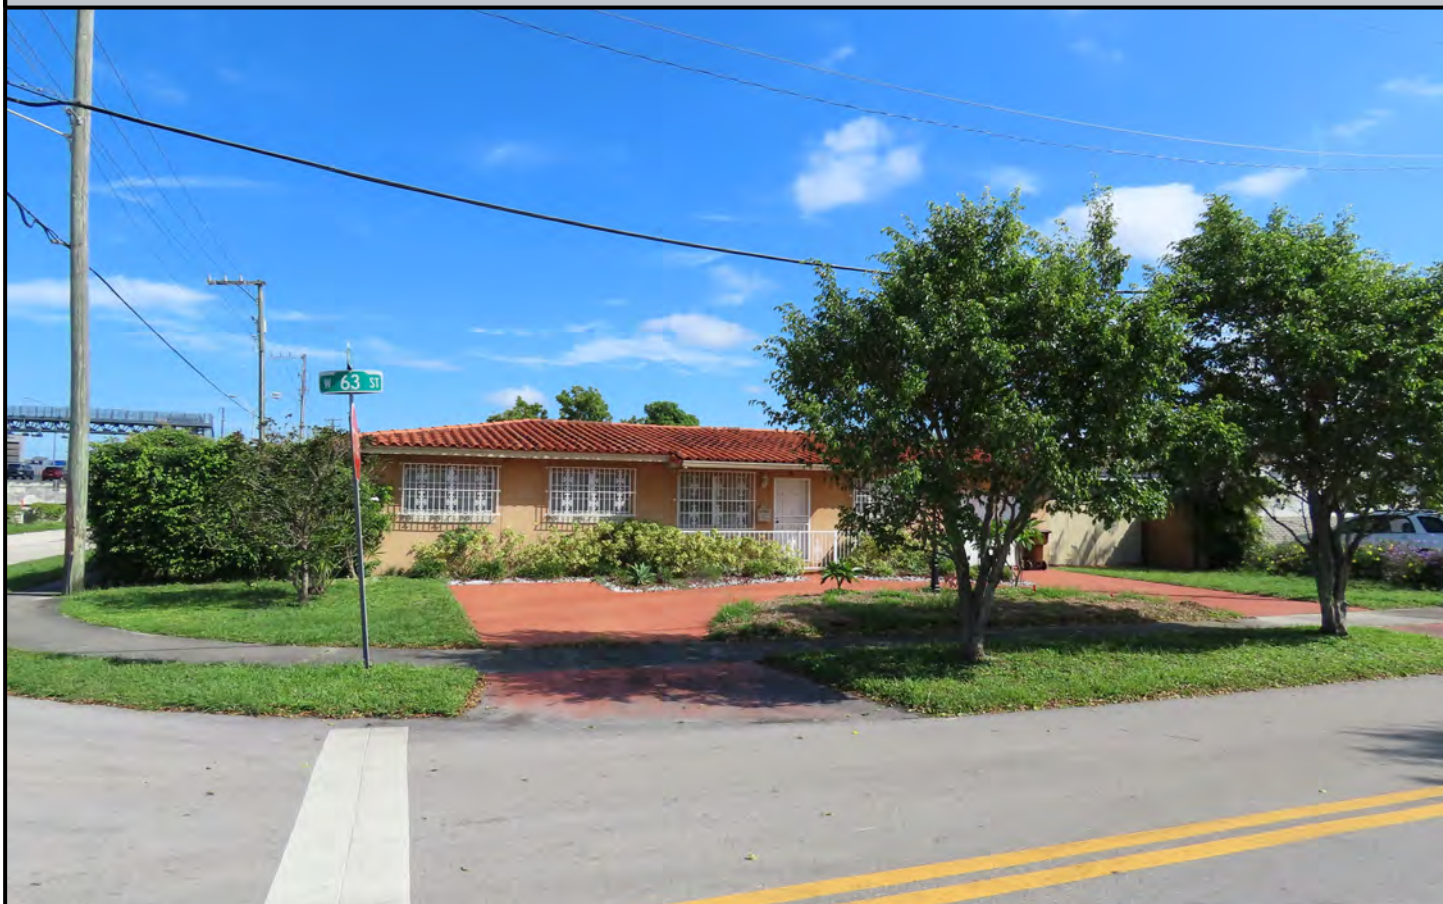
8DA19138

This Masonry Vernacular residence exhibits a common style found in South Florida and lacks any known historical associations. Therefore, it is considered ineligible for listing in the National Register

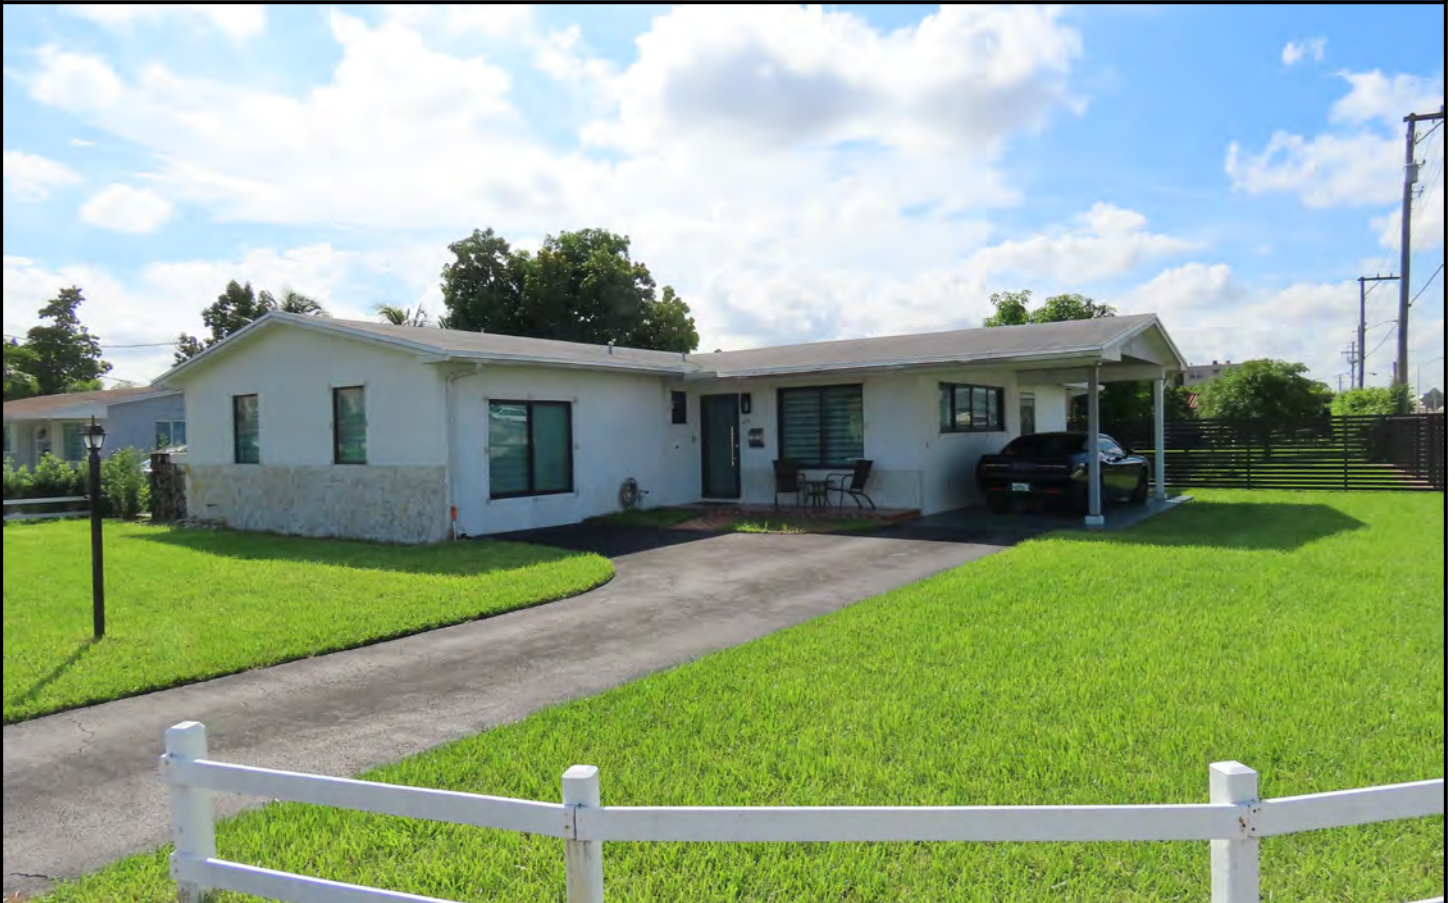
8DA19139

None observed; carport on W facade under gable roof supported by 2 square columns; post&beam wooden fence at property line

This Masonry Vernacular residence features no additions and several alterations including replaced windows/doors. The carport is integrated to the house and connected to gable roof.

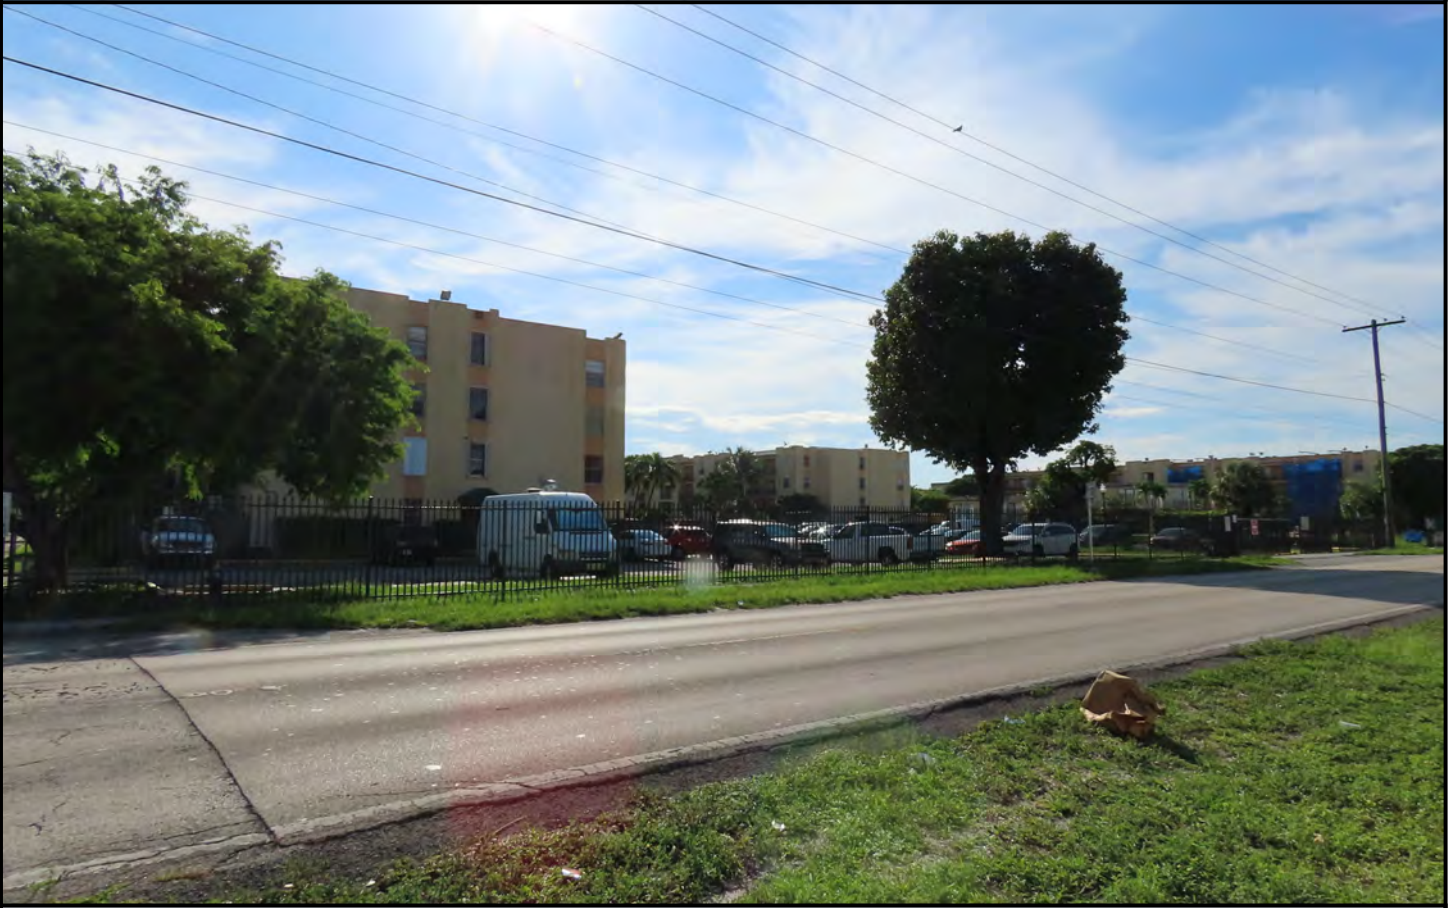
8DA19149

This resource group includes 6 c1972 condo bldgs. The structures exhibit a common style found in South Florida, replaced windows/alterd material and lack historical associations, therefore the resource group is considered National Register-ineligible.

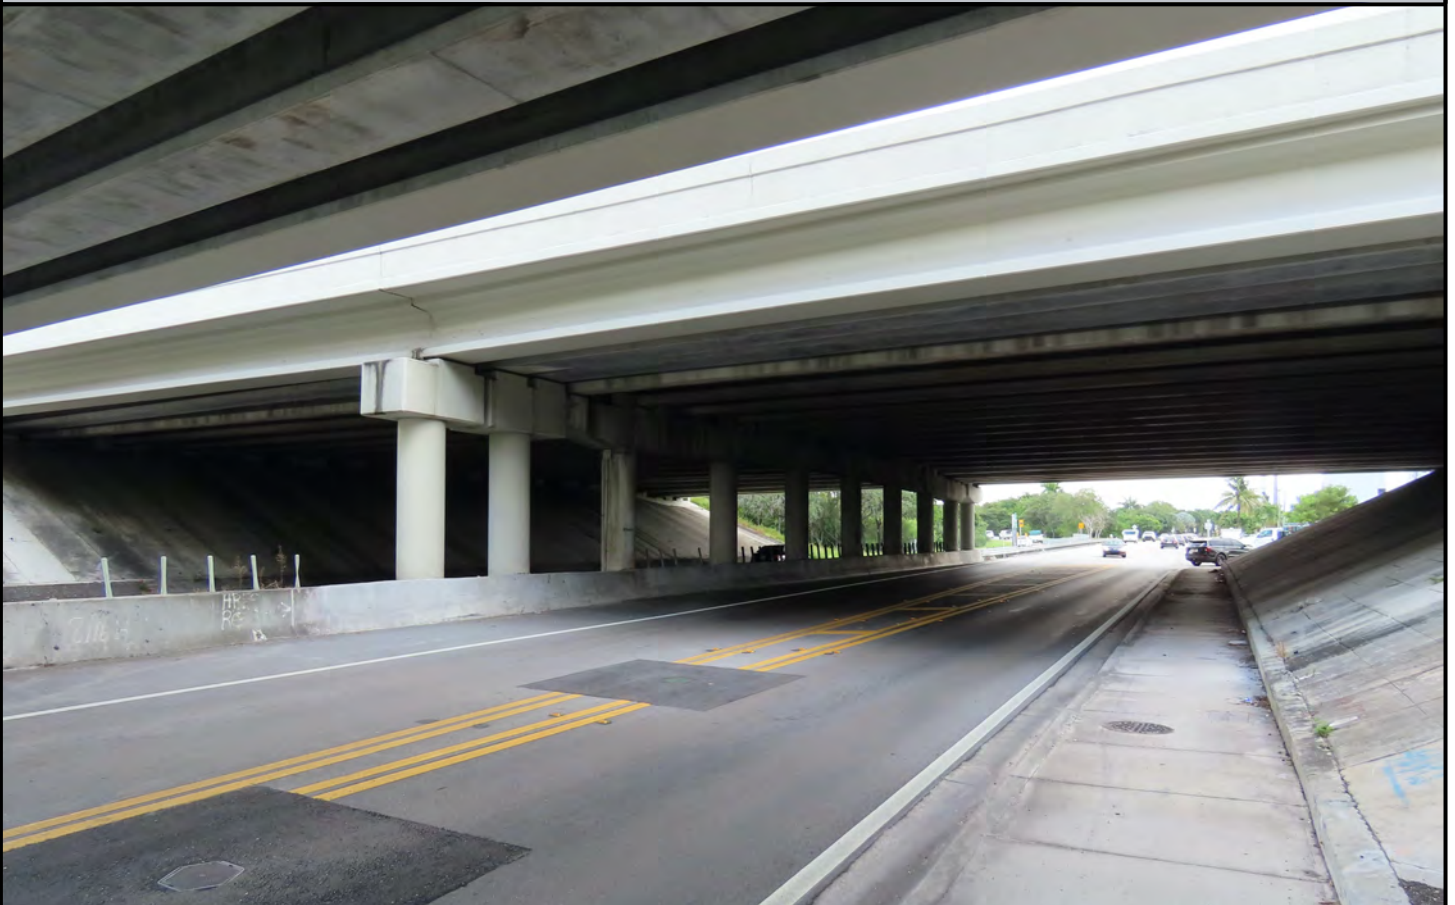
8DA19156

Overall Condition ☐ excellent ☒ good ☐ fair ☐ deteriorated ☐ ruinous
