**CULTURAL RESOURCE ASSESSMENT SURVEY
OF VENETIAN CAUSEWAY FROM NORTH BAYSHORE DRIVE IN THE CITY
OF MIAMI TO PURDY AVENUE IN THE CITY OF MIAMI BEACH**

MIAMI-DADE COUNTY

Financial Management No. 422713-2-22-01

FINAL REPORT

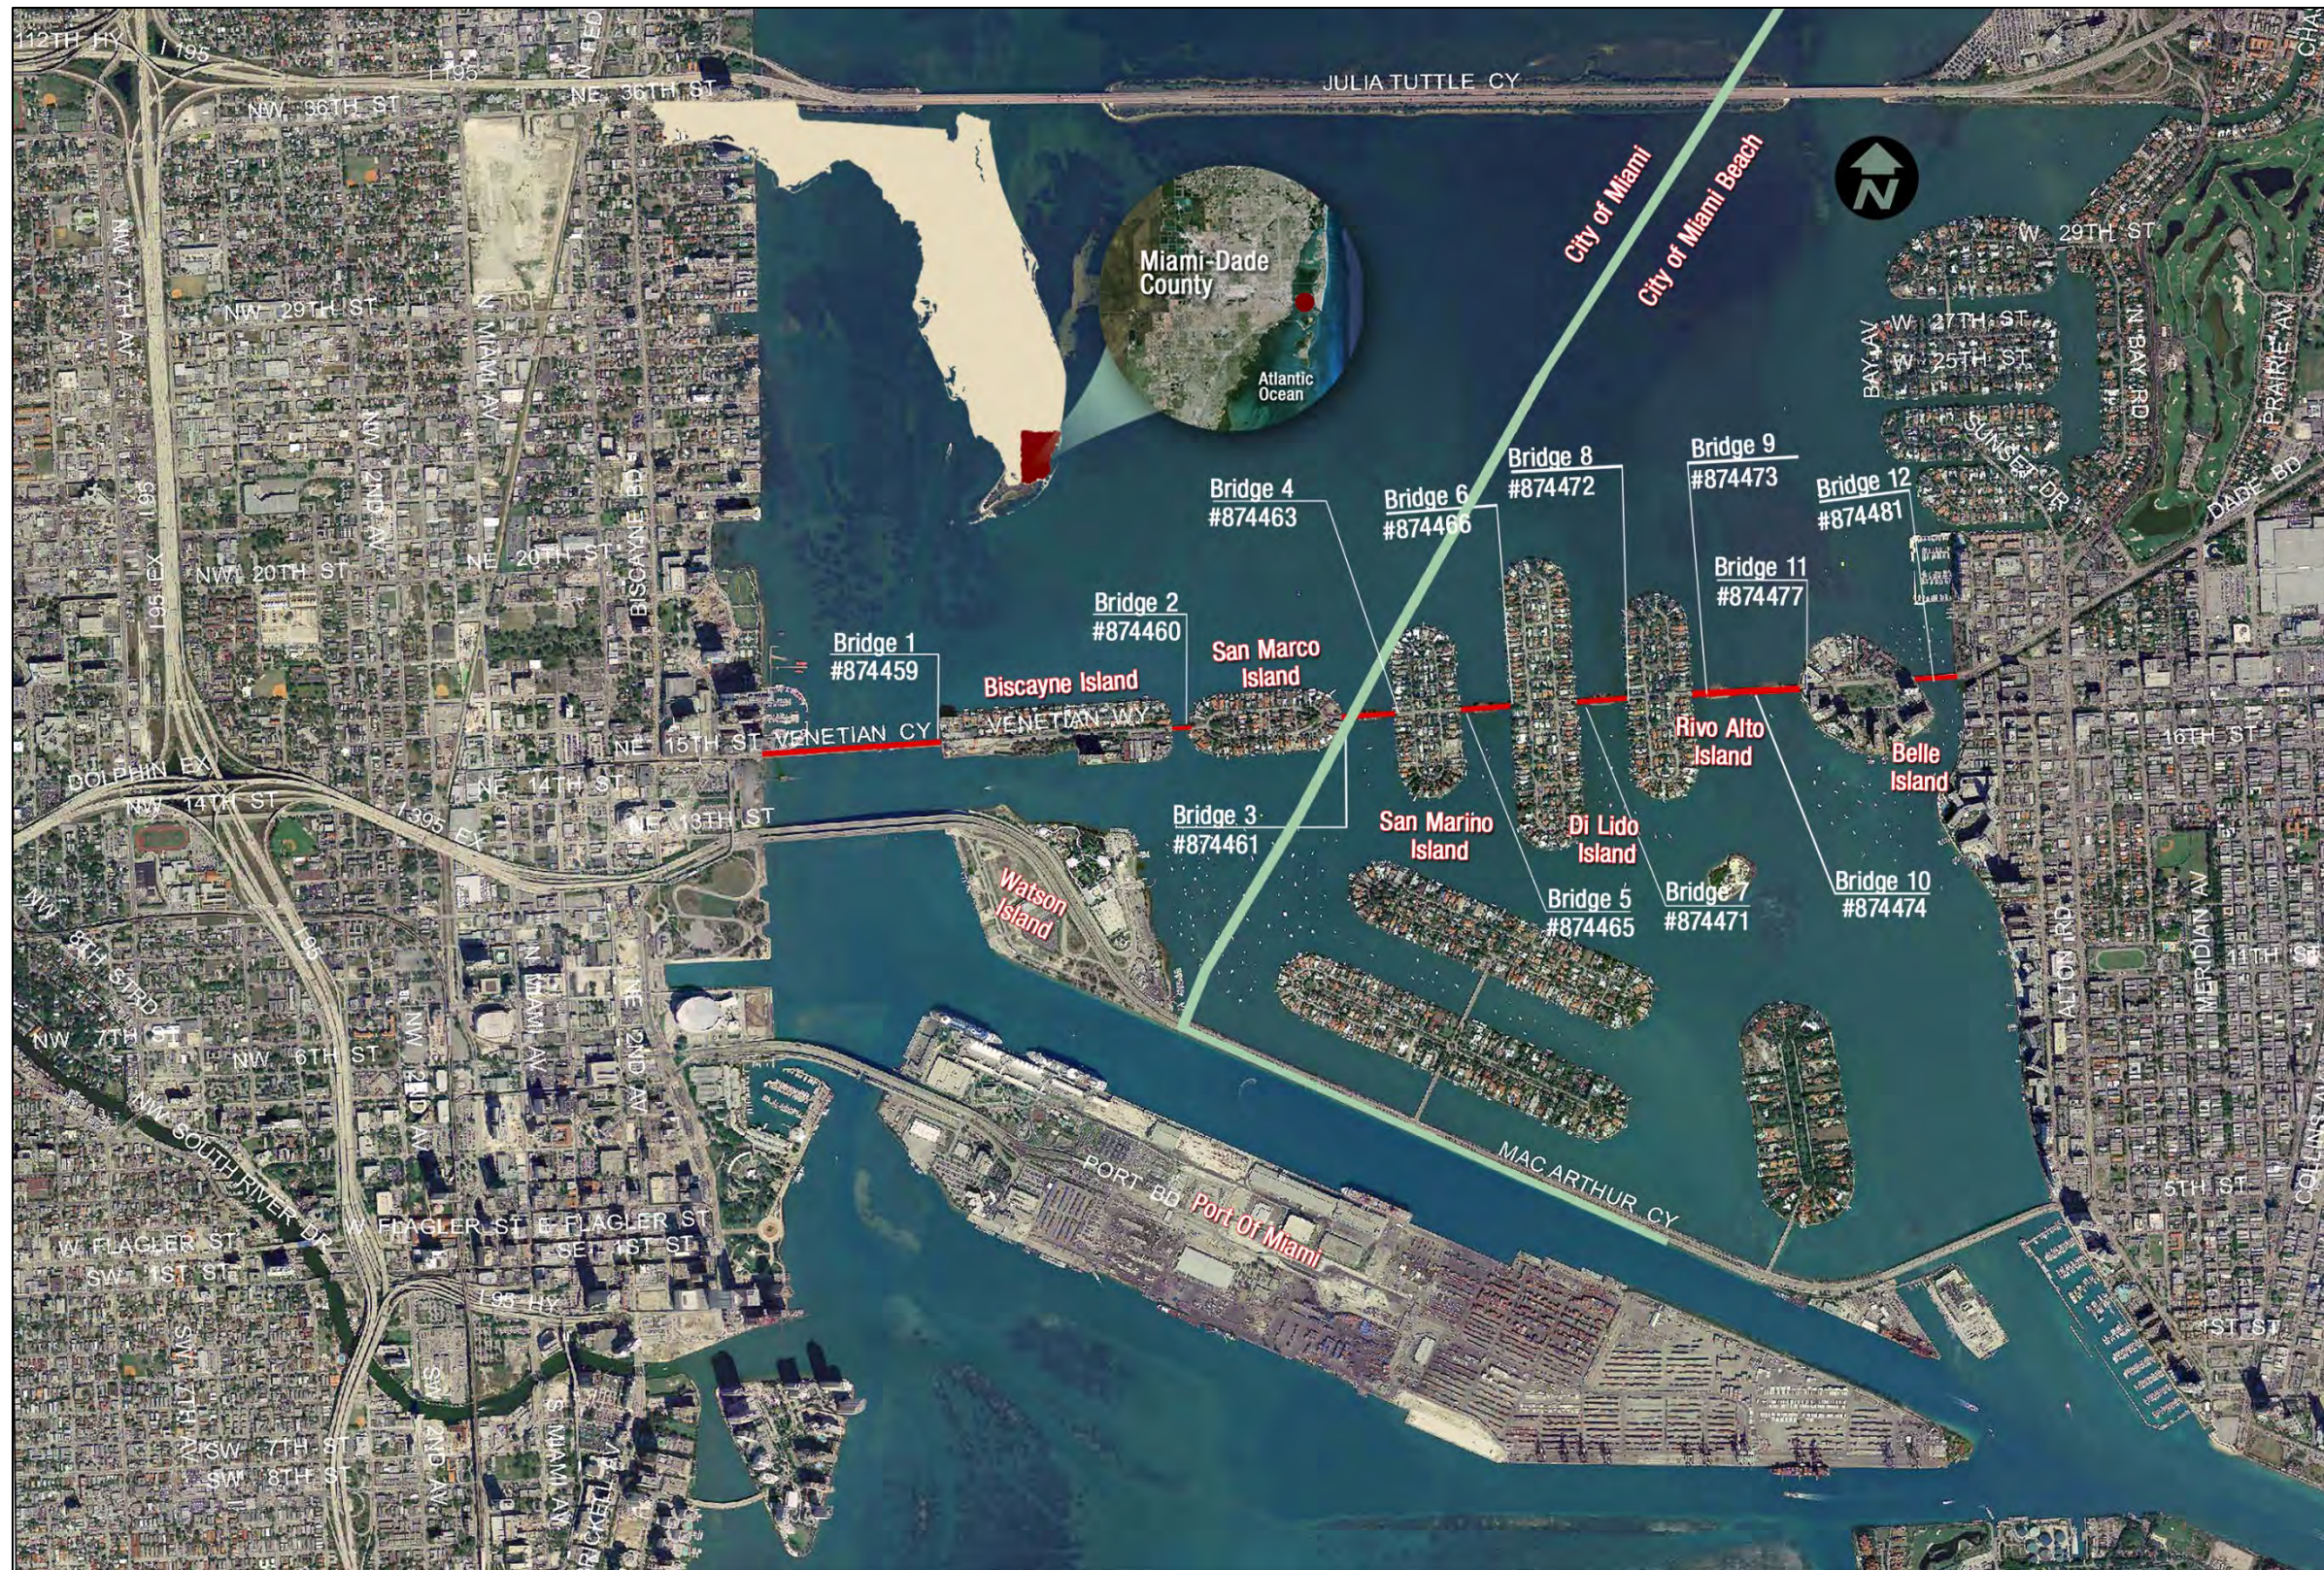
Figure 1: Project Location Map

The causeway bridges are mainly short span reinforced concrete arch beam bridges. Each bridge section consists of two 12 ft. travel lanes with 4 ft. bike lanes and 4 ft. sidewalks on each side. In 1996, the bridges underwent a major rehabilitation consisting of gunite repairs to the superstructure arch beams and full replacement of all sidewalks and railings. The western bascule bridge (Bridge 1) and its spans 17 through 41 were also replaced. Presently, the bridges exhibit severe deterioration because of their proximity to the very aggressive marine environment. Due to new design codes, these bridges do not meet current design and safety requirements. The corridor is tolled, and is owned and operated by Miami-Dade County. A Project Location Map is included as Figure 1.

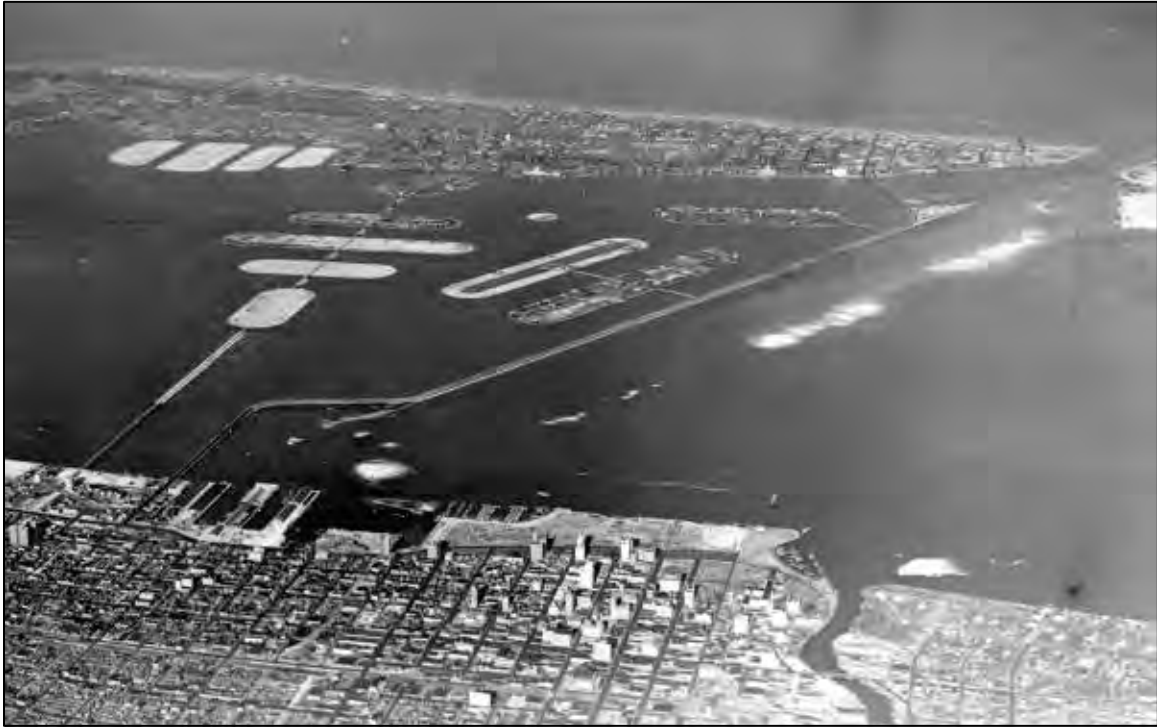
Figure 4: 1927 Aerial View of Miami Beach and Bridges
Courtesy State Archives of Florida, Florida Memory Collection

Hoping to cash in on the boom, real estate developers dredge the bottom of Biscayne Bay to create additional water-front lots (Welcher 1989). In 1921, the Bay Biscayne Improvement Company began an ambitious effort to construct a chain of islands across Biscayne Bay. Officers of the company included Josiah F. Chaille, Colonel Frank B. Shutts, Marshall Price, and Hugh Anderson, as well as F. C. B. Le Gro, who was already involved in the development of Belle Isle (City of Miami 1990). The “Venetian Islands” were to be constructed from dredge material and deposited along Collins Bridge to form a series of residential isles inspired by the landscape of Venice, Italy. Once the four central islands were formed, the Venetian Causeway was constructed to provide access to the newly-developed communities. The Causeway was completed in 1926. Figure 4 depicts Miami Beach and connecting bridges as they appeared in 1927.

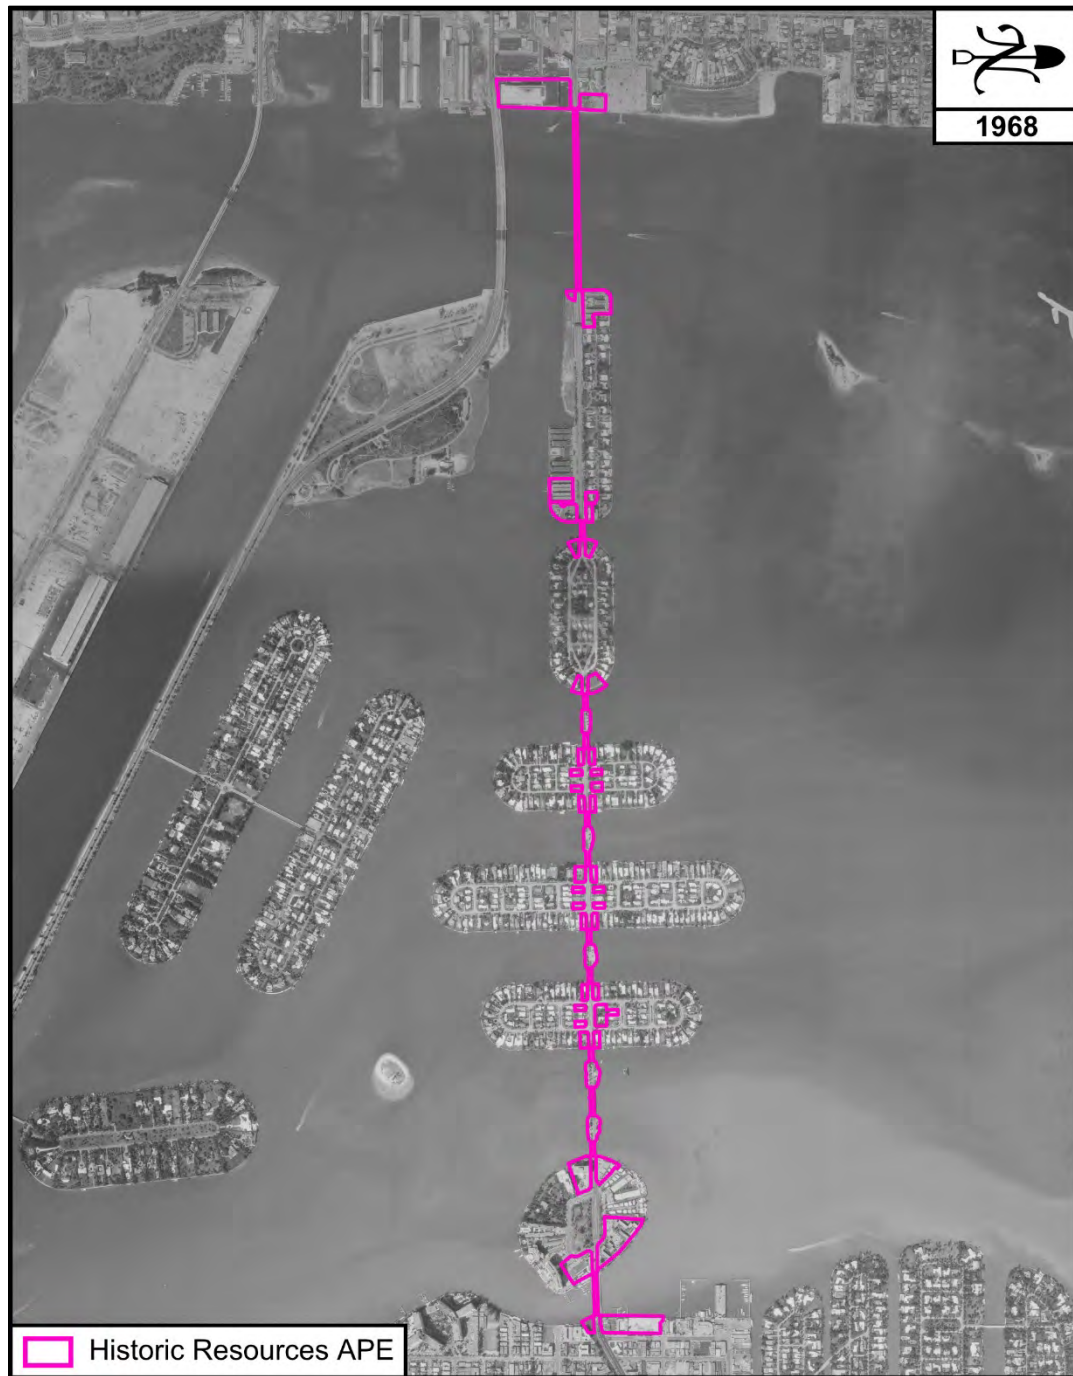
Figure 6: 1968 Aerial Photograph, Western Extent of Historic APE

family buildings that were constructed in the 1960s. The bridges connecting the man-made islands are visible, as are the small man-made earthen landings. A small section of the APE on Biscayne Island remains submerged. The 1968 aerals show increased development of multi-family housing on Biscayne Island and Belle Isle (Figure 6).

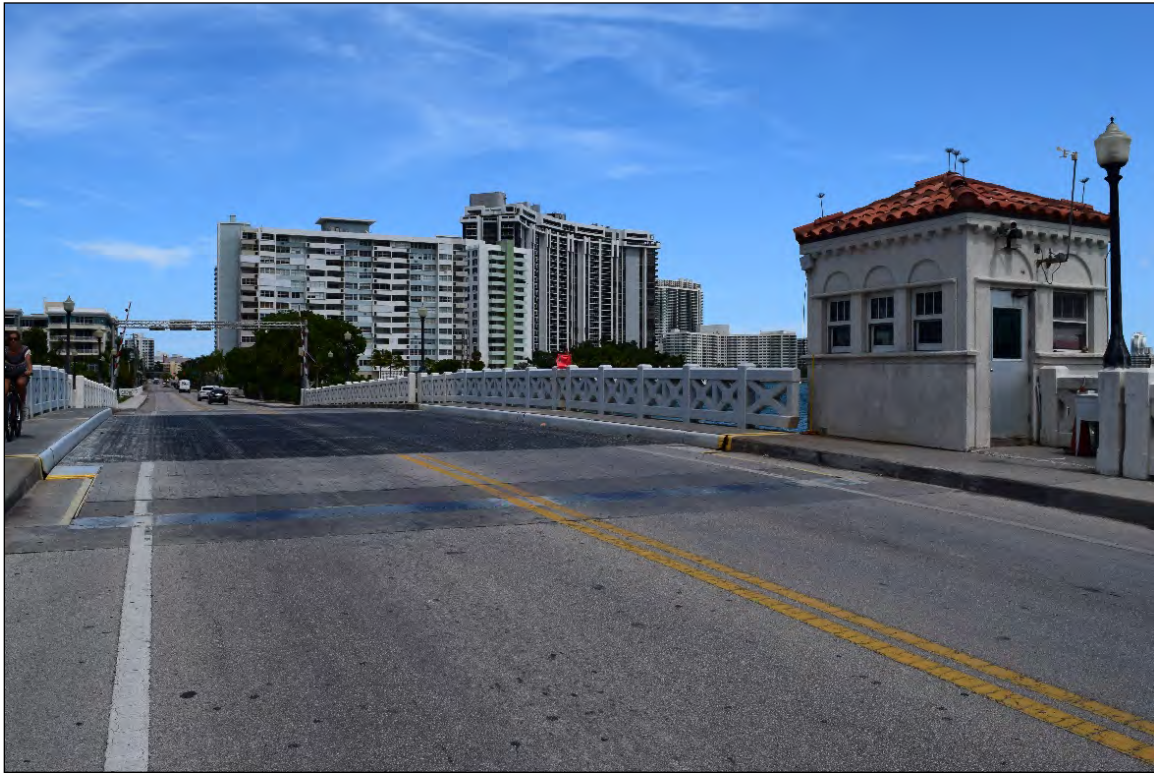
Figure 8: Existing Concrete Decking, Sidewalks, and Railings within the Archaeological APE at Venetian Causeway Bridge 10 (8DA14382), Facing East

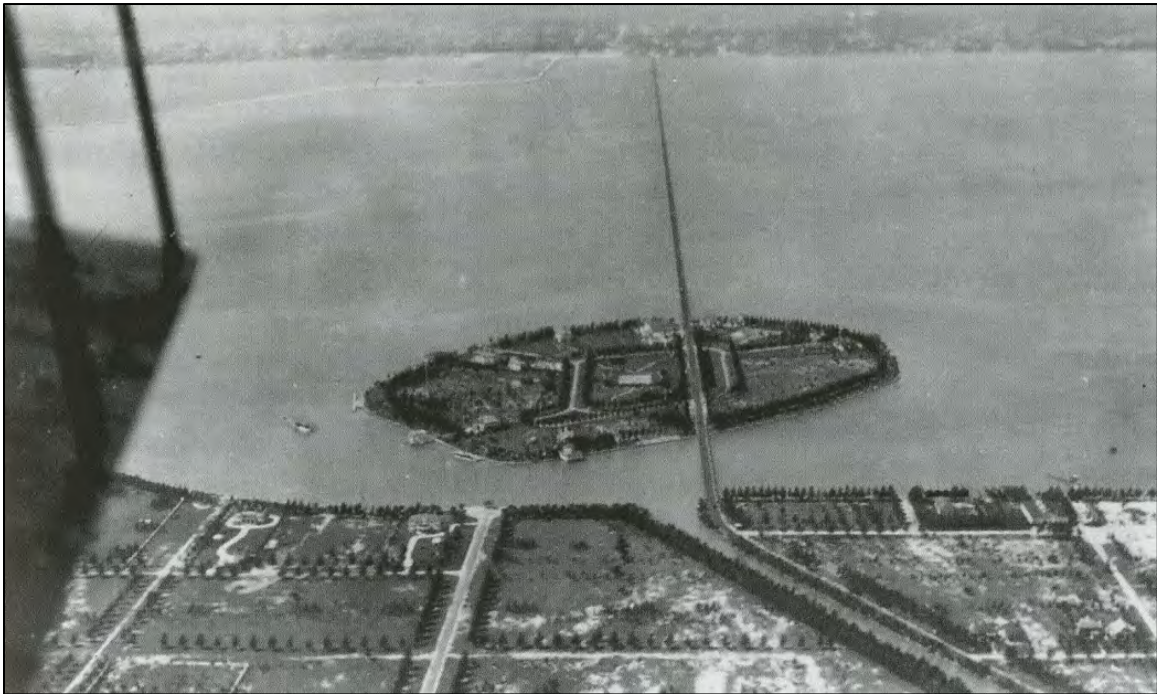
Figure 11: 1920s Aerial View of Belle Isle and Collins Bridge
Courtesy State Archives of Florida, Florida Memory Collection

Belle Isle, the earliest of the islands, was largely shaped of dredge material excavated from the surrounding bay bottom during construction of the Collins Canal and Collins Bridge. The island was formed surrounding the eastern portion of the Collins Bridge. A plat map for the island was submitted in 1915 by the Biscayne Engineering Co., owned by W.E. Brown. Development of the island resulted from a partnership between F.C.B. Le Gro and John S. Collins (Figure 11). During the 1920s, several large estates were constructed on the island, including J.C. Penny's residence known as "White Haven" (City of Miami 1990).

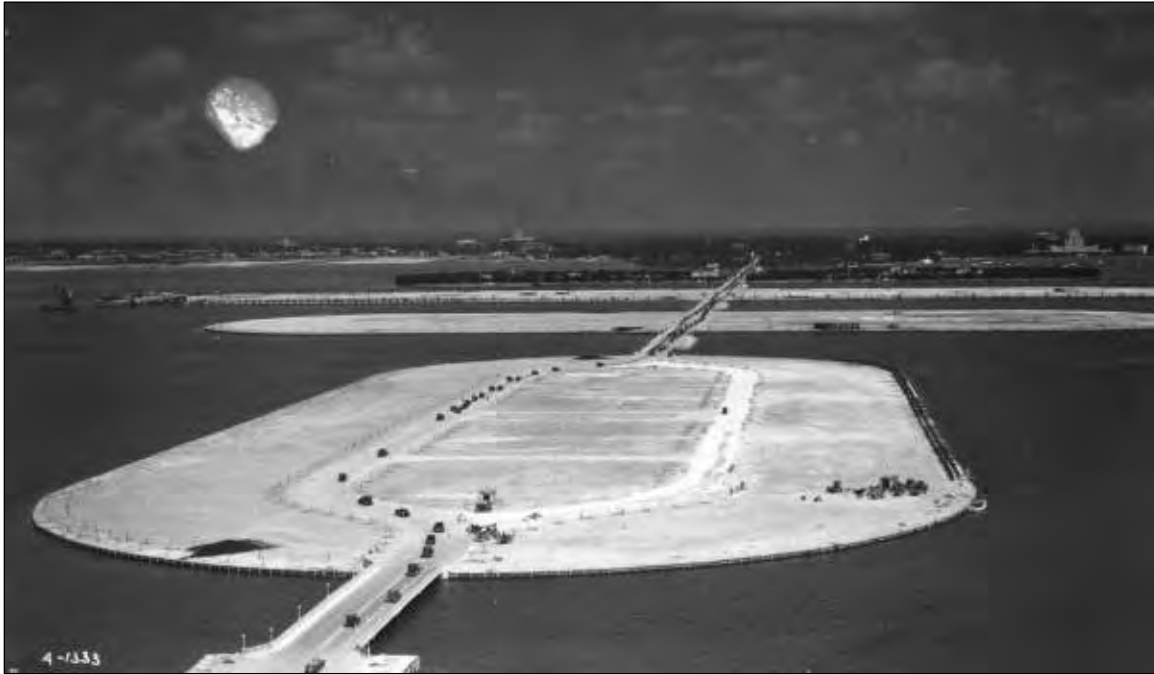
Figure 12: 1925 Photograph of Construction on the Venetian Islands
Courtesy State Archives of Florida, Florida Memory Collection

Island building began immediately with Rivo Alto in 1922 (Figure 12). The remaining islands of Di Lido, San Marco, and San Marino were platted by 1923. Whitney C. Bliss, Engineer of Record, was responsible for establishing the layout of the islands (Welcher 1989). When completed, the islands were expected to contain over four-hundred and fifty residential lots, as well as interior roads and access to the mainland via an elegant causeway. The Bay Biscayne Improvement Company immediately established two sales offices in Miami and began selling lots, still underwater, to would-be homeowners (City of Miami 1990). Contracts included an

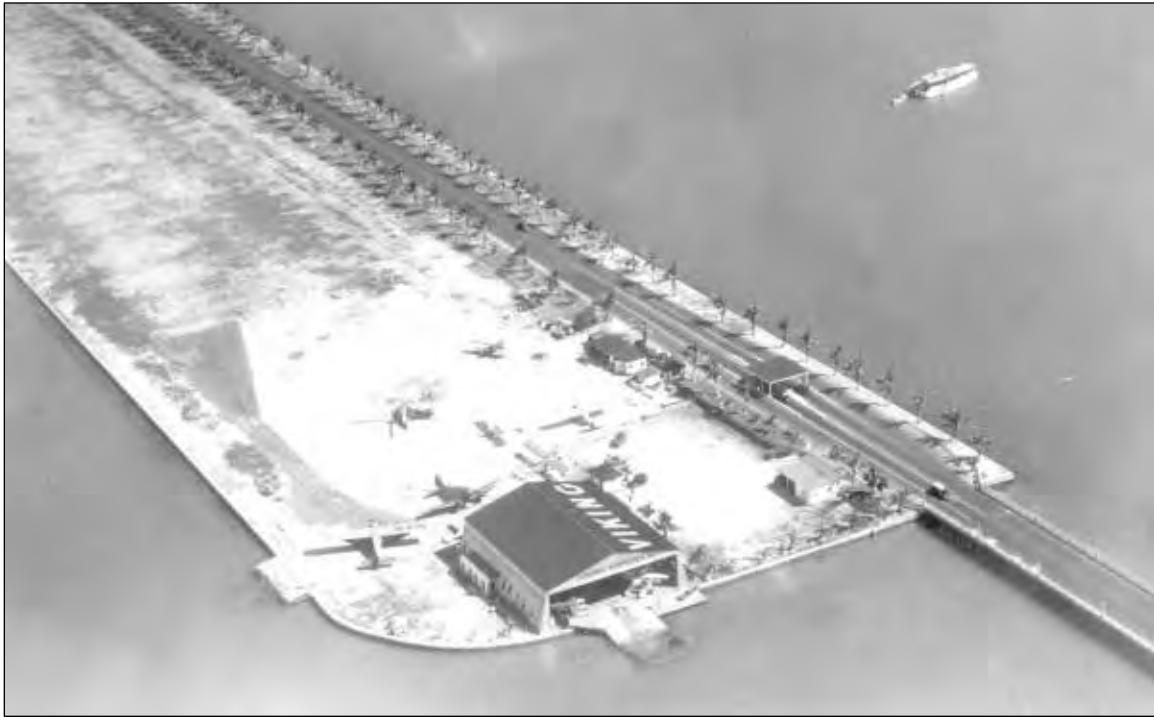
Figure 13: 1930s Aerial Photograph of Biscayne Island and the Viking Seaplane Base
Courtesy State Archives of Florida, Florida Memory Collection

The final island of the chain, Biscayne Island, was formed from residual dredging material accumulated during the construction of the previous islands, however was not immediately developed during the 1920s (Welcher 1989). The island was home to a small airport operated as the Viking Seaplane Base (Figure 13). In 1936, the Biscayne Island Corporation submitted a plat map showing subdivision for residential development on the island.

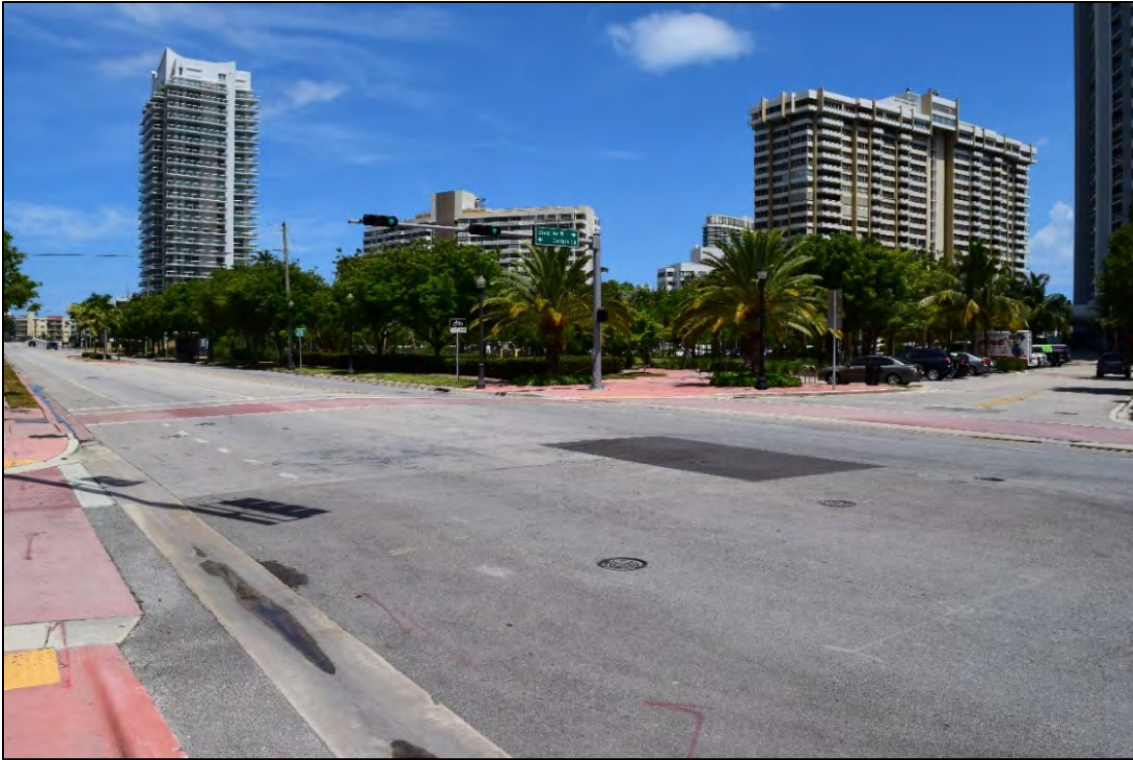
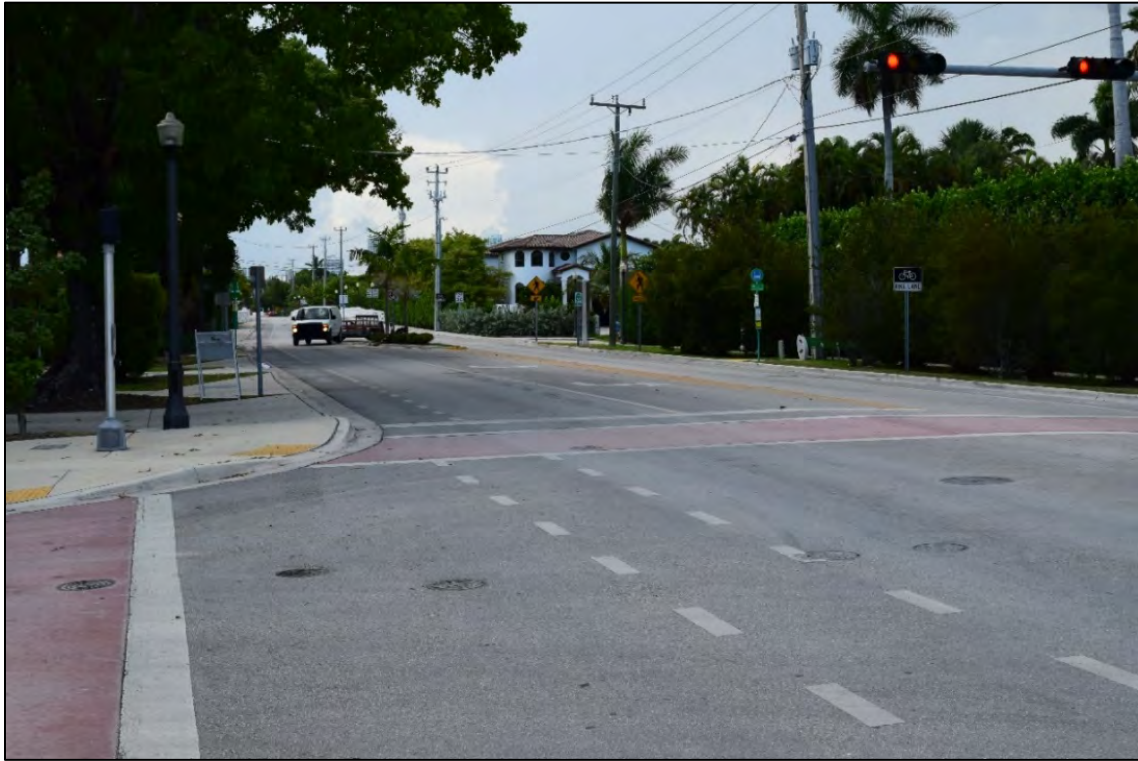
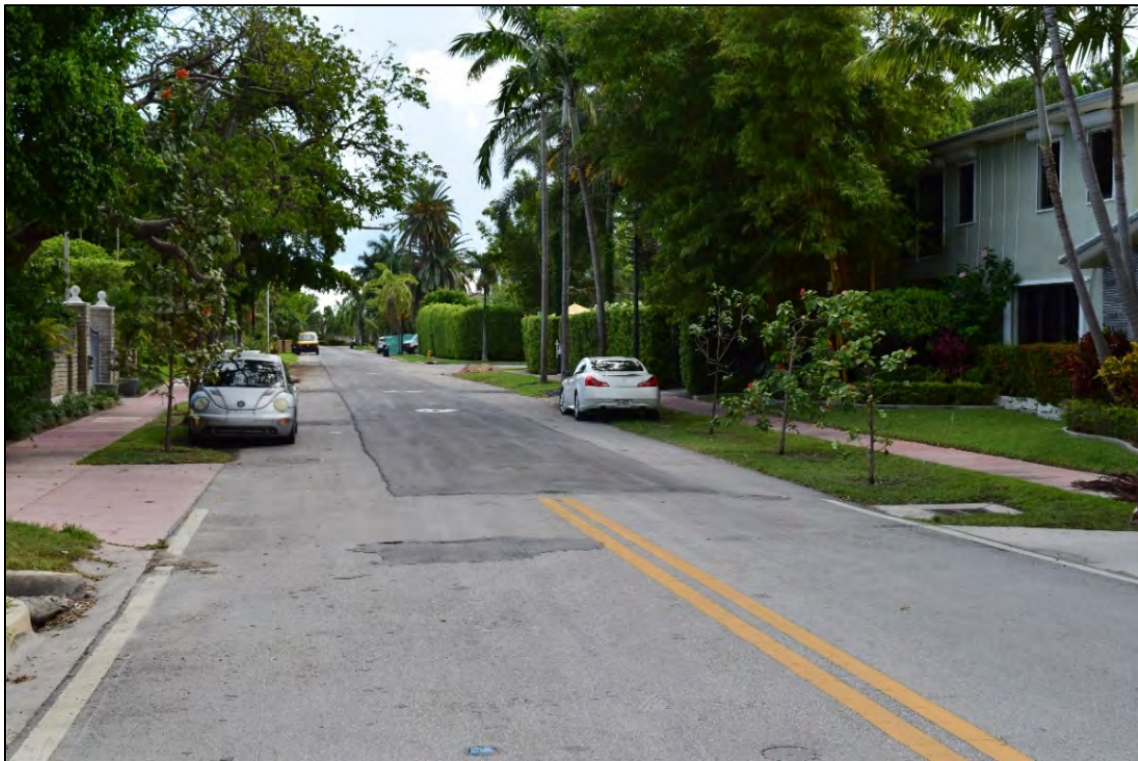
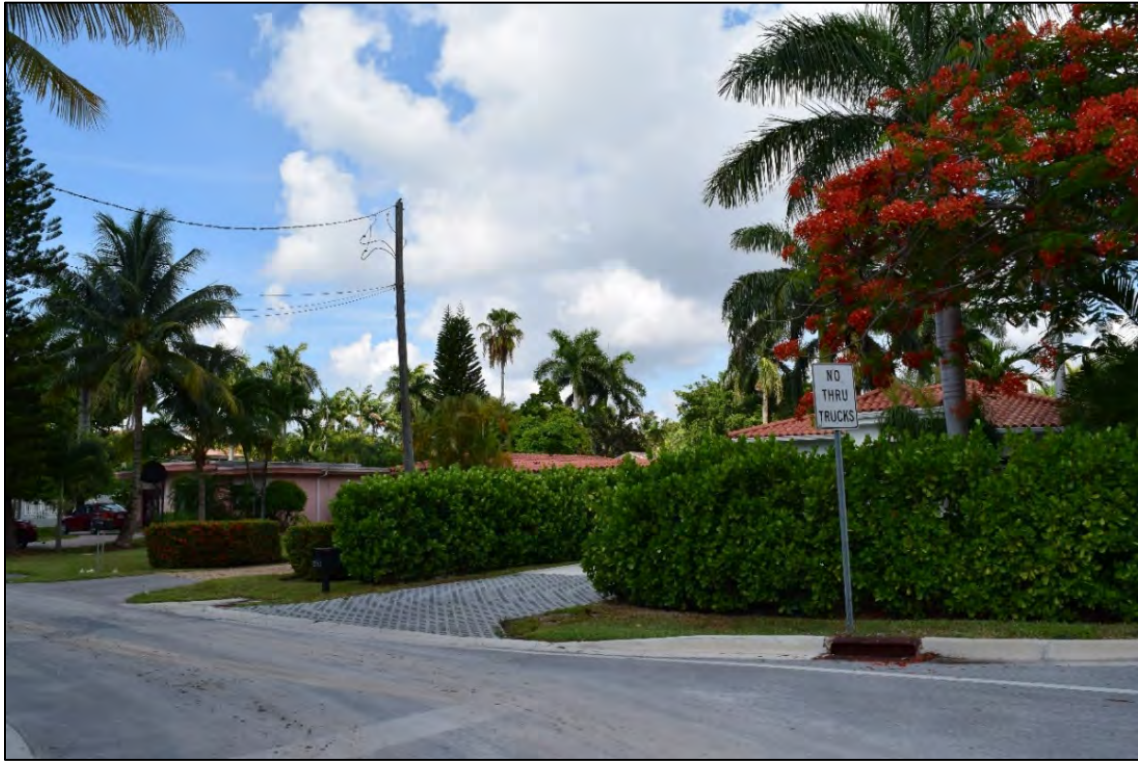
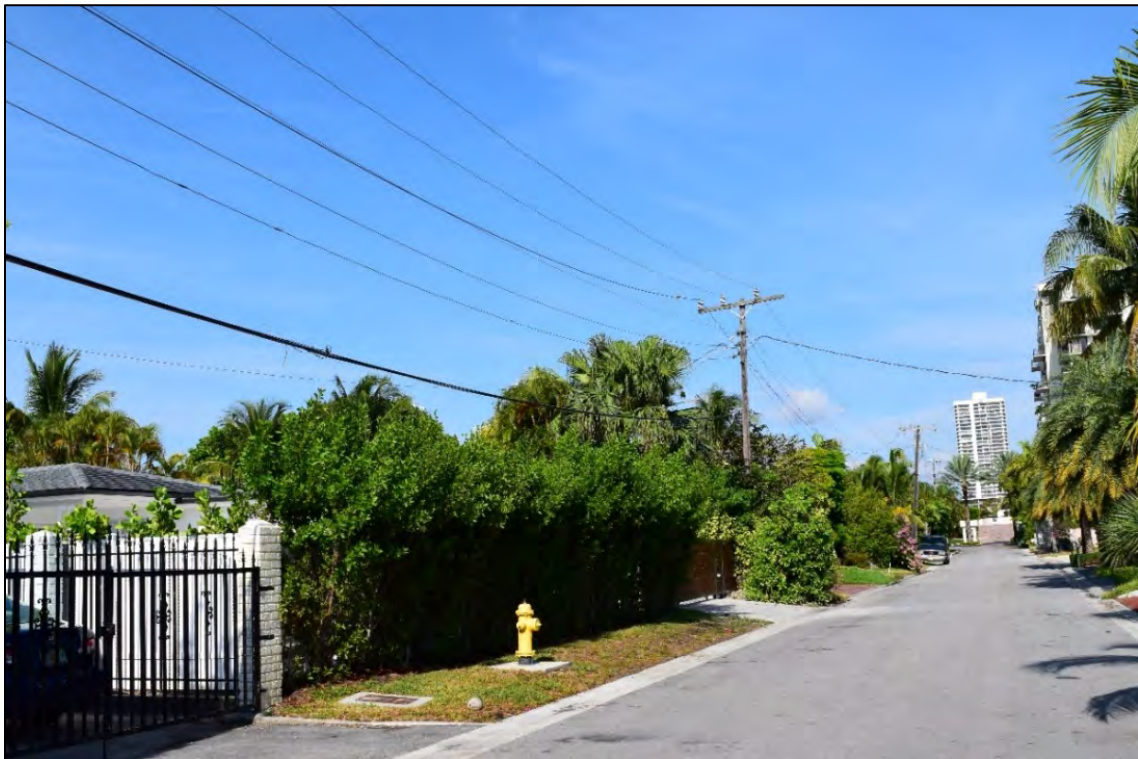
Based on current photographs of the streetscapes and comparison with descriptions of the original roadway and sidewalk widths, it appears that the roadways, curbing, sidewalks, landscaping, and lighting have all been updated since the time of construction (Figures 14-18). According to the *Section 106 Documentation and Determination of Effects Venetian Causeway Streetscape Improvements Project* (FMSF Manuscript No. 16537) conducted by Janus Research in 2008, these elements no longer retain sufficient integrity to convey significance.

Figure 14: Streetscape View of Belle Isle, Facing Southeast

Figure 15: Streetscape View of Rivo Alto Island, Facing West

Figure 16: Streetscape View of Di Lido Island, Facing North

Figure 17: Streetscape View of San Marco Island, Facing Southwest

Figure 18: Streetscape View of Biscayne Island, Facing West

As previously discussed in the *Methods* section part of the current project, the residential parcels surrounding the historic APE were evaluated for the potential of a historic district (Figures 14-18). There does not appear to be a significant concentration, linkage, or continuity between the buildings. Many of these buildings have sustained substantial alterations and additions, resulting in an overwhelming loss of integrity of design, materials, workmanship, feeling, and association. Furthermore, there has been continued construction of non-historic residential infill in recent years. Therefore, while the islands themselves are contributing, there does not appear to be sufficient integrity for a historic district within the Venetian Islands.

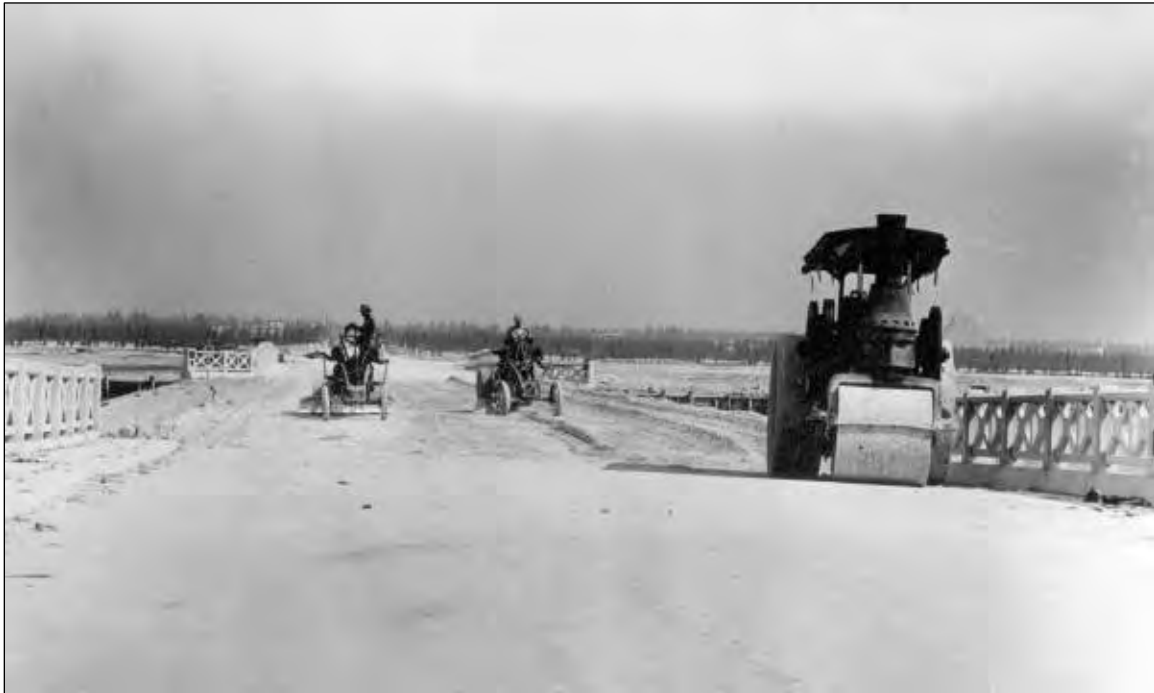
Beginning in 1925, the bridges and earthen causeways were constructed as the final phase in the development of the island communities (Figure 19). Harvey Stanley was responsible for the design of the bridges and the cost for the concrete structures was estimated at two-million dollars (Welcher 1989). The Raymond Concrete Pile Company of New York was selected as the building contractor and James M. Thompson served as superintendent. Plans for the new bridge included a combination of bridges and earthen causeway landings. The large islands would be connected using two bascule-span bridges, ten fixed-span bridges, and a series of earthen causeways. The bridges were completed in 1926, with a formal dedication occurring on February 28 of that year (Welcher 1989).

Figure 19: 1925 Photograph Showing Construction on the Venetian Causeway
Courtesy State Archives of Florida, Florida Memory Collection

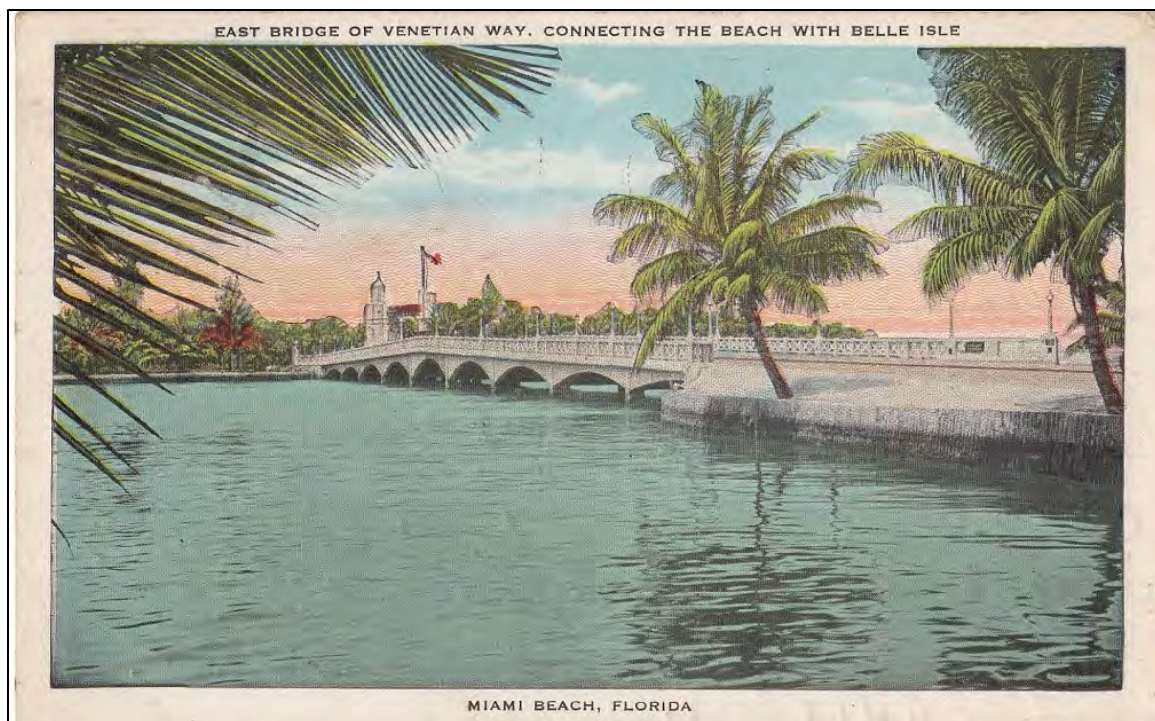
Figure 21: 1930s Postcard Depicting the Venetian Causeway Bridge 12 (8DA14384)
Courtesy Belle Isle Residents Association

A total of ten fixed-span bridges connect the short expanses of bay between the Venetian Islands. These fixed tee-beam spans are constructed of reinforced concrete. Decking is concrete and is carried on shallow arched girders resting on square concrete piers anchored to the bay bottom. The spans are continuous and are seated on fixed bearings at each pier. The variable depth tee beams are cast-in-place concrete and are framed into large end diaphragms which act as integral piers. These diaphragms are supported on square pier columns which rest on concrete pile caps. There are five tee beams in the cross-section spaced at 8 feet 6 inches on center with 3 feet 11 inches overhang. The bridges have a low rise and provide minimal clearance above the mean high water. The guardrails, one of the main decorative features of the bridges, are constructed of reinforced concrete in a pierced, ornamental geometric design that have square units with radiating diagonals forming an “x” pattern (Figure 20). This simple design forms a bold pattern while allowing a view of the bay from all of the bridges. A 1930s postcard shows the eastern-most bridge, Venetian Causeway Bridge 12 (8DA14384), as it originally appeared (Figure 21).

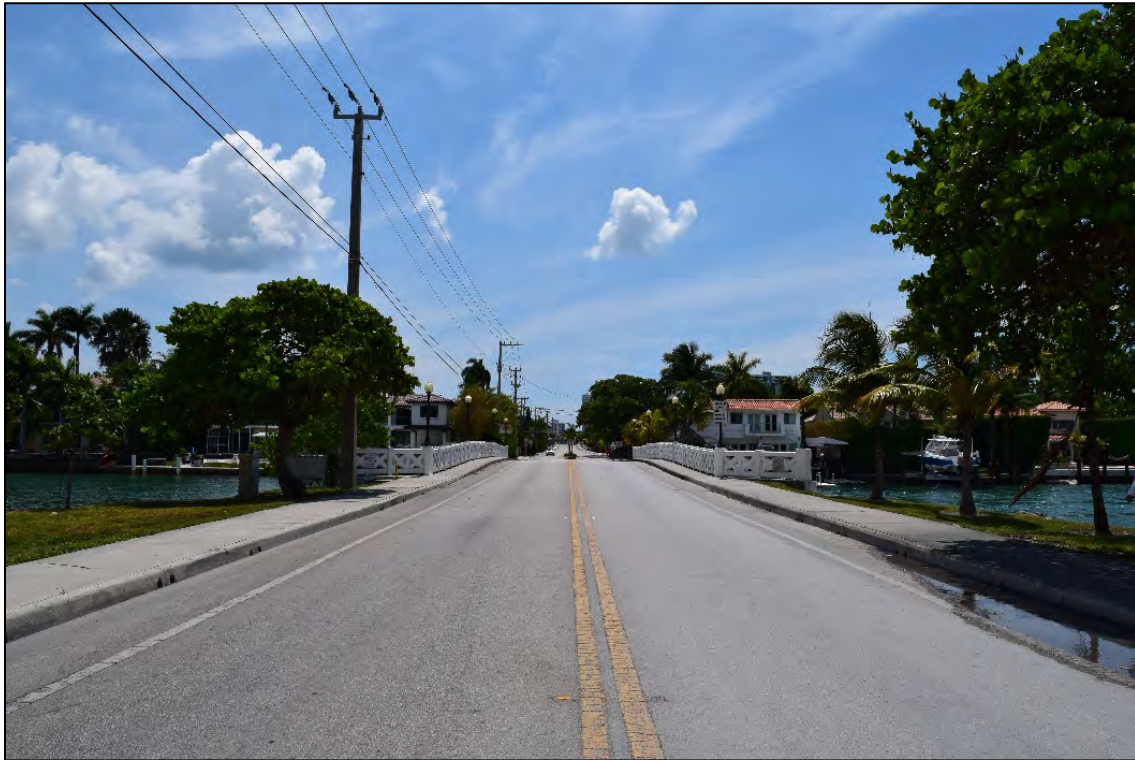
Figure 22: View from Earthen Causeway Landing between Rivo Alto Island and Di Lido Island, Facing East

A total of five man-made earthen causeway landings are located between sections of fixed-span bridges (Figure 22). These small islands are constructed of residual dredge material and serve to connect fixed-span sections. The resulting configuration creates a combination of bridge and earthen causeway between large expanses of water. The landings allowed for shorter spans to be constructed between the large islands. The small islands were also intended to create small channels, which added to the “Venetian” feel of the islands.

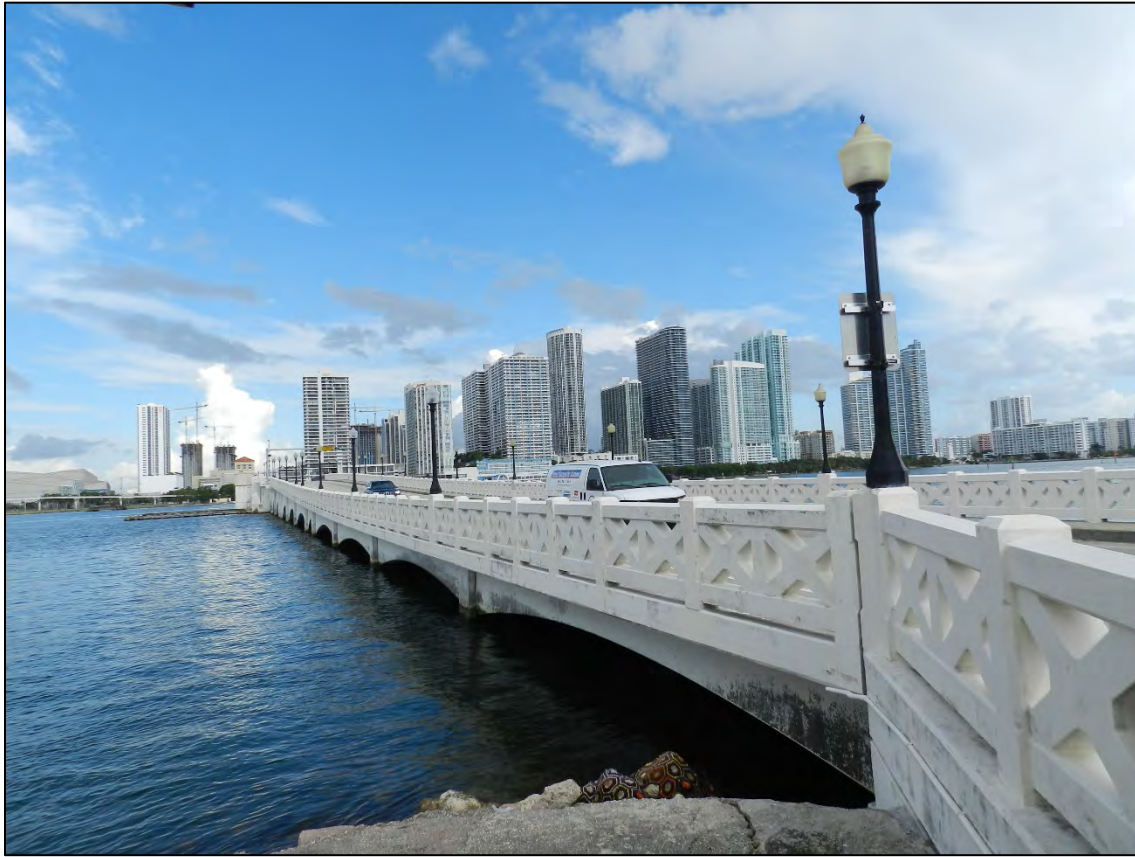
Figure 23: Venetian Causeway Bridge 1 (8DA14373), Facing Northwest

demolish and replace a 730-foot section of the bridge. This work, completed in 2015, included 16 approach spans located west of the bascule-leaf span. Despite the rehabilitation and replacement of various bridge elements, the bridge is considered a National Register-eligible contributing resource to the overall Resource Group.

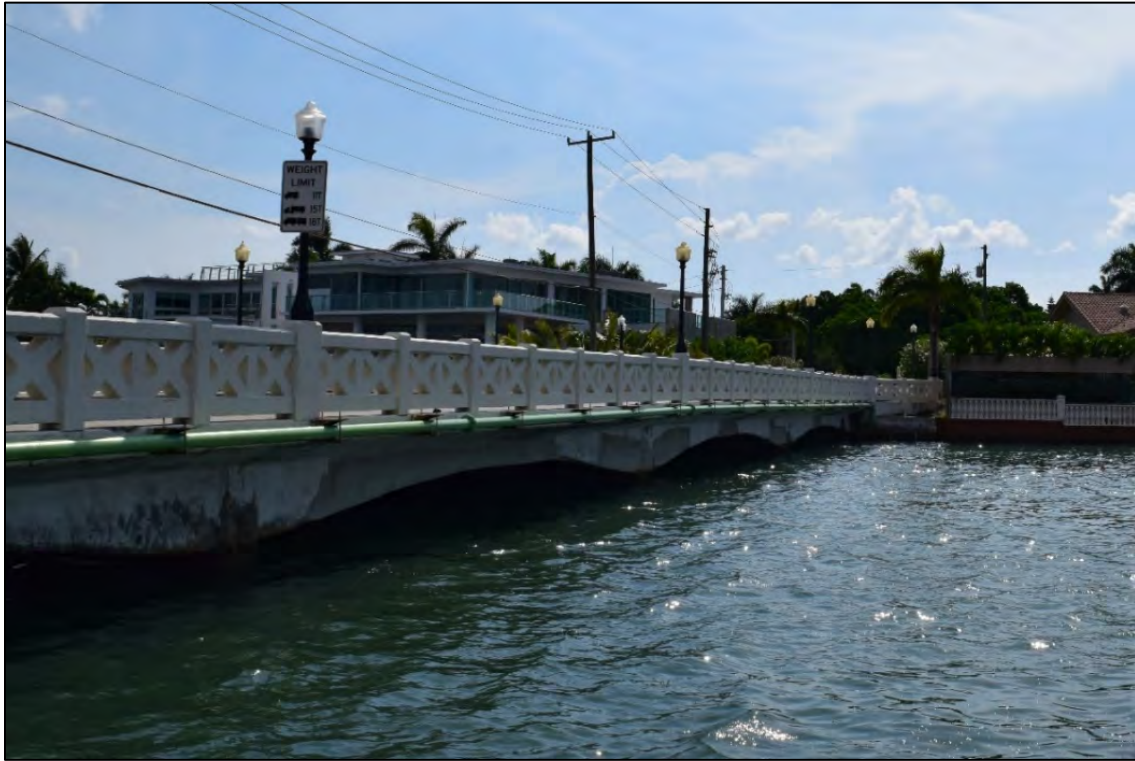
Figure 24: Venetian Causeway Bridge 2 (8DA14374), Facing Northeast

The Venetian Causeway Bridge 2 (8DA14374) is 200 feet long with three fixed, tee-beam spans of concrete. It connects Biscayne Island to San Marco Island. The deck carries two lanes of vehicular traffic, one in each direction. Each bridge section is comprised of two 12-foot wide travel lanes with 4-foot wide shoulders that are used as bicycle lanes, and 4-foot wide sidewalks on each side. The fixed tee-beam spans are constructed of reinforced concrete. Decking is concrete and is carried on shallow arched girders resting on square concrete piers anchored to the bay bottom. The spans are continuous and are seated on fixed bearings at each pier. The variable depth tee beams are cast-in-place concrete and are framed into large end diaphragms which act as integral piers. These diaphragms are supported on square pier columns which rest on concrete pile caps. There are five tee beams in the cross-section spaced at 8 feet 6 inches on center. The arched girders provide limited clearance above the mean high water. The guardrails, one of the main decorative features of the bridge, are constructed of reinforced concrete in a pierced, ornamental geometric design that have square units with radiating diagonals forming an “x” pattern. Despite the rehabilitation and replacement of various bridge elements, the bridge is considered a National Register-eligible contributing resource to the overall Resource Group.

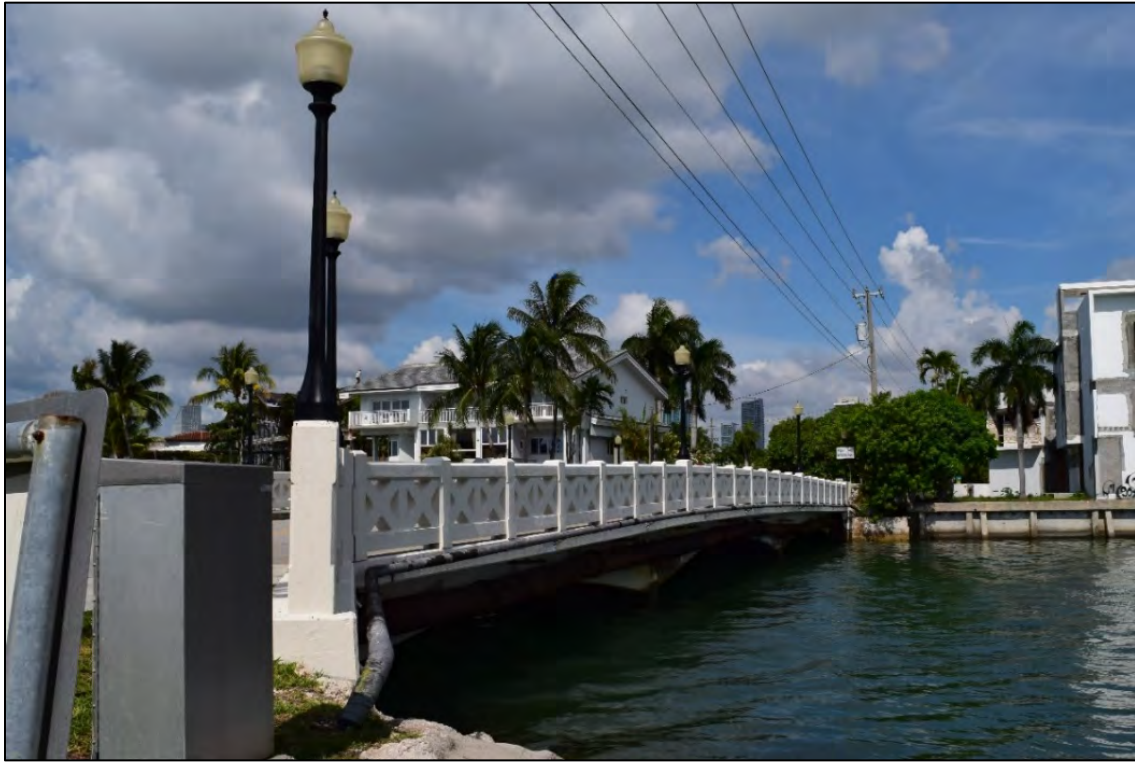
Figure 25: Venetian Causeway Bridge 3 (8DA14375), Facing Southwest

The Venetian Causeway Bridge 3 (8DA14375) is 160 feet long with three fixed, tee-beam spans of concrete. It connects San Marco Island to a small man-made landing to the east. The deck carries two lanes of vehicular traffic, one in each direction. Each bridge section is comprised of two 12-foot wide travel lanes with 4-foot wide shoulders that are used as bicycle lanes, and 4-foot wide sidewalks on each side. The fixed tee-beam spans are constructed of reinforced concrete. Decking is concrete and is carried on shallow arched girders resting on square concrete piers anchored to the bay bottom. The spans are continuous and are seated on fixed bearings at each pier. The variable depth tee beams are cast-in-place concrete and are framed into large end diaphragms which act as integral piers. These diaphragms are supported on square pier columns which rest on concrete pile caps. There are five tee beams in the cross-section spaced at 8 feet 6 inches on center. The arched girders provide limited clearance above the mean high water. The guardrails, one of the main decorative features of the bridge, are constructed of reinforced concrete in a pierced, ornamental geometric design that have square units with radiating diagonals forming an “x” pattern. Despite the rehabilitation and replacement of various bridge elements, the bridge is considered a National Register-eligible contributing resource to the overall Resource Group.
