**CULTURAL RESOURCE ASSESSMENT SURVEY
OF VENETIAN CAUSEWAY FROM NORTH BAYSHORE DRIVE IN THE CITY
OF MIAMI TO PURDY AVENUE IN THE CITY OF MIAMI BEACH**

MIAMI-DADE COUNTY

Financial Management No. 422713-2-22-01

FINAL REPORT

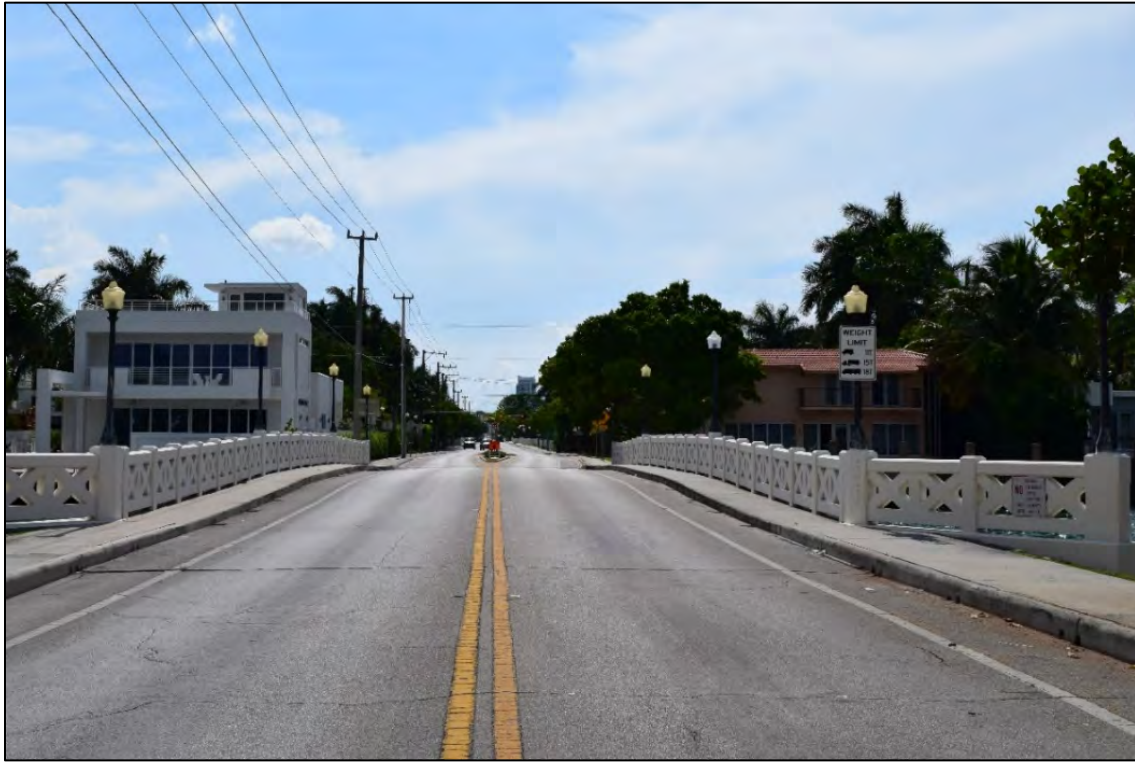
Figure 26: Venetian Causeway Bridge 4 (8DA14376), Facing East

The Venetian Causeway Bridge 4 (8DA14376) is 160 feet long with three fixed, tee-beam spans of concrete. It connects San Marino Island to a small man-made landing to the west. The deck carries two lanes of vehicular traffic, one in each direction. Each bridge section is comprised of two 12-foot wide travel lanes with 4-foot wide shoulders that are used as bicycle lanes, and 4-foot wide sidewalks on each side. The fixed tee-beam spans are constructed of reinforced concrete. Decking is concrete and is carried on shallow arched girders resting on square concrete piers anchored to the bay bottom. The spans are continuous and are seated on fixed bearings at each pier. The variable depth tee beams are cast-in-place concrete and are framed into large end diaphragms which act as integral piers. These diaphragms are supported on square pier columns which rest on concrete pile caps. There are five tee beams in the cross-section spaced at 8 feet 6 inches on center. The arched girders provide limited clearance above the mean high water. The guardrails, one of the main decorative features of the bridge, are constructed of reinforced concrete in a pierced, ornamental geometric design that have square units with radiating diagonals forming an “x” pattern. Despite the rehabilitation and replacement of various bridge elements, the bridge is considered a National Register-eligible contributing resource to the overall Resource Group.

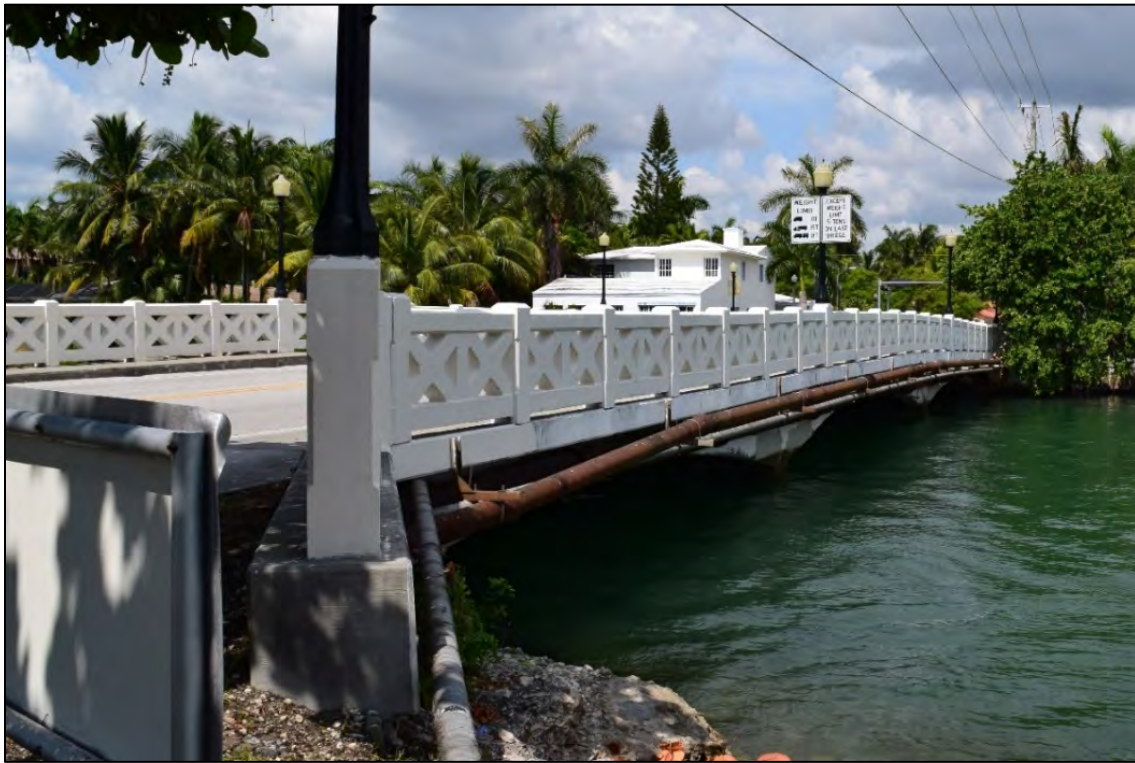
Figure 27: Venetian Causeway Bridge 5 (8DA14377), Facing Southwest

The Venetian Causeway Bridge 5 (8DA14377) is 160 feet long with three fixed, tee-beam spans of concrete. It connects San Marino Island to a small man-made landing to the east. The deck carries two lanes of vehicular traffic, one in each direction. Each bridge section is comprised of two 12-foot wide travel lanes with 4-foot wide shoulders that are used as bicycle lanes, and 4-foot wide sidewalks on each side. The fixed tee-beam spans are constructed of reinforced concrete. Decking is concrete and is carried on shallow arched girders resting on square concrete piers anchored to the bay bottom. The spans are continuous and are seated on fixed bearings at each pier. The variable depth tee beams are cast-in-place concrete and are framed into large end diaphragms which act as integral piers. These diaphragms are supported on square pier columns which rest on concrete pile caps. There are five tee beams in the cross-section spaced at 8 feet 6 inches on center. The arched girders provide limited clearance above the mean high water. The guardrails, one of the main decorative features of the bridge, are constructed of reinforced concrete in a pierced, ornamental geometric design that have square units with radiating diagonals forming an “x” pattern. Despite the rehabilitation and replacement of various bridge elements, the bridge is considered a National Register-eligible contributing resource to the overall Resource Group.

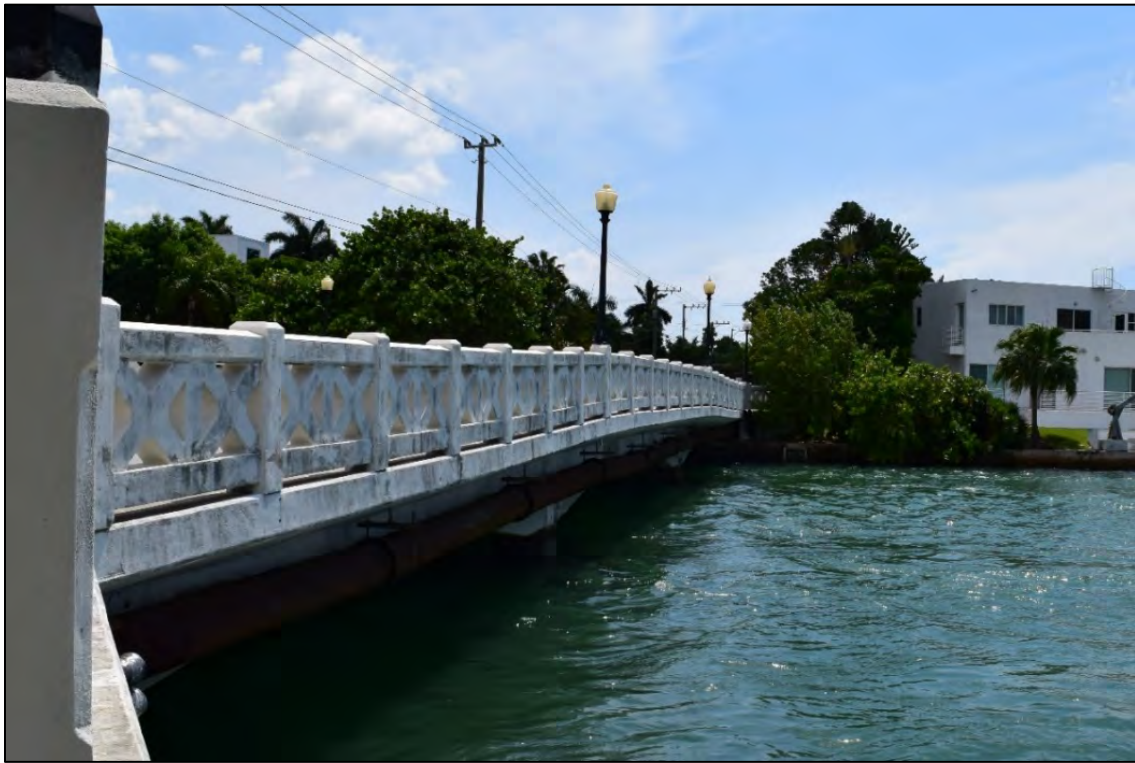
Figure 28: Venetian Causeway Bridge 6 (8DA14378), Facing Northeast

The Venetian Causeway Bridge 6 (8DA14378) is 160 feet long with three fixed, tee-beam spans of concrete. It connects Di Lido Island to a small man-made landing to the west. The deck carries two lanes of vehicular traffic, one in each direction. Each bridge section is comprised of two 12-foot wide travel lanes with 4-foot wide shoulders that are used as bicycle lanes, and 4-foot wide sidewalks on each side. The fixed tee-beam spans are constructed of reinforced concrete. Decking is concrete and is carried on shallow arched girders resting on square concrete piers anchored to the bay bottom. The spans are continuous and are seated on fixed bearings at each pier. The variable depth tee beams are cast-in-place concrete and are framed into large end diaphragms which act as integral piers. These diaphragms are supported on square pier columns which rest on concrete pile caps. There are five tee beams in the cross-section spaced at 8 feet 6 inches on center. The arched girders provide limited clearance above the mean high water. The guardrails, one of the main decorative features of the bridge, are constructed of reinforced concrete in a pierced, ornamental geometric design that have square units with radiating diagonals forming an “x” pattern. Despite the rehabilitation and replacement of various bridge elements, the bridge is considered a National Register-eligible contributing resource to the overall Resource Group.

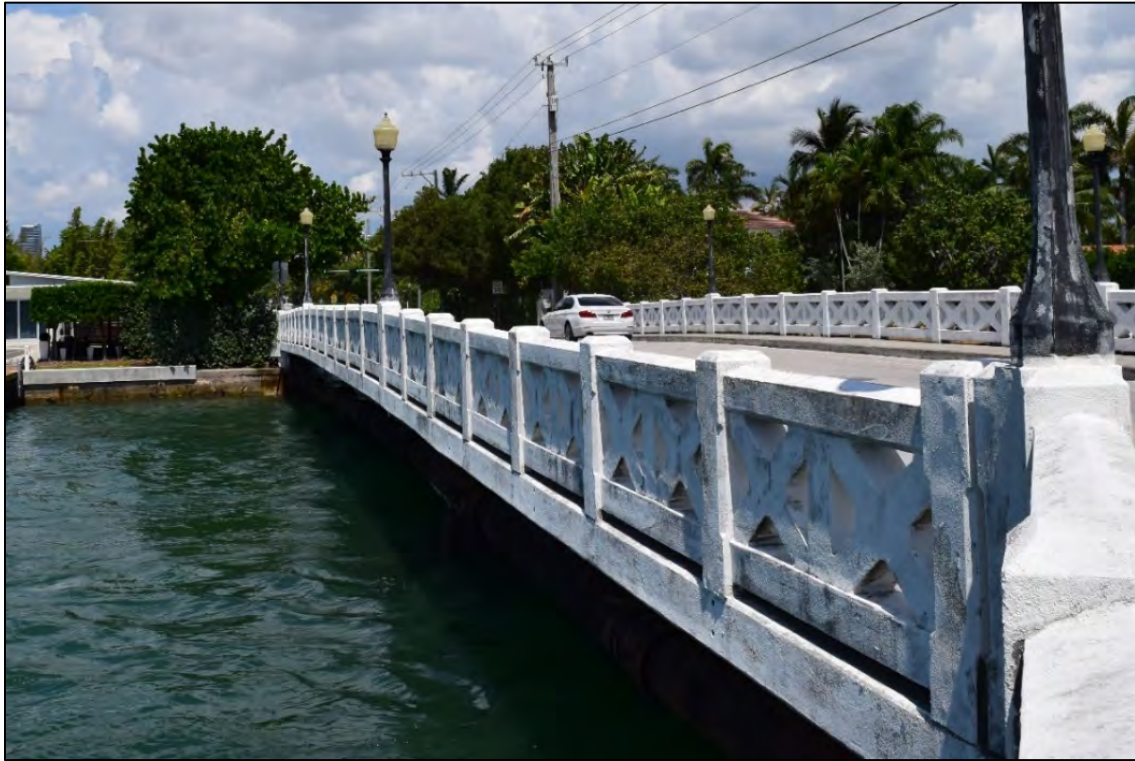
Figure 29: Venetian Causeway Bridge 7 (8DA14379), Facing Northwest

The Venetian Causeway Bridge 7 (8DA14379) is 160 feet long with three fixed, tee-beam spans of concrete. It connects Di Lido Island to a small man-made landing to the east. The deck carries two lanes of vehicular traffic, one in each direction. Each bridge section is comprised of two 12-foot wide travel lanes with 4-foot wide shoulders that are used as bicycle lanes, and 4-foot wide sidewalks on each side. The fixed tee-beam spans are constructed of reinforced concrete. Decking is concrete and is carried on shallow arched girders resting on square concrete piers anchored to the bay bottom. The spans are continuous and are seated on fixed bearings at each pier. The variable depth tee beams are cast-in-place concrete and are framed into large end diaphragms which act as integral piers. These diaphragms are supported on square pier columns which rest on concrete pile caps. There are five tee beams in the cross-section spaced at 8 feet 6 inches on center. The arched girders provide limited clearance above the mean high water. The guardrails, one of the main decorative features of the bridge, are constructed of reinforced concrete in a pierced, ornamental geometric design that have square units with radiating diagonals forming an “x” pattern. Despite the rehabilitation and replacement of various bridge elements, the bridge is considered a National Register-eligible contributing resource to the overall Resource Group.

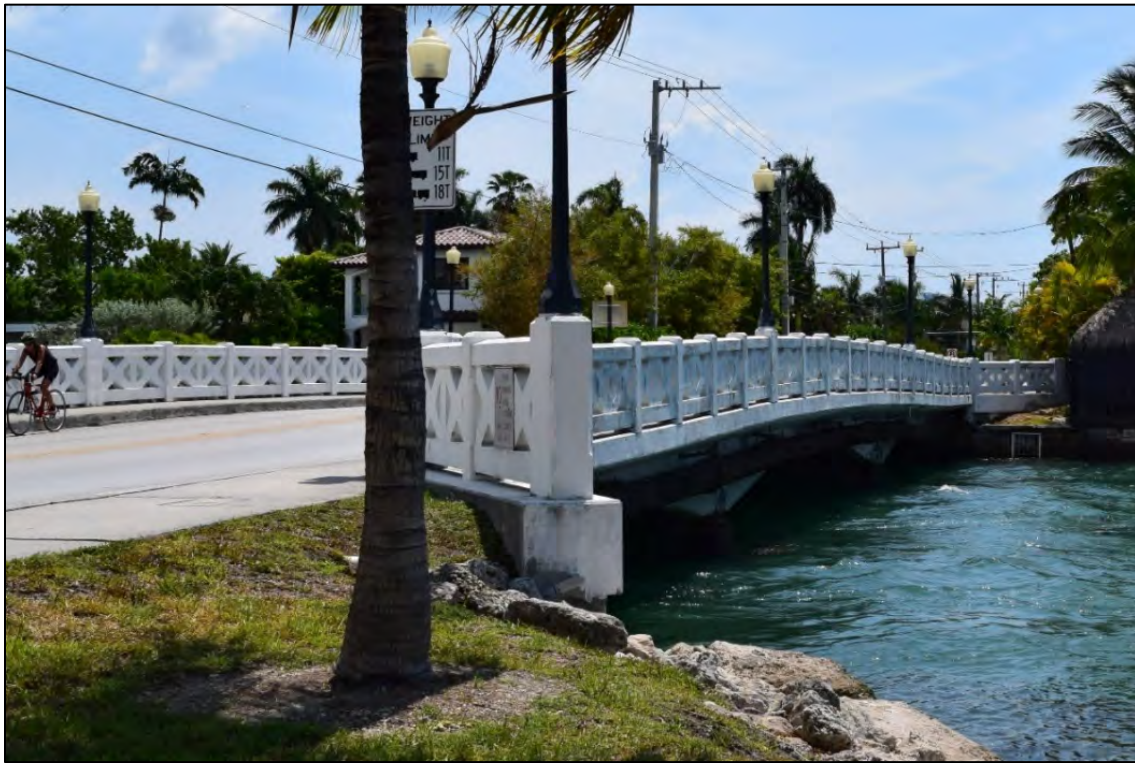
Figure 30: Venetian Causeway Bridge 8 (8DA14380), Facing Northeast

The Venetian Causeway Bridge 8 (8DA14380) is 160 feet long with three fixed, tee-beam spans of concrete. It connects Rivo Alto Island to a small man-made landing to the west. The deck carries two lanes of vehicular traffic, one in each direction. Each bridge section is comprised of two 12-foot wide travel lanes with 4-foot wide shoulders that are used as bicycle lanes, and 4-foot wide sidewalks on each side. The fixed tee-beam spans are constructed of reinforced concrete. Decking is concrete and is carried on shallow arched girders resting on square concrete piers anchored to the bay bottom. The spans are continuous and are seated on fixed bearings at each pier. The variable depth tee beams are cast-in-place concrete and are framed into large end diaphragms which act as integral piers. These diaphragms are supported on square pier columns which rest on concrete pile caps. There are five tee beams in the cross-section spaced at 8 feet 6 inches on center. The arched girders provide limited clearance above the mean high water. The guardrails, one of the main decorative features of the bridge, are constructed of reinforced concrete in a pierced, ornamental geometric design that have square units with radiating diagonals forming an “x” pattern. Despite the rehabilitation and replacement of various bridge elements, the bridge is considered a National Register-eligible contributing resource to the overall Resource Group.

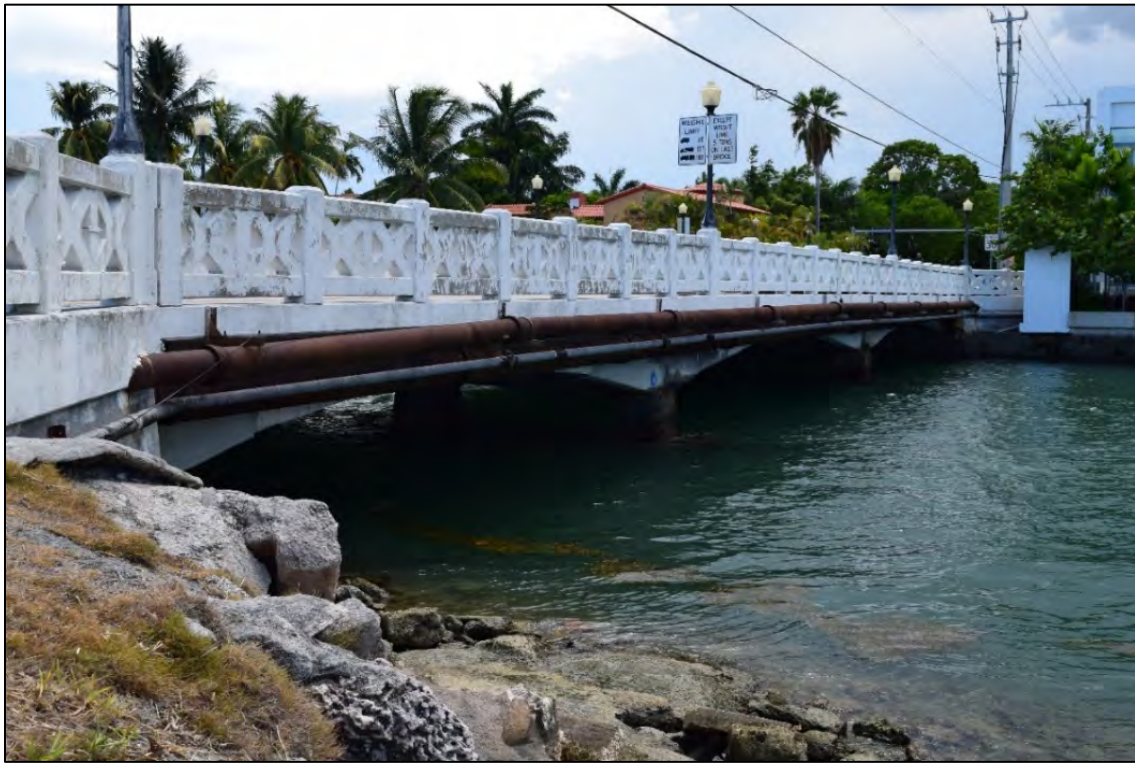
Figure 31: Venetian Causeway Bridge 9 (8DA14381), Facing Southwest

The Venetian Causeway Bridge 9 (8DA14381) is 154 feet long with three fixed, tee-beam spans of concrete. It connects Rivo Alto Island to a small man-made landing to the east. The deck carries two lanes of vehicular traffic, one in each direction. Each bridge section is comprised of two 12-foot wide travel lanes with 4-foot wide shoulders that are used as bicycle lanes, and 4-foot wide sidewalks on each side. The fixed tee-beam spans are constructed of reinforced concrete. Decking is concrete and is carried on shallow arched girders resting on square concrete piers anchored to the bay bottom. The spans are continuous and are seated on fixed bearings at each pier. The variable depth tee beams are cast-in-place concrete and are framed into large end diaphragms which act as integral piers. These diaphragms are supported on square pier columns which rest on concrete pile caps. There are five tee beams in the cross-section spaced at 8 feet 6 inches on center. The arched girders provide limited clearance above the mean high water. The guardrails, one of the main decorative features of the bridge, are constructed of reinforced concrete in a pierced, ornamental geometric design that have square units with radiating diagonals forming an “x” pattern. Despite the rehabilitation and replacement of various bridge elements, the bridge is considered a National Register-eligible contributing resource to the overall Resource Group.

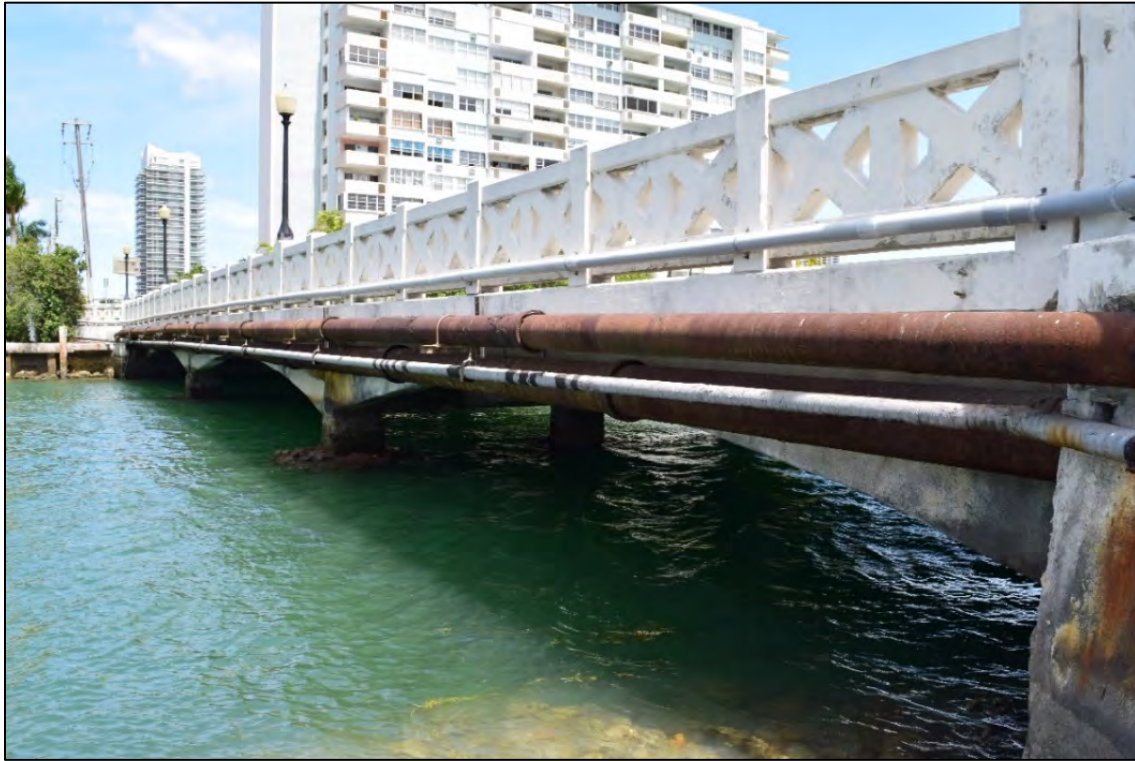
Figure 33: Venetian Causeway Bridge 11 (8DA14383), Facing Southeast

The Venetian Causeway Bridge 11 (8DA14383) is 154 feet long with three fixed, tee-beam spans of concrete. It connects Belle Isle to a small man-made landing to the west. The deck carries two lanes of vehicular traffic, one in each direction. Each bridge section is comprised of two 12-foot wide travel lanes with 4-foot wide shoulders that are used as bicycle lanes, and 4-foot wide sidewalks on each side. The fixed tee-beam spans are constructed of reinforced concrete. Decking is concrete and is carried on shallow arched girders resting on square concrete piers anchored to the bay bottom. The spans are continuous and are seated on fixed bearings at each pier. The variable depth tee beams are cast-in-place concrete and are framed into large end diaphragms which act as integral piers. These diaphragms are supported on square pier columns which rest on concrete pile caps. There are five tee beams in the cross-section spaced at 8 feet 6 inches on center. The arched girders provide limited clearance above the mean high water. The guardrails, one of the main decorative features of the bridge, are constructed of reinforced concrete in a pierced, ornamental geometric design that have square units with radiating diagonals forming an “x” pattern. Despite the rehabilitation and replacement of various bridge elements, the bridge is considered a National Register-eligible contributing resource to the overall Resource Group.

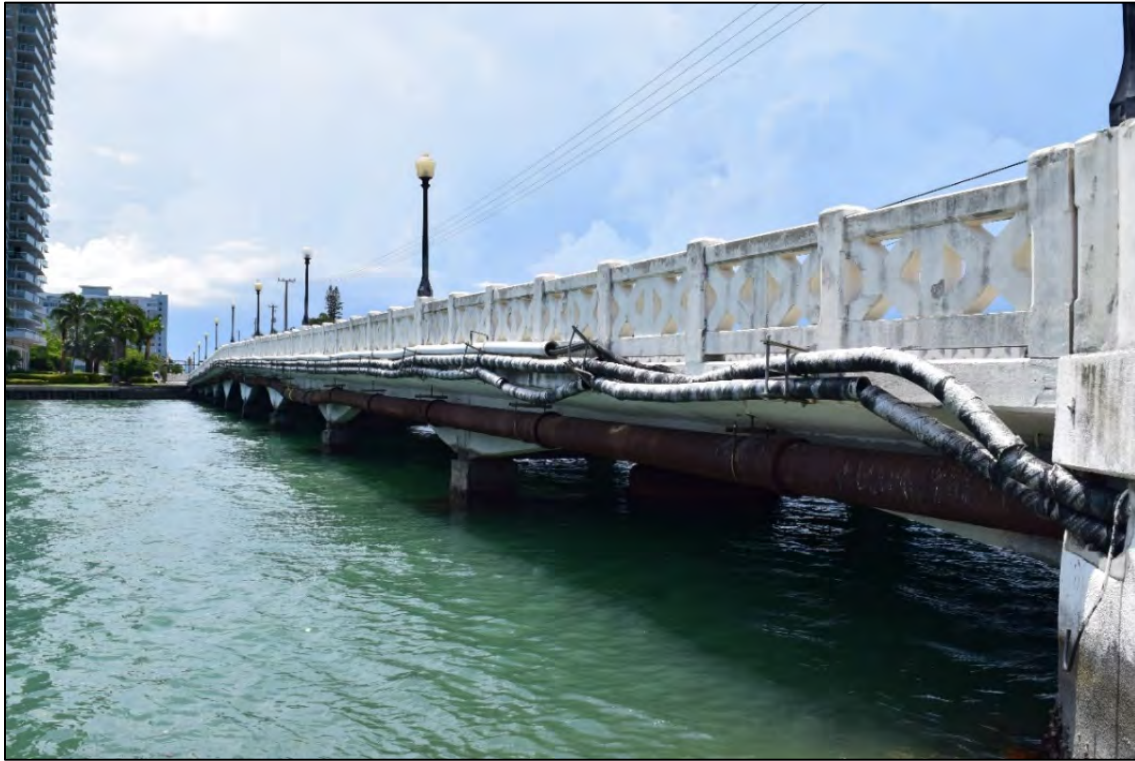
Figure 34: Venetian Causeway Bridge 12 (8DA14384), Facing Northwest

The Venetian Causeway Bridge 12 (8DA14384) is 460 feet long with nine fixed, tee-beam spans. It connects Belle Isle to Miami Beach (Dade Boulevard). The deck carries two lanes of vehicular traffic, one in each direction. Each bridge section is comprised of two 12-foot wide travel lanes with 4-foot wide shoulders that are used as bicycle lanes, and 4-foot wide sidewalks on each side. The fixed tee-beam spans are constructed of reinforced concrete. Decking is concrete and is carried on shallow arched girders resting on square concrete piers anchored to the bay bottom. The spans are continuous and are seated on fixed bearings at each pier. The variable depth tee beams are cast-in-place concrete and are framed into large end diaphragms which act as integral piers. These diaphragms are supported on square pier columns which rest on concrete pile caps. There are five tee beams in the cross-section spaced at 8 feet 6 inches on center. The arched girders provide limited clearance above the mean high water. The guardrails, one of the main decorative features of the bridge, are constructed of reinforced concrete in a pierced, ornamental geometric design that have square units with radiating diagonals forming an “x” pattern. Despite the rehabilitation and replacement of various bridge elements, the bridge is considered a National Register-eligible contributing resource to the overall Resource Group.

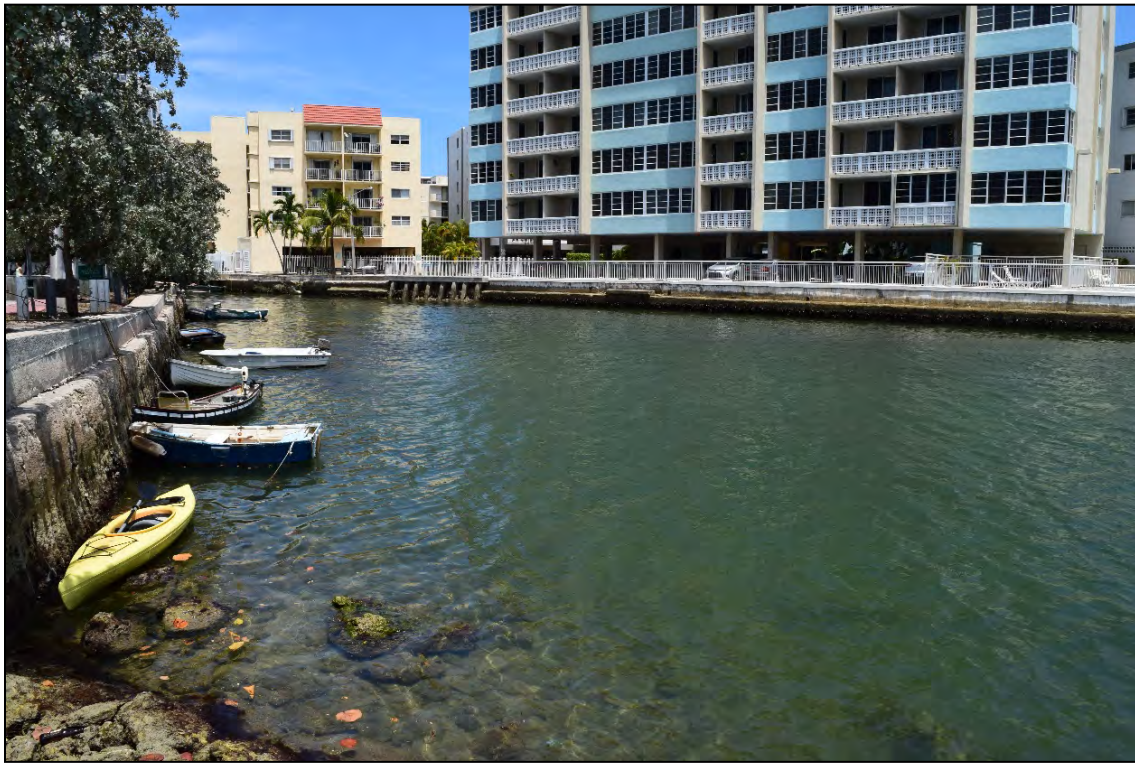
Figure 35: Collins Canal (8DA11375), Facing Southeast

The Collins Canal is located in Section 33 of Township 53 South, Range 42 East (Miami, FL 1994 USGS 7.5-mi. Topographic Quadrangle), in the City of Miami Beach, Miami-Dade County, Florida. The majority of the canal is approximately 40 feet wide, although the westernmost portion opens up to more than 100 feet at Biscayne Bay. From the bay, Collins Canal extends to the northeast running parallel to Dade Boulevard and eventually joining Lake Pancoast at Collins Avenue. The canal as viewed from the APE is characterized by concrete seawalls with some surrounding fencing and vegetation.

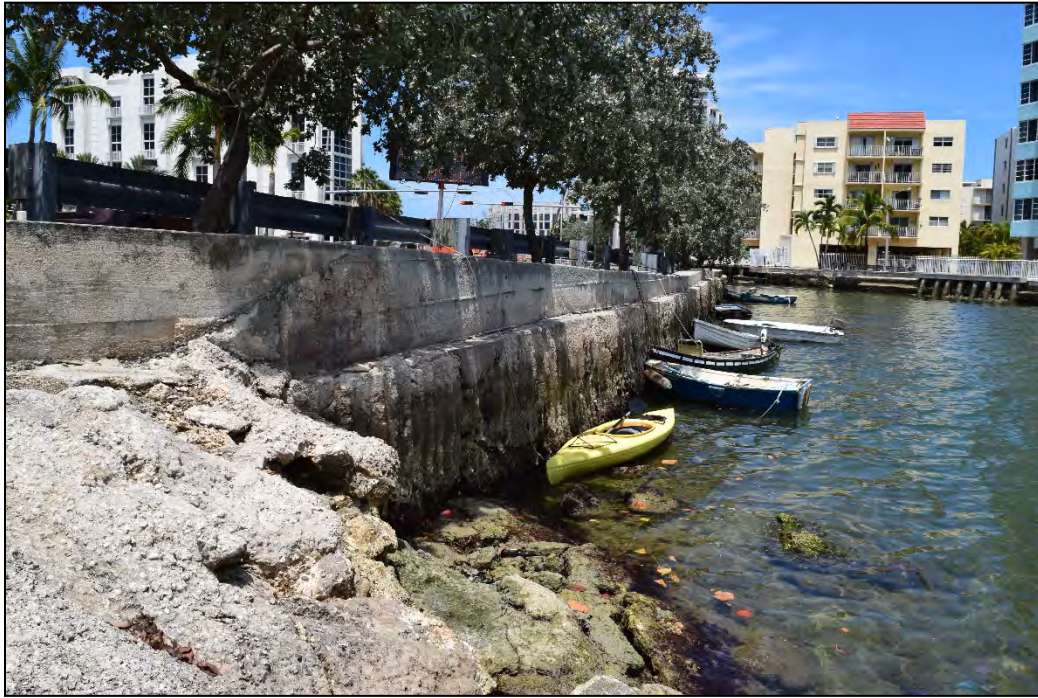
Figure 39: Collins Canal Seawall (8DA12366), Facing East

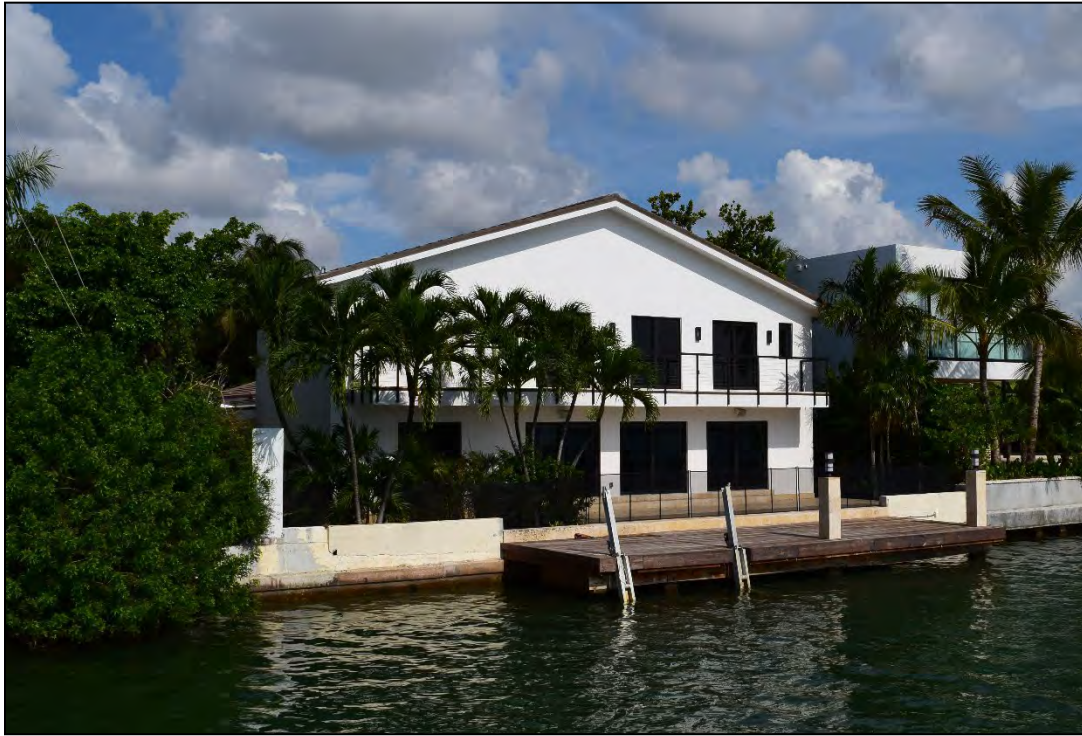
8DA14385 1132 N Venetian Drive

Figure 40: 1132 N Venetian Drive (8DA14385), Facing Northwest

This two-story, Masonry Vernacular building is located at 1132 N Venetian Drive in Section 31 of Township 53 South, Range 42 East (Miami, FL 1994 USGS 7.5-mi. Topographic Quadrangle), in the City of Miami Beach, Miami-Dade County, Florida. This circa 1955 residence contains a gable-roof main body with an attached garage and a two-story, gable-roof rear addition. The concrete-block building rests on a concrete-slab foundation. The exterior is clad in stucco. Windows include single-pane, metal casement and one-by-one, metal sliding. Roofing consists of flat tile. A large hedge row obscures the façade and elevations. The building currently serves as a private residence.

Although over fifty years old, this resource does not retain sufficient integrity of design, materials, workmanship, and feeling. Modifications include the replacement of windows and doors, as well as alterations to the fenestration pattern and unsympathetic additions. There does not exist a concentrated visual sense of historic significance, nor is there an obvious shared interrelationship between this resource and the surrounding built environment. Therefore, given its loss of integrity and lack of historic significance, this building is considered ineligible for listing in the National Register individually or as part of a historic district.

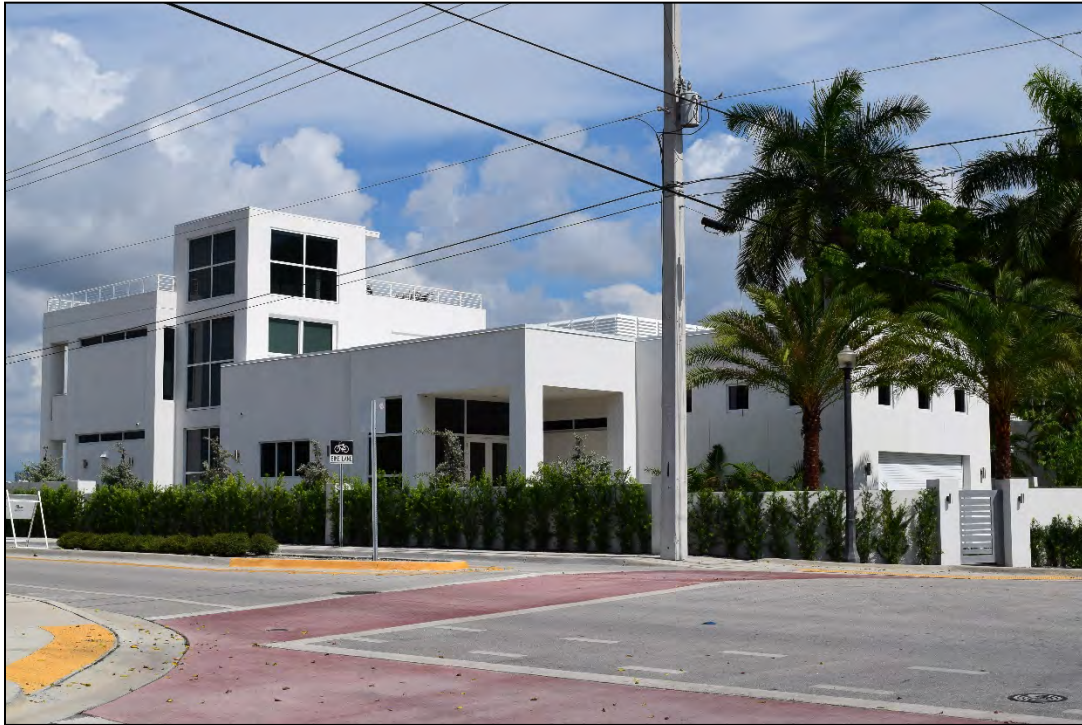
8DA14386 230 W San Marino Drive

Figure 41: 230 W San Marino Drive (8DA14386), Facing Northwest

This two-story, Masonry Vernacular building is located at 230 W San Marino Drive in Section 32 of Township 53 South, Range 42 East (Miami, FL 1994 USGS 7.5-mi. Topographic Quadrangle), in the City of Miami Beach, Miami-Dade County, Florida. This circa 1955 residence contains a flat-roof main body, an attached garage with second-story, and a two-story rear addition with rooftop access. The garage and two-story addition were completed in the 1980s. The concrete-block building rests on a concrete-slab foundation. The exterior is clad in stucco. Windows include paired, single-pane, metal casement; triple, single-pane, metal casement; and four-pane fixed metal. The home has extensive renovations and loss of integrity. The building currently serves as a private residence.

Although over fifty years old, this resource does not retain sufficient integrity of design, materials, workmanship, and feeling. Modifications include the replacement of windows, doors, and exterior fabric, as well as alterations to the fenestration pattern and unsympathetic additions. Therefore, given its loss of integrity, this building is considered ineligible for listing in the National Register individually or as part of a historic district.

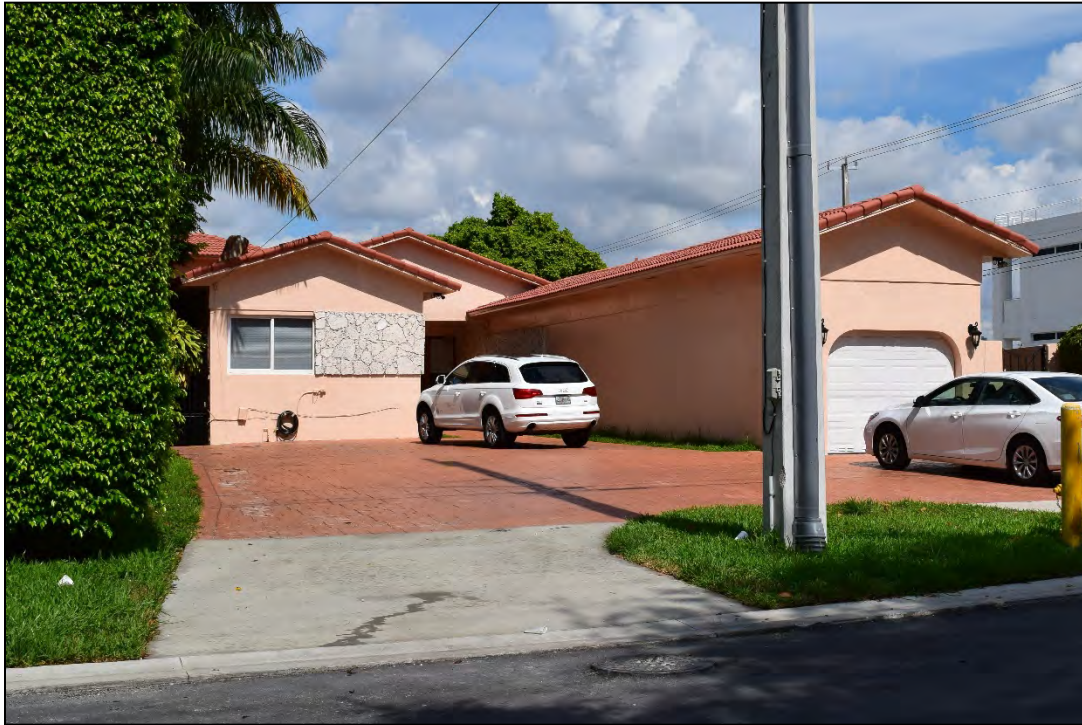
8DA14387 226 W San Marino Drive

Figure 42: 226 W San Marino Drive (8DA14387), Facing Northwest

This two-story, Masonry Vernacular building is located at 226 W San Marino Drive in Section 32 of Township 53 South, Range 42 East (Miami, FL 1994 USGS 7.5-mi. Topographic Quadrangle), in the City of Miami Beach, Miami-Dade County, Florida. This circa 1947 residence contains a gable-roof main body, an attached gable-roof garage, and a two-story hip-roof addition. The concrete-block building rests on a continuous concrete-block foundation. The exterior is clad in stucco. Windows include paired, single-pane, metal casement and one-by-one metal sliding. Roofing consists of Spanish tile. A garage addition obscures the historic façade. The building currently serves as a private residence.

Although over fifty years old, this resource exhibits a common design type found throughout Florida. Modifications include the replacement of windows and exterior fabric, as well as unsympathetic additions. Therefore, given its common design and lack of historic integrity, this building is considered ineligible for listing in the National Register individually or as part of a historic district.

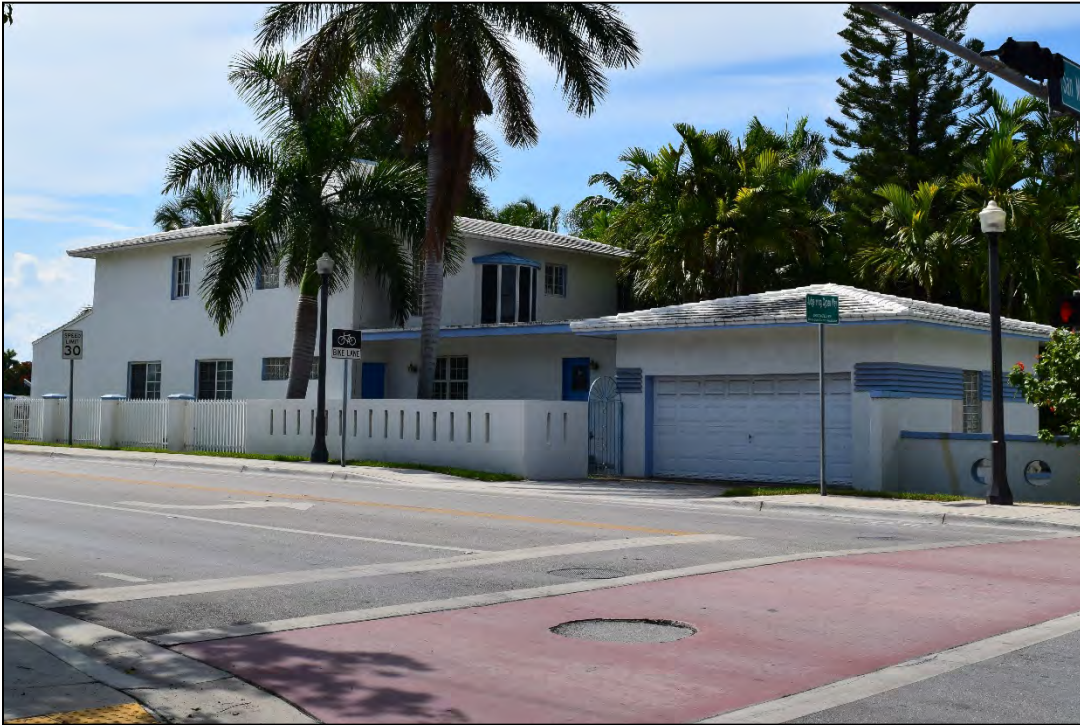
8DA14388 227 E San Marino Drive

Figure 43: 227 E San Marino Drive (8DA14388), Facing Southeast

This two-story, Masonry Vernacular building is located at 227 E San Marino Drive in Section 32 of Township 53 South, Range 42 East (Miami, FL 1994 USGS 7.5-mi. Topographic Quadrangle), in the City of Miami Beach, Miami-Dade County, Florida. This circa 1939 residence contains a two-story hip-roof main body, an attached Florida room and hip-roof garage, and a rear shed-roof addition. The concrete-block building rests on a continuous concrete-block foundation. The exterior is clad in stucco. Windows include paired, six-over-six, metal single-hung; eight-by-eight, metal sliding; single-pane, metal bay; and both vertical and horizontal glass block. The windows have been replaced, some of them multiple times, likely in the 1960s and 1980s. Roofing consists of flat tile. A concrete wall with decorative metal gates surrounds the exterior. The main entry is obscured by a wall and landscaping. The building currently serves as a private residence.

Although over fifty years old, this resource exhibits a common design type found throughout Florida. Modifications include the replacement of windows and unsympathetic additions. Therefore, given its common design and lack of historic integrity, this building is considered ineligible for listing in the National Register individually or as part of a historic district.

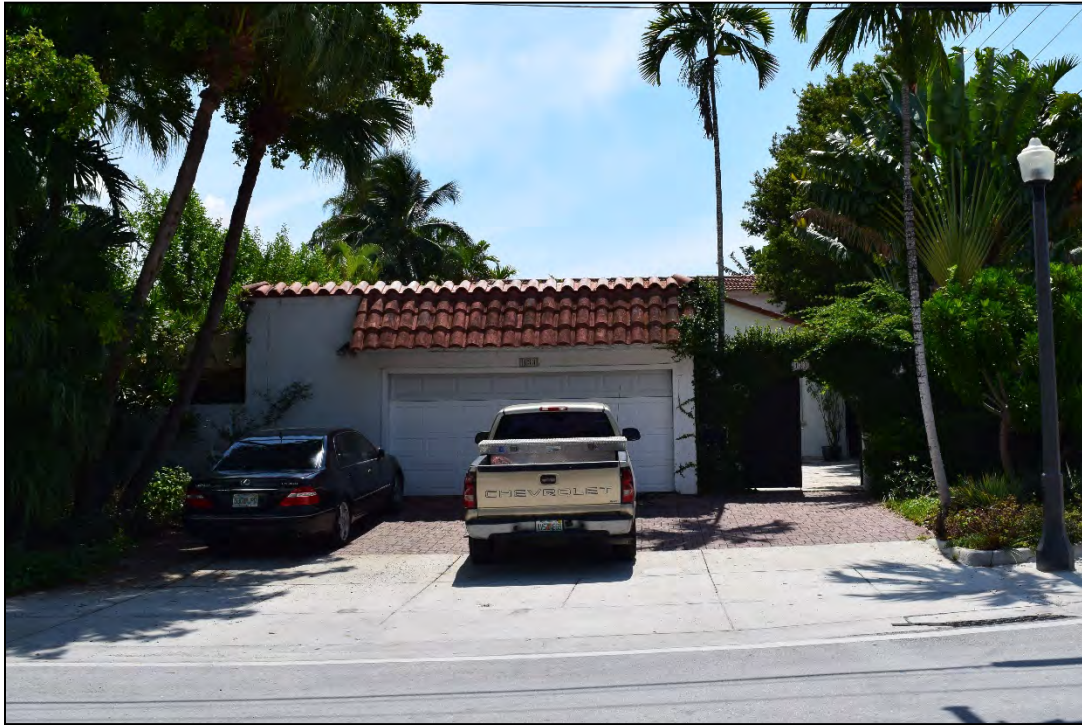
8DA14390 433 E Di Lido Drive

Figure 44: 433 E Di Lido Drive (8DA14390), Facing East

This two-story, Masonry Vernacular building is located at 433 E Di Lido Drive in Section 32 of Township 53 South, Range 42 East (Miami, FL 1994 USGS 7.5-mi. Topographic Quadrangle), in the City of Miami Beach, Miami-Dade County, Florida. This circa 1932 residence contains a gable-roof main body, a garage addition, and a two-story gable-roof addition. The concrete-block building rests on a continuous concrete-block foundation. The exterior is clad in stucco. Windows include one-by-one, metal horizontal sliding and paired, single-pane metal fixed. Roofing consists of Spanish tile. A garage addition and hedge row obscure much of the façade and south elevation. The building currently serves as a private residence.

Although over fifty years old, this resource exhibits a common design type found throughout Florida. Modifications include the replacement of windows and unsympathetic additions. Therefore, given its common design and lack of historic integrity, this building is considered ineligible for listing in the National Register individually or as part of a historic district.

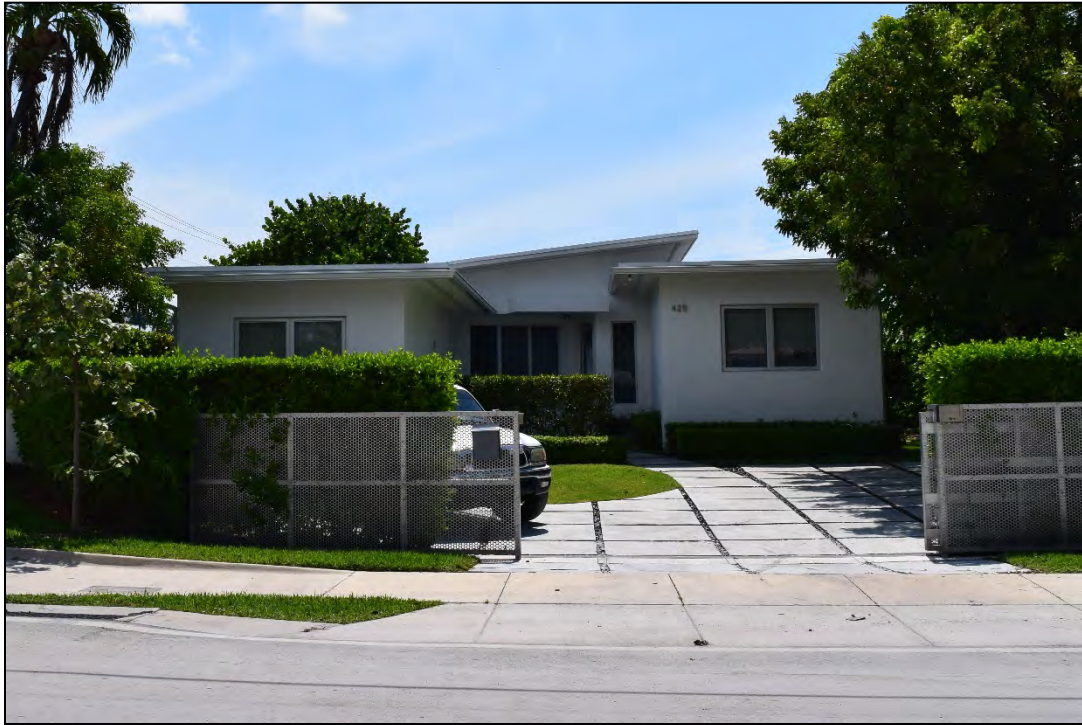
8DA14391 425 E Di Lido Drive

Figure 45: 425 E Di Lido Drive (8DA14391), Facing East

This one-story, Masonry Vernacular building is located at 425 E Di Lido Drive in Section 32 of Township 53 South, Range 42 East (Miami, FL 1994 USGS 7.5-mi. Topographic Quadrangle), in the City of Miami Beach, Miami-Dade County, Florida. This circa 1949 residence contains a Miami Modern-style shed-roof with clerestory main body, flat-roof enclosed garage/carport, and a flat-roof rear extension. The concrete-block building rests on a concrete-slab foundation. The exterior is clad in stucco. Windows include single-pane, metal fixed; paired, single-pane, metal casement; and triple, single-pane, metal casement. Roofing consists of composition shingles. The entryway has been altered and a garage/carport enclosed. The residence may have been constructed in the Miami Modern style originally, the alterations and additions have detracted from the integrity of the style. The building currently serves as a private residence.

Although over fifty years old, this resource does not retain sufficient integrity of design, materials, workmanship, and feeling. Modifications include the replacement of windows and doors, as well as unsympathetic additions. Therefore, given its common design and lack of historic integrity, this building is considered ineligible for listing in the National Register individually or as part of a historic district.

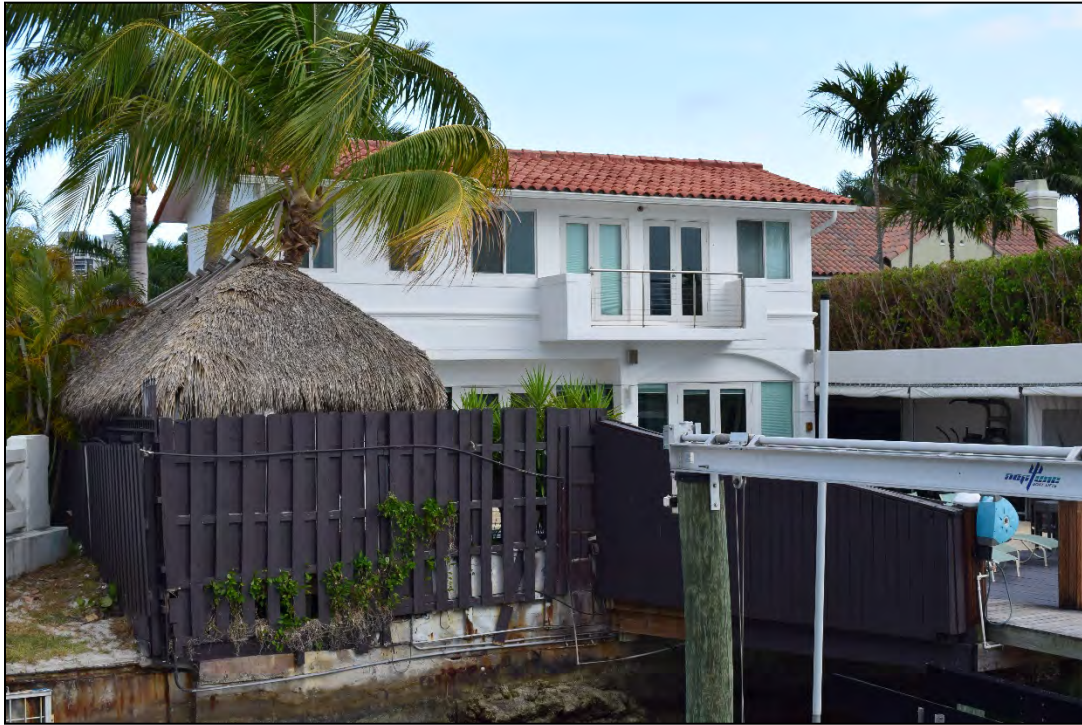
8DA14392 226 W Rivo Alto Drive

Figure 46: 226 W Rivo Alto Drive (8DA14392), Facing East

This two-story, Masonry Vernacular building is located at 226 W Rivo Alto Drive in Section 33 of Township 53 South, Range 42 East (Miami, FL 1994 USGS 7.5-mi. Topographic Quadrangle), in the City of Miami Beach, Miami-Dade County, Florida. This circa 1939 residence contains a hip-roof main body and a two-story gable-roof rear addition. The concrete-block building rests on a continuous concrete-block foundation. The exterior is clad in stucco. Replacement windows include one-by-one, metal horizontal sliding and paired, single-pane, metal casement. Roofing consists of Spanish tile. A hedge row with gate obscures the façade and north elevation. The building currently serves as a private residence.

Although over fifty years old, this resource exhibits a common design type found throughout Florida. Modifications include the replacement of windows and an unsympathetic addition. Therefore, given its common design and lack of historic integrity, this building is considered ineligible for listing in the National Register individually or as part of a historic district.

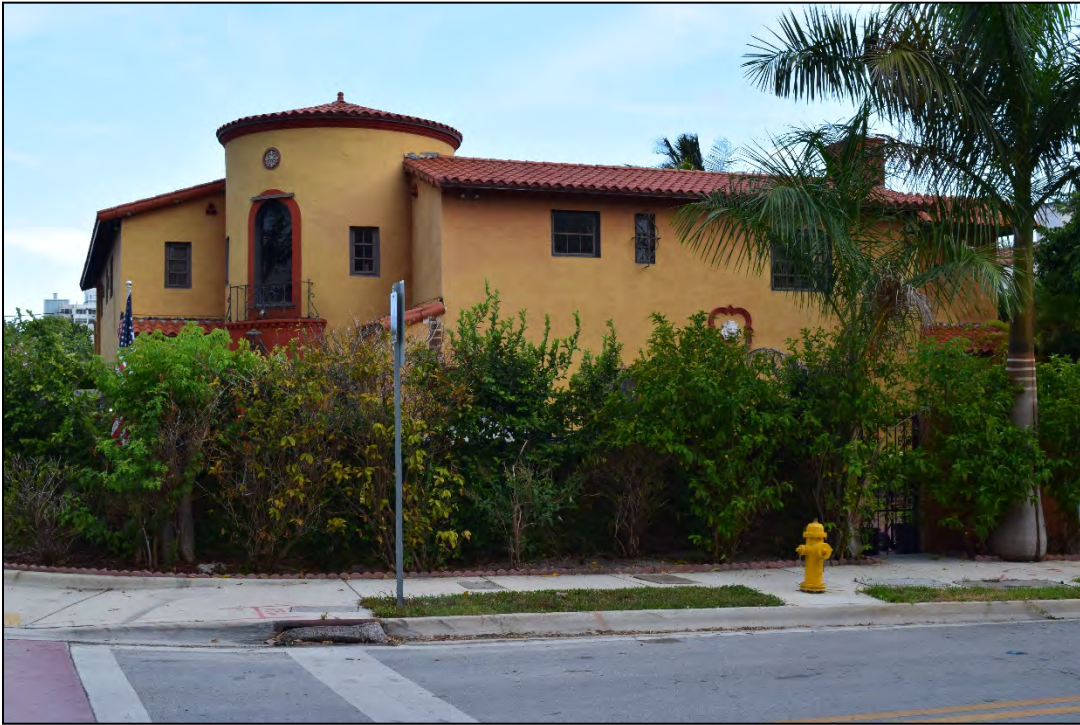
8DA14393 227 E Rivo Alto Drive

Figure 47: 227 E Rivo Alto Drive (8DA14393), Facing East

This two-story, Mediterranean Revival building is located at 227 E Rivo Alto Drive in Section 33 of Township 53 South, Range 42 East (Miami, FL 1994 USGS 7.5-mi. Topographic Quadrangle), in the City of Miami Beach, Miami-Dade County, Florida. This circa 1932 residence contains a gable-roof main body, central two-story rotunda entry, a gable-roof ell, and flat-roof rear addition. The concrete-block building rests on a continuous concrete-block foundation. The exterior is clad in stucco. Windows include six-by-six, metal horizontal sliding; three-light, metal casement; and six-light, metal casement. Roofing consists of Spanish tile. The home contains a two-story rotunda entry with a metal-balustrade balcony and decorative medallion. Ground-floor windows have decorative security bars on the windows. A concrete wall with metal gates surrounds the home. The building currently serves as a private residence.

This resource does not retain sufficient integrity of design, materials, workmanship, and feeling. The building has undergone renovations including the replacement of windows and doors, as well as an unsympathetic rear addition. There does not exist a concentrated visual sense of historic significance, nor is there an obvious shared interrelationship between this resource and the surrounding built environment. Therefore, given its common design and lack of historic significance, this building is considered ineligible for listing in the National Register individually or as part of a historic district.

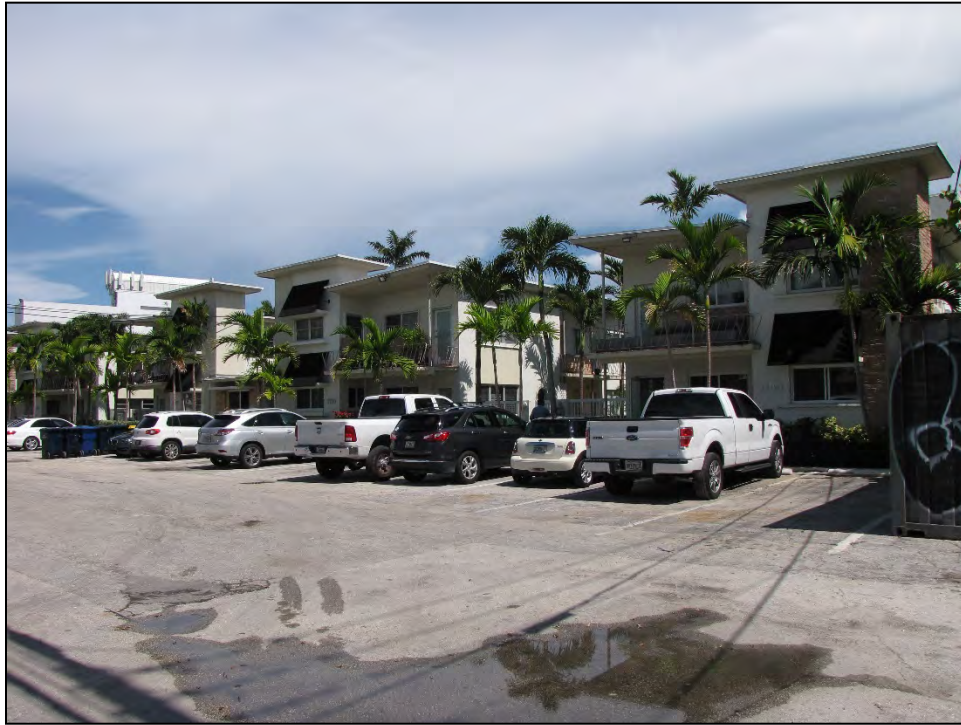
8DA15805 Sandpiper Villas Co-Op

Figure 48: Sandpiper Villas Co-Op/1100-1140 Venetian Way (8DA15805), historic resource group, Facing Southeast

This apartment co-operative complex consists of five Masonry Vernacular buildings located at 1100-1140 Venetian Way in Section 31 of Township 53 South, Range 42 East (Miami, FL 1994 USGS 7.5-mi. Topographic Quadrangle), in the City of Miami, Miami-Dade County, Florida. This circa 1949 apartment complex contains five nearly identical buildings (8DA15806-8DA15810). These Masonry Vernacular buildings are rectangular and constructed of concrete block. The buildings are covered in stucco and in some areas a faux stone material. The buildings are two stories tall, with their main entrances facing east and west. There are balconies and porches for each unit. The buildings at 1110 and 1120 are connected through a one-story addition. Buildings 1130 and 1140 are connected through a similar addition. The buildings feature wide eaves, concrete sills, and large awnings.

This resource does not retain sufficient integrity of design, materials, and workmanship. The buildings have undergone renovations including the replacement of windows and doors, as well as two additions that connected the once separate buildings. Therefore, given its common design and lack of historic integrity, this building complex is considered ineligible for listing in the National Register individually or as part of a historic district.
