**CULTURAL RESOURCE ASSESSMENT SURVEY
OF VENETIAN CAUSEWAY FROM NORTH BAYSHORE DRIVE IN THE CITY
OF MIAMI TO PURDY AVENUE IN THE CITY OF MIAMI BEACH**

MIAMI-DADE COUNTY

Financial Management No. 422713-2-22-01

FINAL REPORT

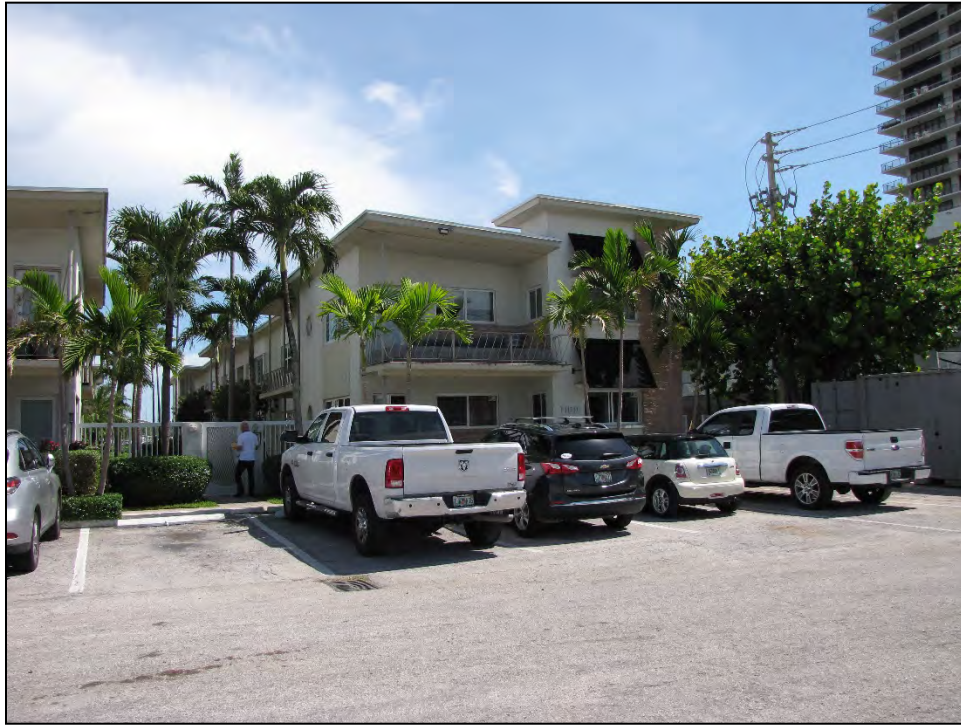
8DA15806 Sandpiper Villas Co-Op Building 1100

Figure 49: Sandpiper Villas Co-Op Building 1100 (8DA15806), Facing Southwest

This Masonry Vernacular apartment co-operative building is located at 1100 Venetian Way in Section 31 of Township 53 South, Range 42 East (Miami, FL 1994 USGS 7.5-mi. Topographic Quadrangle), in the City of Miami, Miami-Dade County, Florida. This circa 1949 apartment building was constructed of concrete block covered in stucco. The northwest corner of the building also features a faux stone material. The building is two stories tall, with main entrances facing east. There are balconies and porches for each unit. The metal and vinyl windows consist of one-over-one single-hung-sash, three- and four-light awning, and two-light sliding. The buildings featured wide eaves, concrete sills, and large awnings on the north side windows.

This resource does not retain sufficient integrity of design, materials, and workmanship. The building has undergone renovations including the replacement of windows and doors, as well as the additions of the window awnings and the faux stone material on the north side of the building. Therefore, given its common design and lack of historic integrity, this building is considered ineligible for listing in the National Register individually or as part of a historic district. The building is part of the historic resource group Sandpiper Villas Co-Op (8DA15805), which is considered National Register–ineligible.

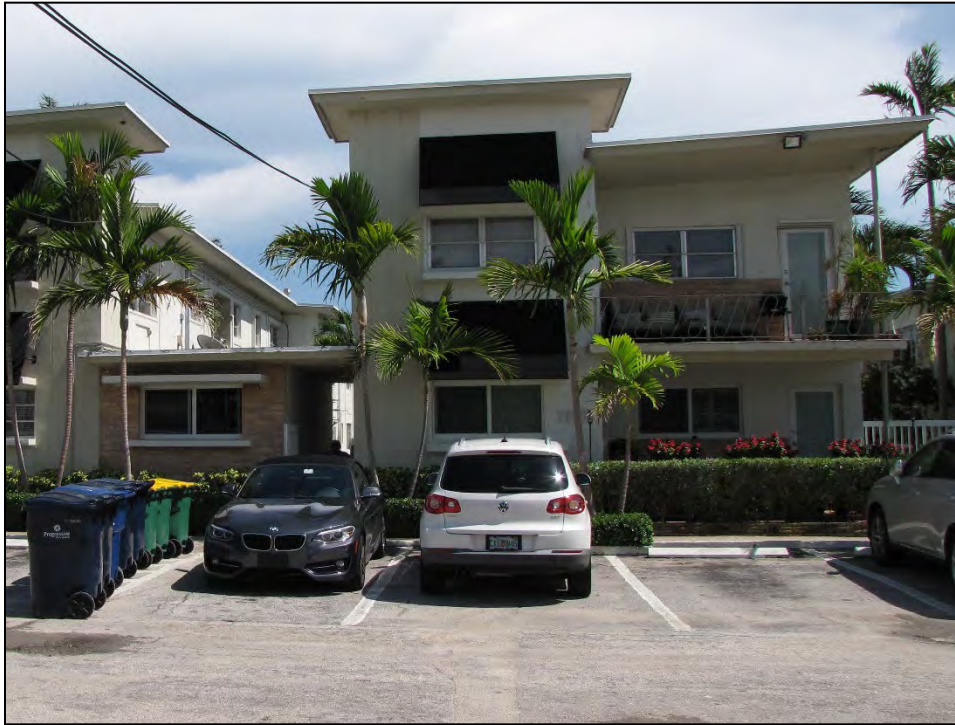
8DA15807 Sandpiper Villas Co-Op Building 1110

Figure 50: Sandpiper Villas Co-Op Building 1110 (8DA15807), Facing South

This Masonry Vernacular apartment co-operative building is located at 1110 Venetian Way in Section 31 of Township 53 South, Range 42 East (Miami, FL 1994 USGS 7.5-mi. Topographic Quadrangle), in the City of Miami, Miami-Dade County, Florida. This circa 1949 apartment building was constructed of concrete block covered in stucco. There is a one-story 1980s addition at the northeast corner of the building that connects it to the building at 1120 Venetian Way (8DA15808). This addition is covered in a faux stone material. The building is two stories tall, with main entrances facing east. There are balconies and porches for each unit. The metal and vinyl windows consist of one-over-one single-hung-sash, three- and four-light awning, and two-light sliding. The buildings featured wide eaves, concrete sills, and large awnings on the north side windows.

This resource does not retain sufficient integrity of design, materials, and workmanship. The building has undergone renovations including the replacement of windows and doors, as well as the non-historic addition at the northeast corner that connects it to the building at 1120 Venetian Way (8DA15808). Therefore, given its common design and lack of historic integrity, this building is considered ineligible for listing in the National Register individually or as part of a historic district. The building is part of the historic resource group Sandpiper Villas Co-Op (8DA15805), which is considered National Register–ineligible.

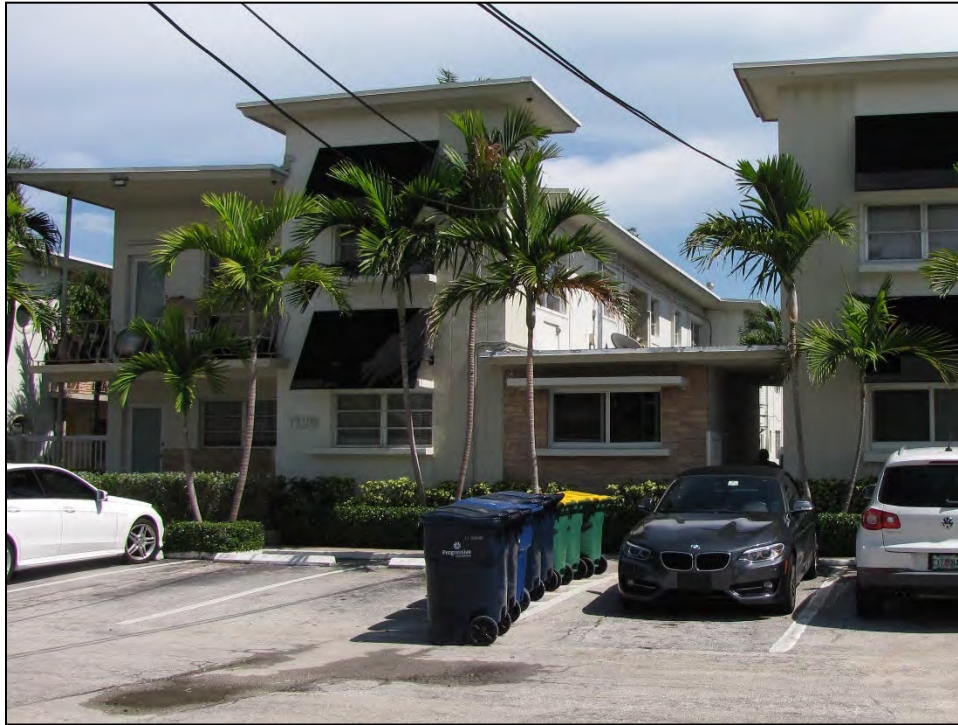
8DA15808 Sandpiper Villas Co-Op Building 1120

Figure 51: Sandpiper Villas Co-Op Building 1120 (8DA15808), Facing South

This Masonry Vernacular apartment co-operative building is located at 1120 Venetian Way in Section 31 of Township 53 South, Range 42 East (Miami, FL 1994 USGS 7.5-mi. Topographic Quadrangle), in the City of Miami, Miami-Dade County, Florida. This circa 1949 apartment building was constructed of concrete block covered in stucco. There is a one-story 1980s addition at the northwest corner of the building that connects it to the building at 1110 Venetian Way (8DA15807). This addition is covered in a faux stone material. The building is two stories tall, with main entrances facing west. There are balconies and porches for each unit. The metal and vinyl windows consist of one-over-one single-hung-sash, three- and four-light awning, two-light sliding, one-light circular fixed, and tripartite with a fixed center and flanking four-light awning. The buildings featured wide eaves, concrete sills, and large awnings on the north side windows.

This resource does not retain sufficient integrity of design, materials, and workmanship. The building has undergone renovations including the replacement of windows and doors, as well as the non-historic addition at the northwest corner that connects it to the building at 1110 Venetian Way (8DA15807). Therefore, given its common design and lack of historic integrity, this building is considered ineligible for listing in the National Register individually or as part of a historic district. The building is part of the historic resource group Sandpiper Villas Co-Op (8DA15805), which is considered National Register–ineligible.

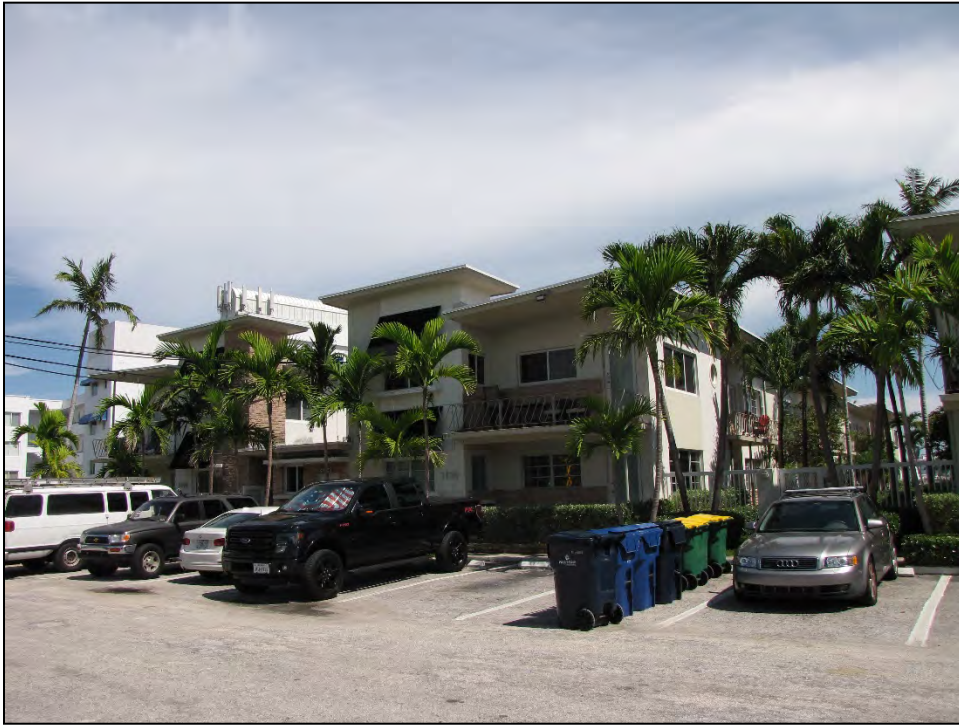
8DA15809 Sandpiper Villas Co-Op Building 1130

Figure 52: Sandpiper Villas Co-Op Building 1130 (8DA15809), Facing Southeast

This Masonry Vernacular apartment co-operative building is located at 1110 Venetian Way in Section 31 of Township 53 South, Range 41 East (Miami, FL 1994 USGS 7.5-mi. Topographic Quadrangle), in the City of Miami, Miami-Dade County, Florida. This circa 1949 apartment building was constructed of concrete block covered in stucco. There is a one-story 1980s addition at the northeast corner of the building that connects it to the building at 1140 Venetian Way (8DA15810). This addition is covered in a faux stone material. The building is two stories tall, with main entrances facing east. There are balconies and porches for each unit. The metal and vinyl windows consist of one-over-one single-hung-sash, three- and four-light awning, and two-light sliding. The buildings featured wide eaves, concrete sills, and large awnings on the north side windows.

This resource does not retain sufficient integrity of design, materials, and workmanship. The building has undergone renovations including the replacement of windows and doors, as well as the non-historic addition at the northeast corner that connects it to the building at 1140 Venetian Way (8DA15810). Therefore, given its common design and lack of historic integrity, this building is considered ineligible for listing in the National Register individually or as part of a historic district. The building is part of the historic resource group Sandpiper Villas Co-Op (8DA15805), which is considered National Register–ineligible.

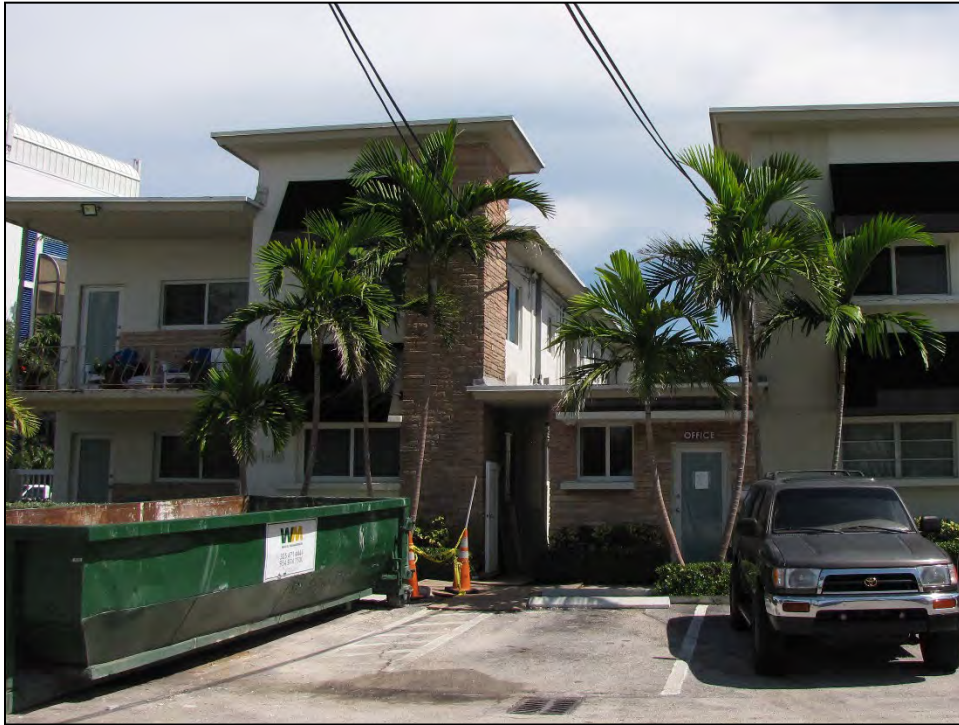
8DA15810 Sandpiper Villas Co-Op Building 1140

Figure 53: Sandpiper Villas Co-Op Building 1140 (8DA15810), Facing South

This Masonry Vernacular apartment co-operative building is located at 1120 Venetian Way in Section 31 of Township 53 South, Range 41 East (Miami, FL 1994 USGS 7.5-mi. Topographic Quadrangle), in the City of Miami, Miami-Dade County, Florida. This circa 1949 apartment building was constructed of concrete block covered in stucco. There is a one-story 1980s addition at the northwest corner of the building that connects it to the building at 1130 Venetian Way (8DA15809). This addition is covered in a faux stone material. The building is two stories tall, with main entrances facing west. There are balconies and porches for each unit. The metal and vinyl windows consist of one-over-one single-hung-sash, three- and four-light awning, and two-light sliding. The buildings featured wide eaves, concrete sills, and large awnings on the north side windows.

This resource does not retain sufficient integrity of design, materials, and workmanship. The building has undergone renovations including the replacement of windows and doors, as well as the non-historic addition at the northwest corner that connects it to the building at 1130 Venetian Way (8DA15809). Therefore, given its common design and lack of historic integrity, this building is considered ineligible for listing in the National Register individually or as part of a historic district. The building is part of the historic resource group Sandpiper Villas Co-Op (8DA15805), which is considered National Register–ineligible.

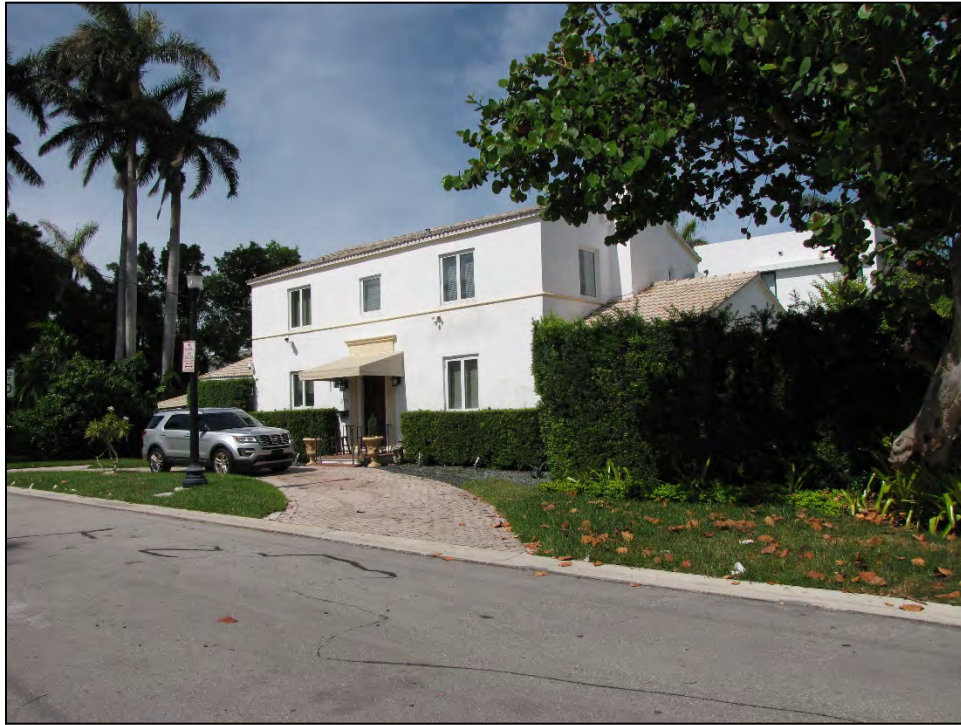
8DA15811 235 W San Marino Drive

Figure 54: 235 W San Marino Drive (8DA15811), Facing Northeast

This resource does not retain sufficient integrity of design, materials, workmanship, and feeling. The building has undergone renovations including the replacement of windows and doors. Therefore, given its common design and lack of historic integrity, this building is considered ineligible for listing in the National Register individually or as part of a historic district.

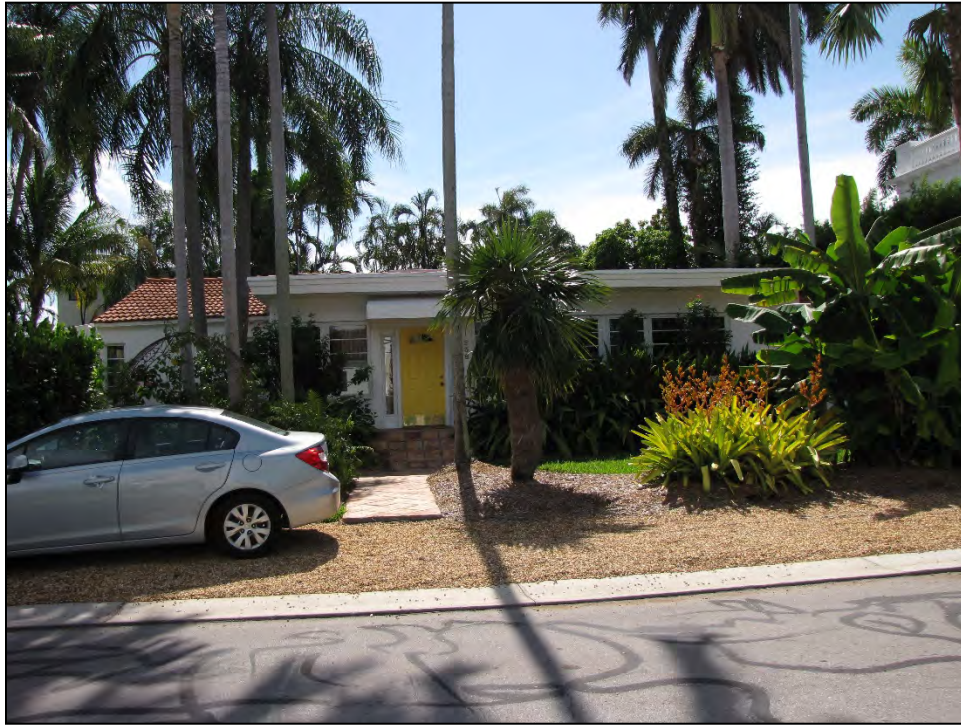
Figure 55: 238 E San Marino Drive (8DA15812), Facing West

8DA15812 238 E San Marino Drive

This Masonry Vernacular building is located at 238 W San Marino Drive in Section 32 of Township 53 South, Range 42 East (Miami, FL 1994 USGS 7.5-mi. Topographic Quadrangle), in the City of Miami Beach, Miami-Dade County, Florida. This circa 1936 residence contains a gable-roof main body, a flat roof east side portion, and flat-roof rear addition. The brick building is covered with stucco. The exterior is clad in stucco. Windows include three-, four-, and five-light, metal casement. Roofing consists of barrel tile. The east side flat roof portion of the house was originally an entry porch. It was enclosed in the 1980s and the main entrance now consists of a panel door with an inset fanlight under a canvas awning. The building currently serves as a private residence.

This resource does not retain sufficient integrity of design, materials, workmanship, and feeling. The building has undergone renovations including the replacement of windows and doors, as well as the enclosure of the original entry porch and a rear addition. Therefore, given its common design and lack of historic integrity, this building is considered ineligible for listing in the National Register individually or as part of a historic district.

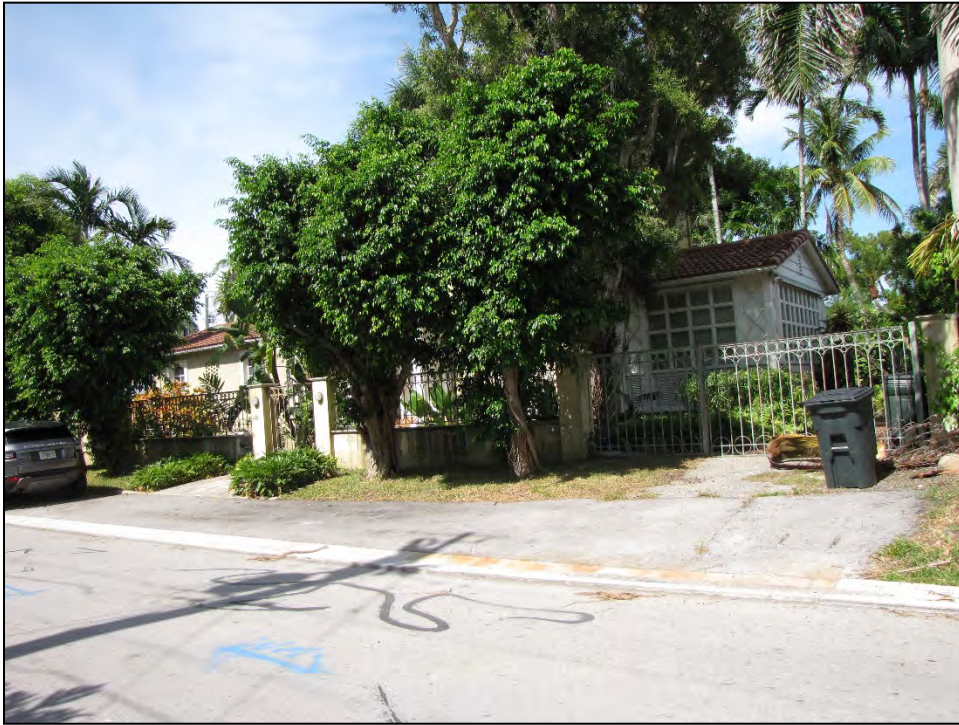
Figure 56: 221 W San Marino Drive (8DA15813), Facing Northeast

8DA15813 221 W San Marino Drive

This two-story, Masonry Vernacular building is located at 221 W San Marino Drive in Section 32 of Township 53 South, Range 42 East (Miami, FL 1994 USGS 7.5-mi. Topographic Quadrangle), in the City of Miami Beach, Miami-Dade County, Florida. This circa 1937 residence contains a gable-roof main body, a north side one-story addition, and a one-story southwest corner addition. The brick building is covered with stucco. The exterior is clad in stucco. Windows include eight- and ten-light, metal casement and three- and four-light, metal awning. Roofing consists of barrel tile. The main west-facing entrance consists of a wood door with enclosed sidelights and a thick door surround. The entry porch is distinguished by rounded tiled steps and two Tuscan columns. The building currently serves as a private residence.

This resource does not retain sufficient integrity of design, materials, workmanship, and feeling. The building has undergone renovations including the replacement of windows and doors, as well as two additions. Therefore, given its common design and lack of historic integrity, this building is considered ineligible for listing in the National Register individually or as part of a historic district.

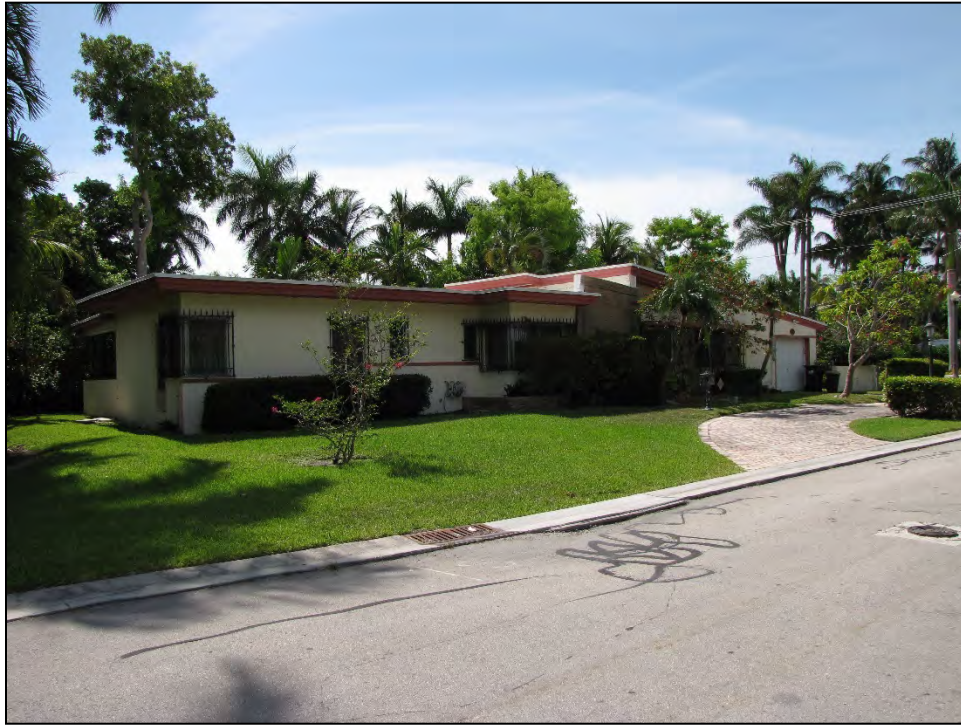
Figure 57: 210 E San Marino Drive (8DA15814), Facing Northwest

8DA15814 210 E San Marino Drive

This Masonry Vernacular building is located at 210 E San Marino Drive in Section 32 of Township 53 South, Range 42 East (Miami, FL 1994 USGS 7.5-mi. Topographic Quadrangle), in the City of Miami Beach, Miami-Dade County, Florida. This circa 1954 residence contains a flat roof southern half and a shed roof northern half. The concrete-block building rests on a continuous concrete-block foundation. The exterior is clad in stucco and a faux stone material. Windows include metal jalousie, two of which are at the southeast corner of the building. Some of the windows have decorative security bars. The main entrance consists of a panel door with an oval light. The entry porch is recessed on the east side and enclosed with a decorative iron screen. The building currently serves as a private residence.

This resource does not retain sufficient integrity of design, materials, workmanship, and feeling. The building has undergone renovations including the replacement of windows and doors, as well as the addition of decorative security bars. Therefore, given its common design and lack of historic integrity, this building is considered ineligible for listing in the National Register individually or as part of a historic district.

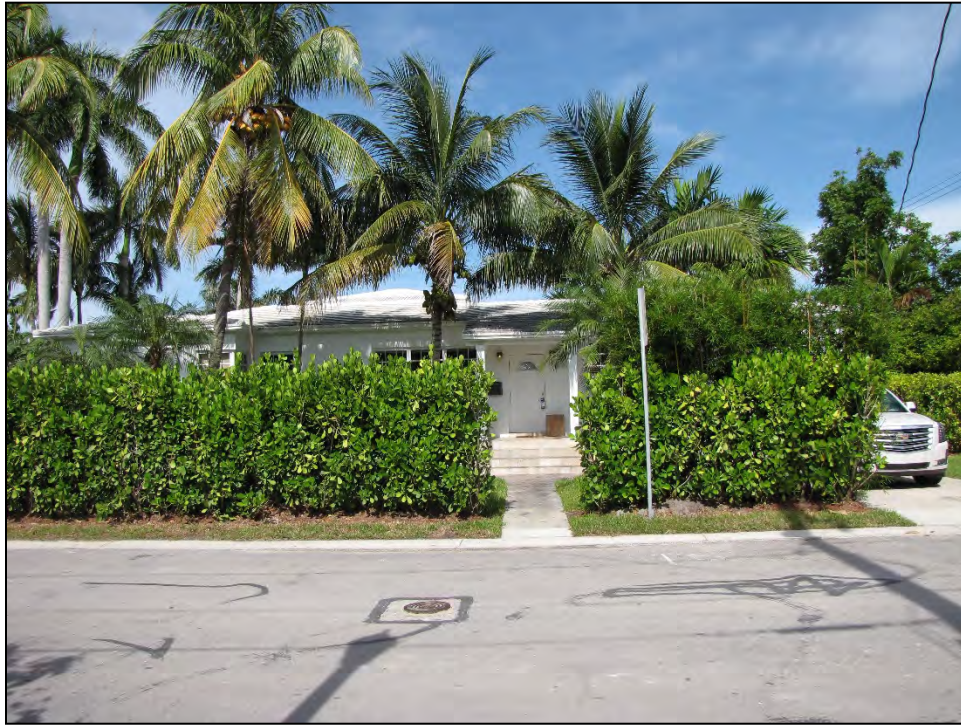
Figure 58: 435 W Di Lido Drive (8DA15815), Facing East

8DA15815 435 W Di Lido Drive

This Masonry Vernacular building is located at 435 W Di Lido Drive in Section 32 of Township 53 South, Range 42 East (Miami, FL 1994 USGS 7.5-mi. Topographic Quadrangle), in the City of Miami Beach, Miami-Dade County, Florida. This circa 1948 is constructed of concrete block resting on a continuous concrete-block foundation. The exterior is clad in stucco. Windows include six -light, metal fixed, some of which are paired and tripled. Roofing consists of flat tile. The main entrance consists of a west-facing panel door with an inset fanlight under a small entry porch distinguished by two square columns. The building currently serves as a private residence.

This resource does not retain sufficient integrity of design, materials, workmanship, and feeling. The building has undergone renovations including the replacement of windows and doors, as well as the reconstruction of the entry porch. Therefore, given its common design and lack of historic integrity, this building is considered ineligible for listing in the National Register individually or as part of a historic district.

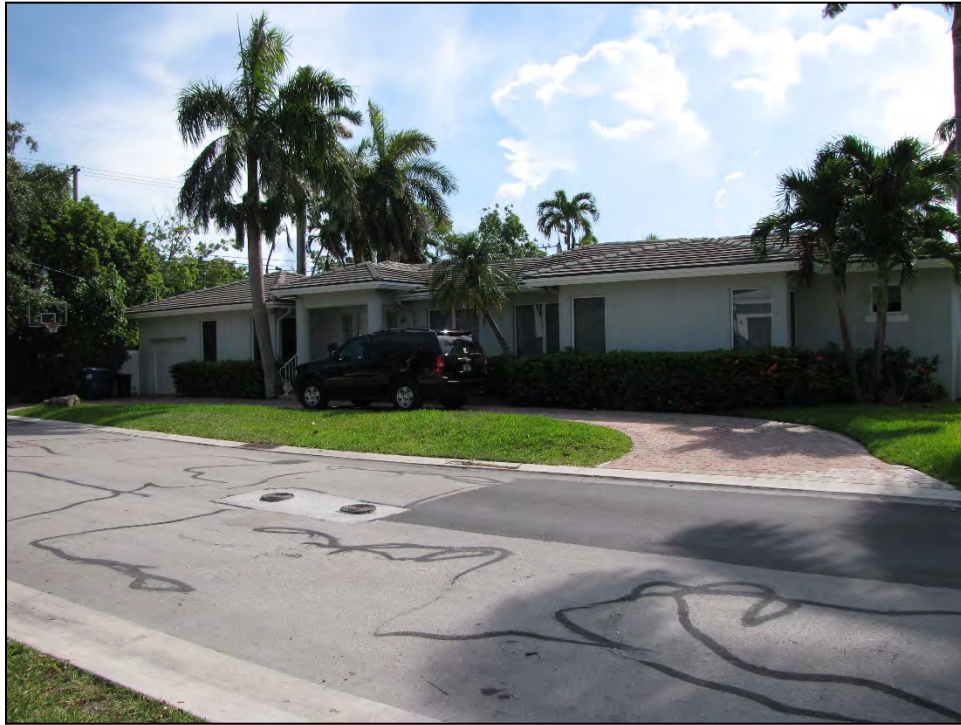
Figure 59: 440 E Di Lido Drive (8DA15816), Facing Southwest

8DA15816 440 E Di Lido Drive

This Masonry Vernacular building is located at 440 E Di Lido Drive in Section 32 of Township 53 South, Range 42 East (Miami, FL 1994 USGS 7.5-mi. Topographic Quadrangle), in the City of Miami Beach, Miami-Dade County, Florida. This circa 1946 residence contains several hipped roof portions including a garage at the southeast corner. The concrete-block building rests on a continuous concrete-block foundation. The exterior is clad in stucco. Windows include two-light, metal horizontal sliding and one-light, metal fixed. Roofing consists of flat tile. The main entrance consists of an east-facing wood door with a small rectangular light and flanking glass block sidelights. The east side raised tiled porch has two large stucco columns and metal railings. The building currently serves as a private residence.

This resource does not retain sufficient integrity of design, materials, workmanship, and feeling. The building has undergone renovations including the replacement of windows and doors, the enclosure of the carport into a garage, as well as a non-historic rear addition. Therefore, given its common design and lack of historic integrity, this building is considered ineligible for listing in the National Register individually or as part of a historic district.

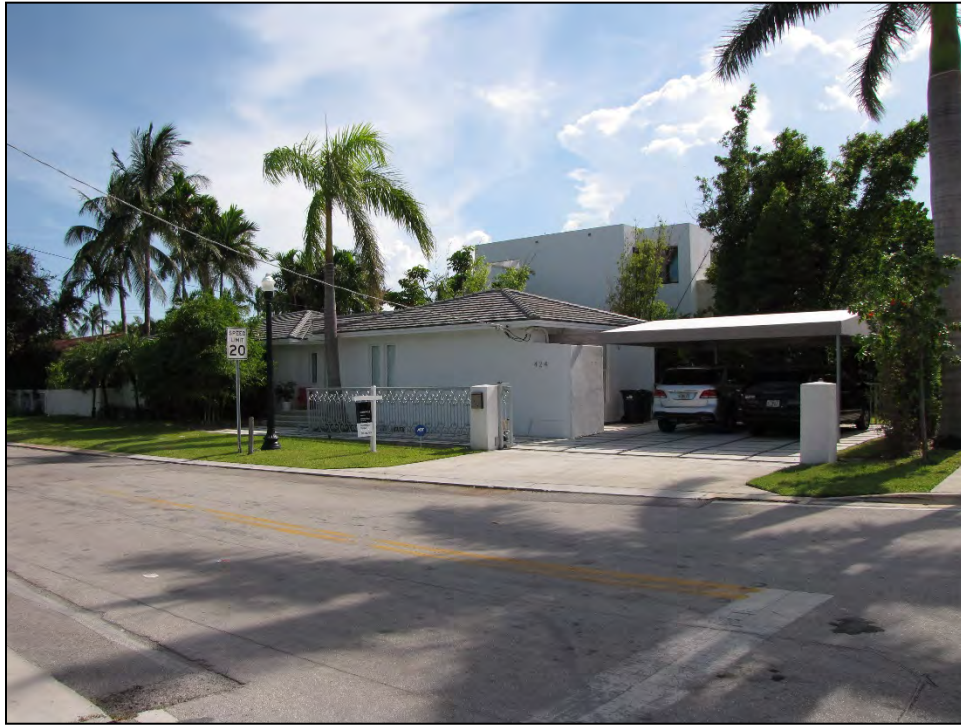
Figure 60: 424 E Di Lido Drive (8DA15817), Facing Southwest

8DA15817 424 E Di Lido Drive

This Masonry Vernacular building is located at 424 E Di Lido Drive in Section 32 of Township 53 South, Range 42 East (Miami, FL 1994 USGS 7.5-mi. Topographic Quadrangle), in the City of Miami Beach, Miami-Dade County, Florida. This circa 1944 residence contains a hip-on-hip-roof main body, and two flat-roof rear additions. The concrete-block building rests on a continuous concrete-block foundation. The exterior is clad in stucco. Windows include one-light, metal fixed. Roofing consists of flat tile. The main entrance consists of east-facing double doors with large rectangular lights at the east side raised entry porch. There is a large awning on the north side that serves as a carport. The building currently serves as a private residence.

This resource does not retain sufficient integrity of design, materials, workmanship, and feeling. The building has undergone renovations including the replacement of windows and doors, as well as two rear addition. Therefore, given its common design and lack of historic integrity, this building is considered ineligible for listing in the National Register individually or as part of a historic district.

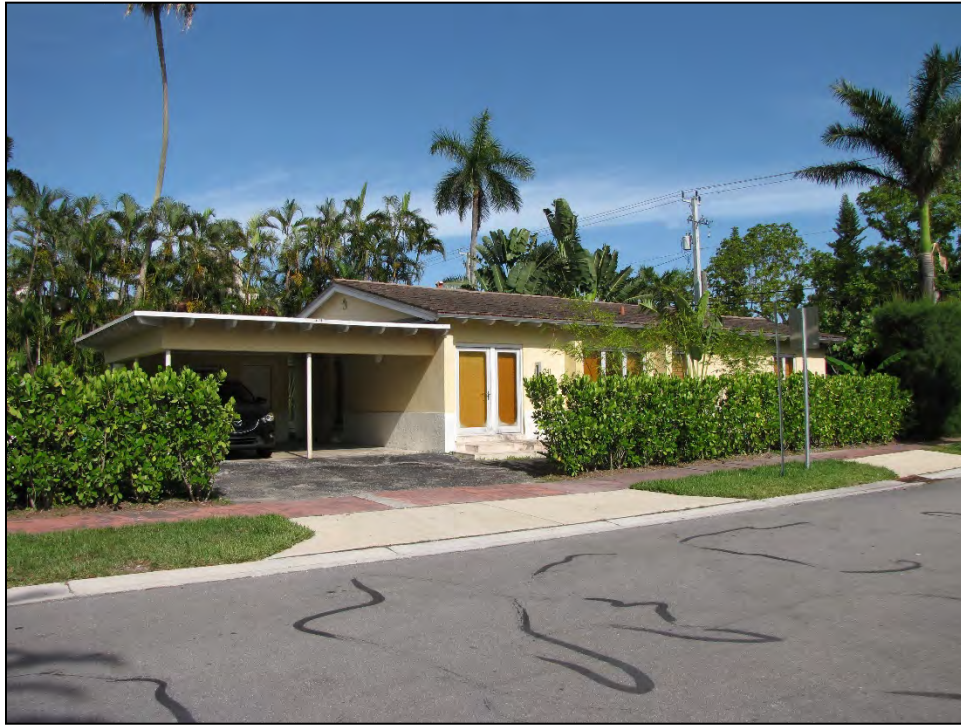
Figure 61: 241 W Rivo Alto Drive (8DA15818), Facing Southeast

8DA15818 241 W Rivo Alto Drive

This Masonry Vernacular building is located at 241 E Rivo Alto Drive in Section 33 of Township 53 South, Range 42 East (Miami, FL 1994 USGS 7.5-mi. Topographic Quadrangle), in the City of Miami Beach, Miami-Dade County, Florida. This circa 1954 residence contains a gable-roof main body and flat-roof carport on the north side. The concrete-block building rests on a continuous concrete-block foundation. The exterior is clad in stucco. Windows include two- and three-light, metal horizontal sliding and one-light, metal fixed. Roofing consists of flat tile. The main entrance consists of an east-facing door with a wide sidelight to the right of the door and a small concrete stoop. There is a secondary entry under the carport. The building currently serves as a private residence.

This resource does not retain sufficient integrity of design, materials, workmanship, and feeling. The building has undergone renovations including the replacement of windows and doors. Therefore, given its common design and lack of historic integrity, this building is considered ineligible for listing in the National Register individually or as part of a historic district.

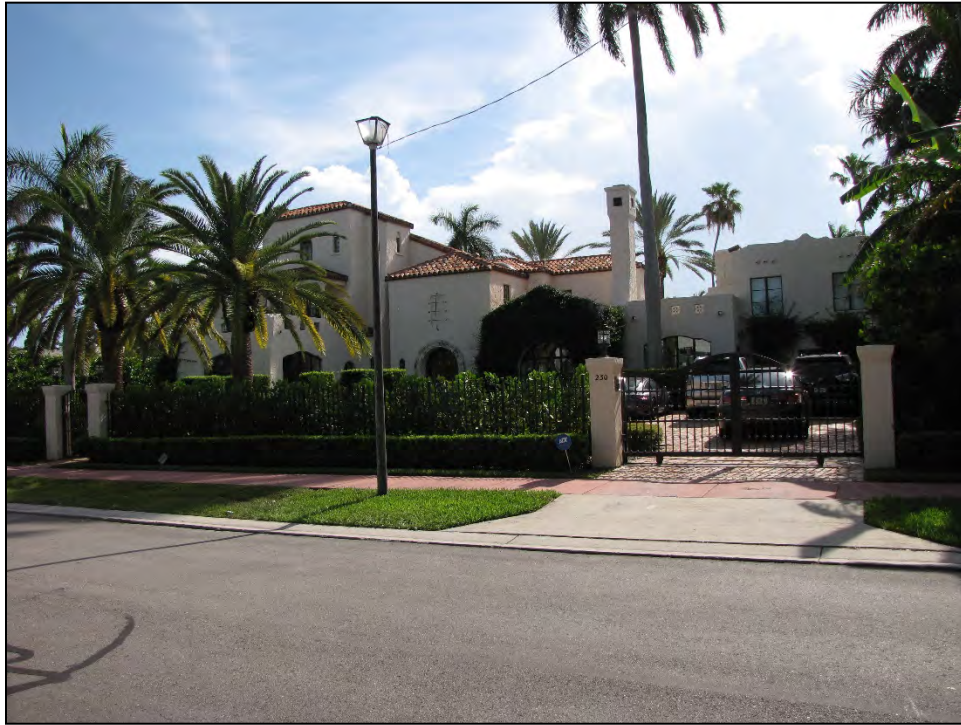
Figure 62: 230 E Rivo Alto Drive (8DA15819), Facing Southwest

8DA15819 230 E Rivo Alto Drive

This three-story, Mediterranean Revival building is located at 230 E Rivo Alto Drive in Section 33 of Township 53 South, Range 42 East (Miami, FL 1994 USGS 7.5-mi. Topographic Quadrangle), in the City of Miami Beach, Miami-Dade County, Florida. This circa 1924 residence contains a hip-roof main body, central two-story hip-roof entry, and flat-roof additions. The wood-frame building rests on a pier foundation that has been filled with stucco. The exterior is clad in stucco. Windows include three-light, wood fixed and replacement three-light, metal fixed. Roofing consists of barrel tile. The two-story east side entrance was added circa 1980 and includes arched double doors with large lights. The flat roof additions on the north and south sides were constructed circa 2011, when the property was completely renovated. The north side addition connected the main building to the once detached garage. The building features scuppers, door surrounds, concrete sills, parapets, decorative iron work, arches molded around third-story windows, and Ionic columns on the entry porch. An iron fence with gates and tall hedges line the edge of the property. The building currently serves as a private residence.

This resource does not retain sufficient integrity of design, materials, workmanship, and feeling. The building has undergone a complete renovation including the replacement of windows and doors, a new stucco treatment, and several additions. Therefore, given its common design and lack of historic integrity, this building is considered ineligible for listing in the National Register individually or as part of a historic district.

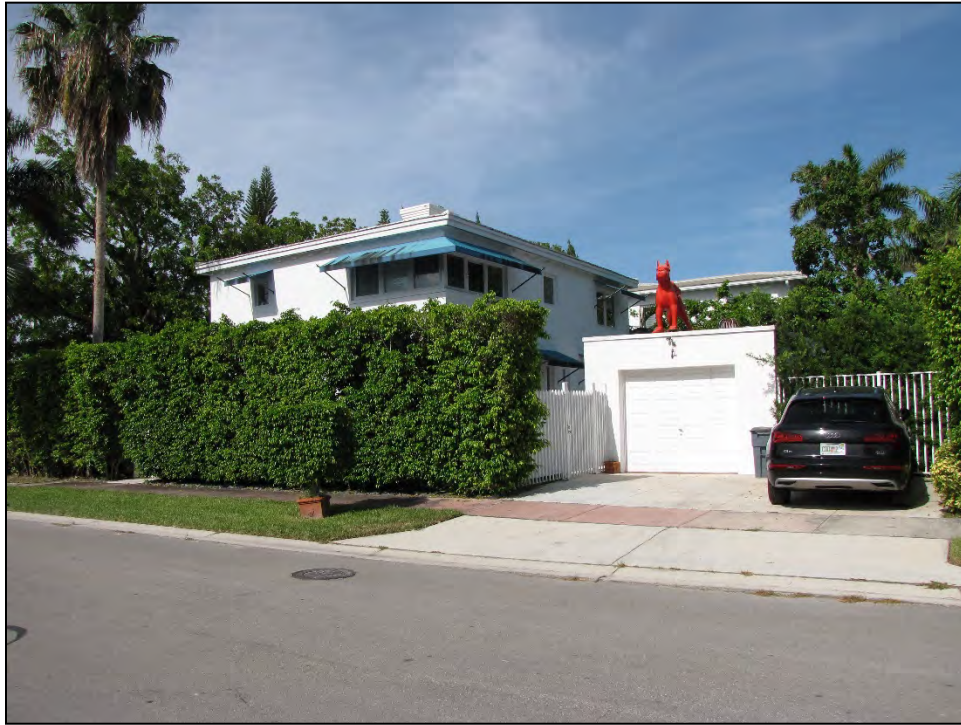
Figure 63: 225 W Rivo Alto Drive (8DA15820), Facing Northeast

8DA15820 225 W Rivo Alto Drive

This two-story, Masonry Vernacular building is located at 225 W Rivo Alto Drive in Section 33 of Township 53 South, Range 42 East (Miami, FL 1994 USGS 7.5-mi. Topographic Quadrangle), in the City of Miami Beach, Miami-Dade County, Florida. This circa 1940 residence contains a hip-roof main body, a circa 1949 porch, and a detached one-story garage. The brick building is covered with stucco. The exterior is clad in stucco. Windows include one-light, metal casement, some of which are paired and tripled. At the southwest corner of the second floor, there are two sets of triple windows that meet in the corner under a large awning. Roofing consists of flat tile. The detached garage is topped with a modern red dog statue. Tall hedges and a fence surround the home. The building currently serves as a private residence.

This resource does not retain sufficient integrity of design, materials, workmanship, and feeling. The building has undergone renovations including the replacement of windows and doors, as well as aa porch addition. Therefore, given its common design and lack of historic integrity, this building is considered ineligible for listing in the National Register individually or as part of a historic district.

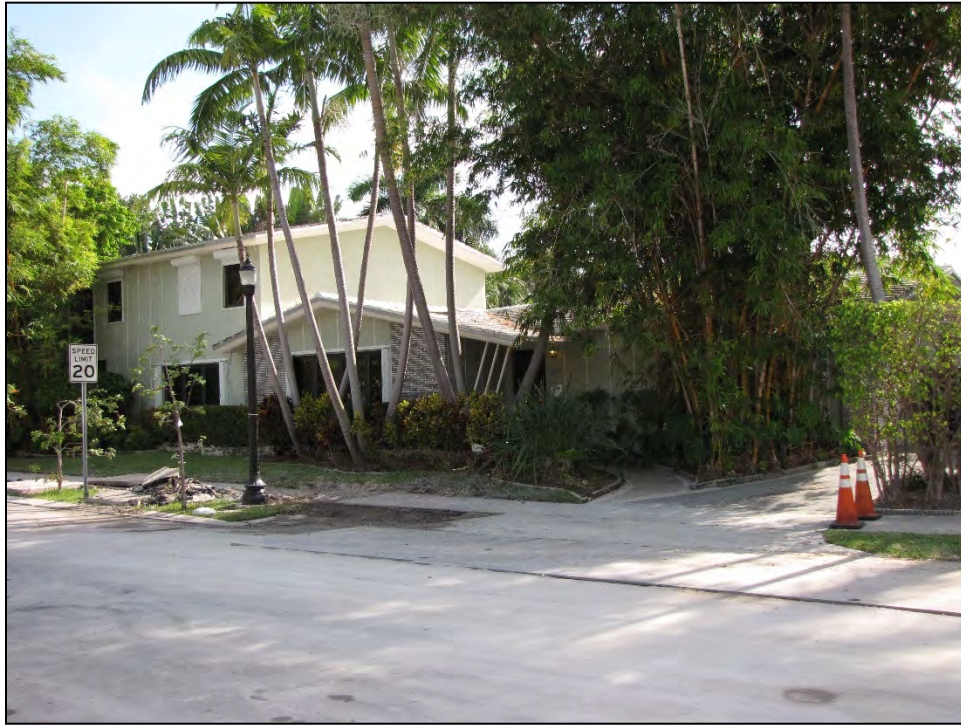
Figure 64: 222 E Rivo Alto Drive (8DA15821), Facing Southwest

8DA15821 222 E Rivo Alto Drive

This two-story, Masonry Vernacular building is located at 222 E Rivo Alto Drive in Section 33 of Township 53 South, Range 42 East (Miami, FL 1994 USGS 7.5-mi. Topographic Quadrangle), in the City of Miami Beach, Miami-Dade County, Florida. This circa 1957 residence contains a cross-gable-roof main body and a two-story south addition. The concrete-block building rests on a continuous concrete-block foundation. The exterior is clad in stucco. Windows include one-light, metal fixed picture, and one-, three-, and four-light, metal casement. Roofing consists of flat tile. The building features vents, molded stucco “stone,” vertical stucco banding, and a garage at the northeast corner that was originally a carport. The building currently serves as a private residence.

This resource does not retain sufficient integrity of design, materials, workmanship, and feeling. The building has undergone renovations including the replacement of windows and doors, a non-historic stucco treatment, and enclosing the carport as a garage, as well as an unsympathetic two-story rear addition. Therefore, given its common design and lack of historic integrity, this building is considered ineligible for listing in the National Register individually or as part of a historic district.

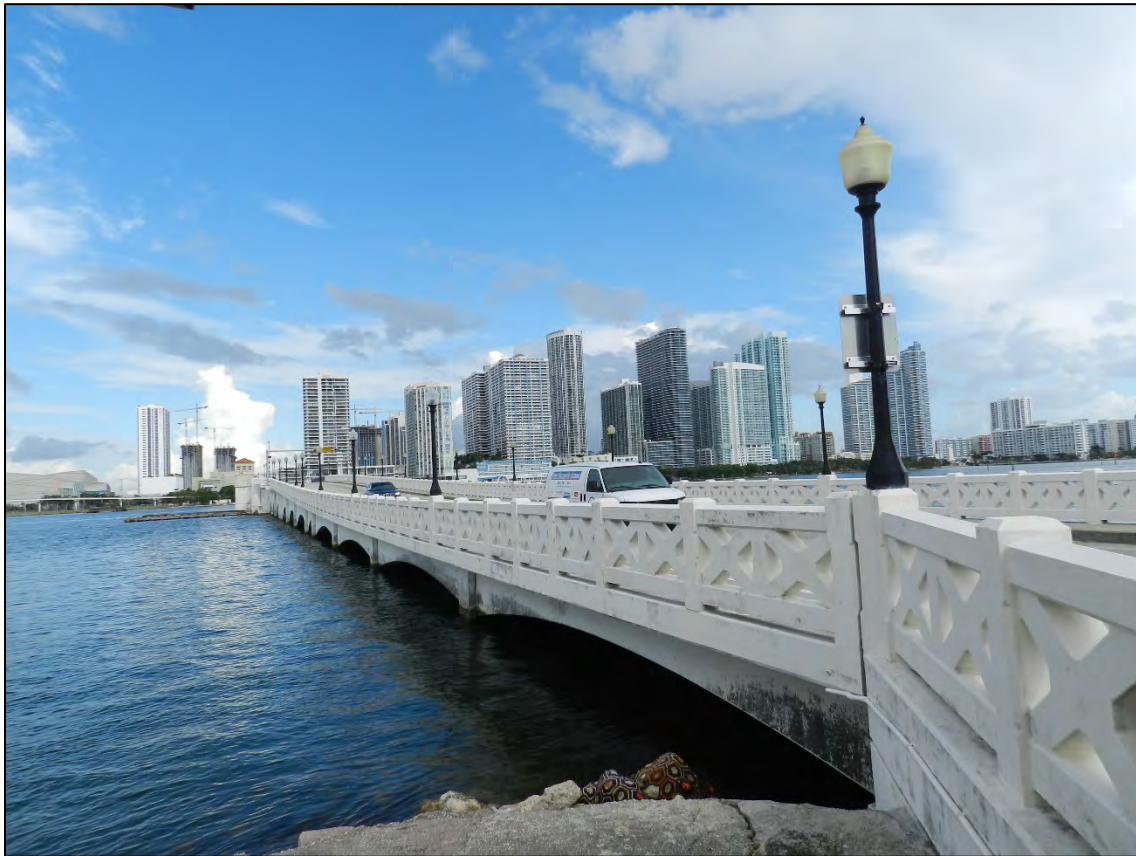
Figure 1: Venetian Causeway Bridge 1 (8DA14373), Facing Northwest

The Venetian Causeway Bridge 1 is 2,005 ft. long with 41 spans including a movable bascule span over the navigation channel, 28 fixed approach spans to the west and 12 fixed approach spans to the east of the movable span (Figure 1). It connects Biscayne Island to the mainland (NE 15th Street). The deck carries two lanes of vehicular traffic, one in each direction, as well as one bicycle lane in each direction with an alignment in the east/west direction.

A 1,274ft. length of bridge - including the movable span and the 12 fixed approach spans on each side of the movable span - were replaced during a rehabilitation project conducted in 1999. The remaining 731ft. length of bridge including 16 fixed approach spans west of the bascule span were replaced as a result of a Miami-Dade County Design-Build Project completed in 2015.

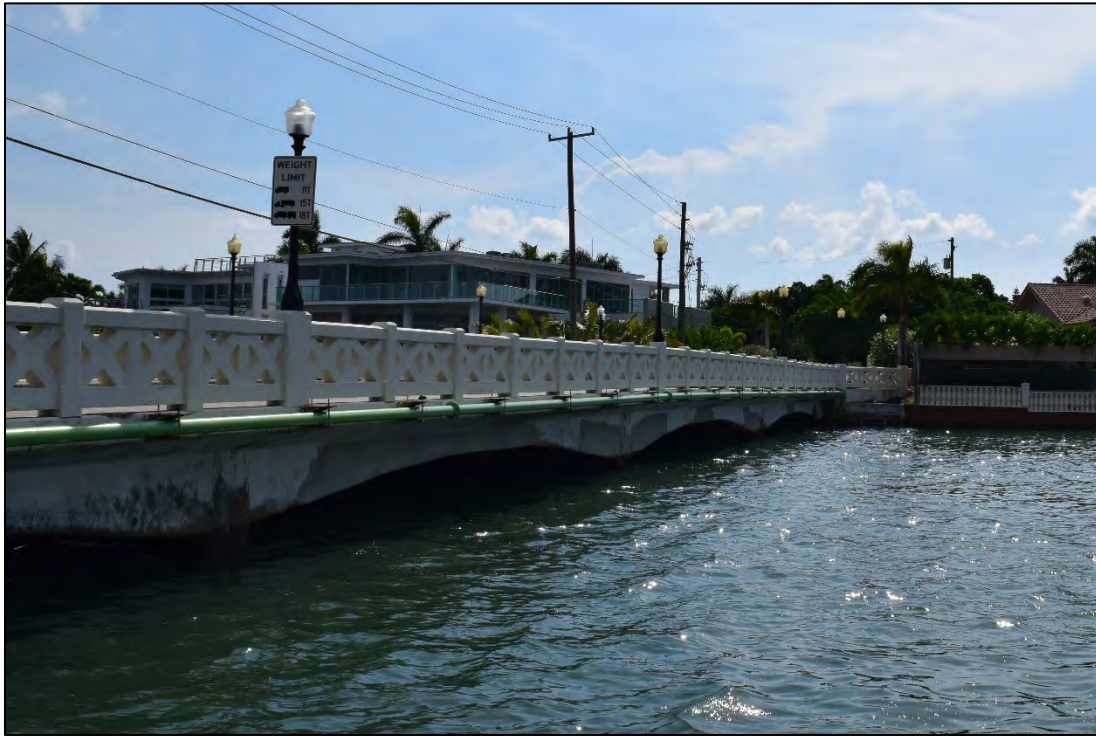
Figure 1: Venetian Causeway Bridge 2 (8DA14374), Facing Northeast

The Venetian Causeway Bridge 2 (8DA14374) is 200 ft. long with three fixed, tee-beam spans (Figure 1). It connects Biscayne Island to San Marco Island. The deck carries two lanes of vehicular traffic, one in each direction. Each bridge section is comprised of two 12-foot travel lanes with 4-foot shoulders that are used as bicycle lanes, and 4-foot wide sidewalks on each side.

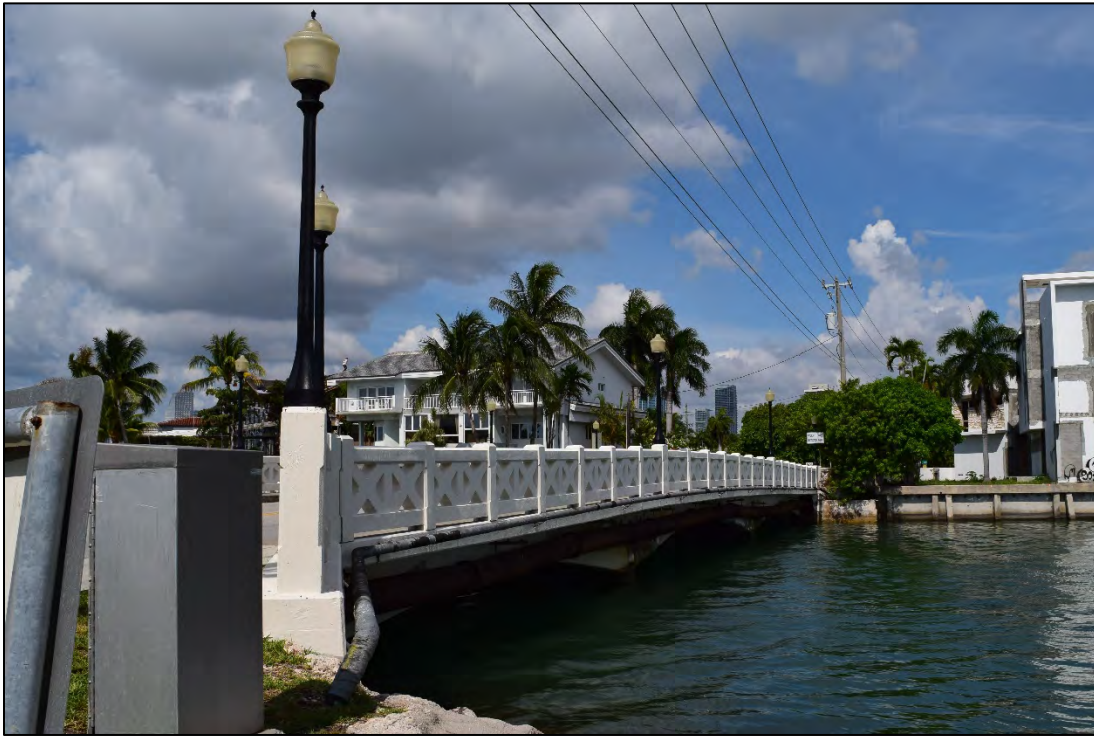
Figure 1: Venetian Causeway Bridge 3 (8DA14375), Facing Southwest

The Venetian Causeway Bridge 3 (8DA14375) is 160 ft. long with three fixed, tee-beam spans (Figure 1). It connects San Marco Island to a small man-made landing to the east. The deck carries two lanes of vehicular traffic, one in each direction. Each bridge section is comprised of two 12-foot travel lanes with 4-foot shoulders that are used as bicycle lanes, and 4-foot wide sidewalks on each side.

Between 1996 and 1999, the Florida Department of Transportation (FDOT) provided funding for necessary bridge repairs. The repairs consisted of major rehabilitation of the beams and decking. Historic features including railings, arched beams, and low profile were retained. Between 2009 and 2011, PWWM conducted a major rehabilitation project to repair the Causeway bridges' beams and decks. The scope of work for this project included major repairs to the support beams, including the removal of existing concrete and adding new, reinforcing concrete. Major repairs were also performed on the diaphragm, the deck underside and the support piers.

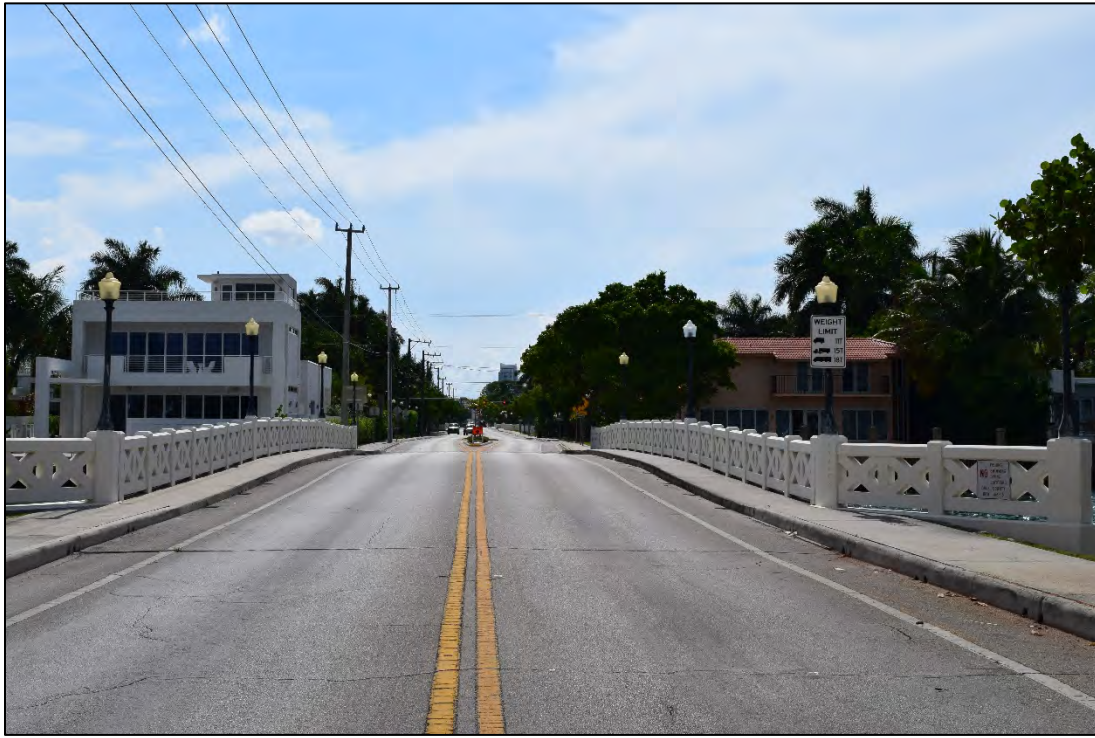
Figure 1: Venetian Causeway Bridge 4 (8DA14376), Facing East

The Venetian Causeway Bridge 4 (8DA14376) is 160 ft. long with three fixed, tee-beam spans (Figure 1). It connects San Marino Island to a small man-made landing to the west. The deck carries two lanes of vehicular traffic, one in each direction. Each bridge section is comprised of two 12-foot travel lanes with 4-foot shoulders that are used as bicycle lanes, and 4-foot wide sidewalks on each side.

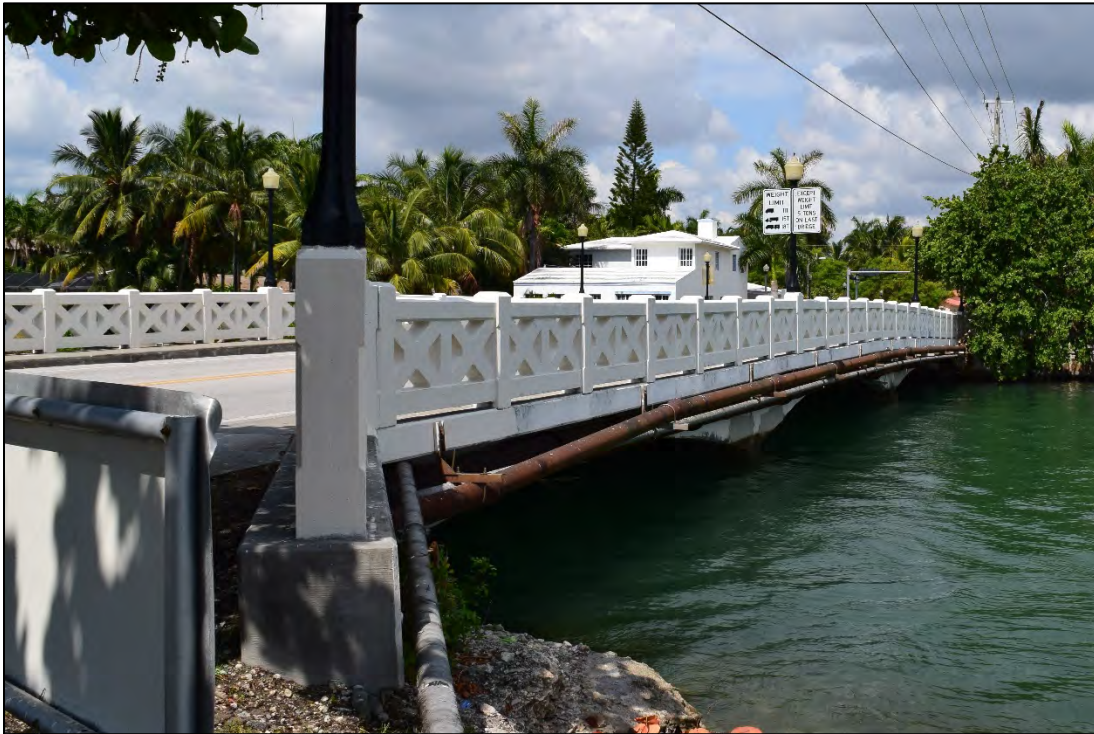
The Venetian Causeway Bridge 5 (8DA14377) is 160 ft. long with three fixed, tee-beam spans (Figure 1). It connects San Marino Island to a small man-made landing to the east. The deck carries two lanes of vehicular traffic, one in each direction. Each bridge section is comprised of two 12-foot travel lanes with 4-foot shoulders that are used as bicycle lanes, and 4-foot wide sidewalks on each side.

Figure 1: Venetian Causeway Bridge 5 (8DA14377), Facing Southwest
