**CULTURAL RESOURCE ASSESSMENT SURVEY
OF VENETIAN CAUSEWAY FROM NORTH BAYSHORE DRIVE IN THE CITY
OF MIAMI TO PURDY AVENUE IN THE CITY OF MIAMI BEACH**

MIAMI-DADE COUNTY

Financial Management No. 422713-2-22-01

FINAL REPORT

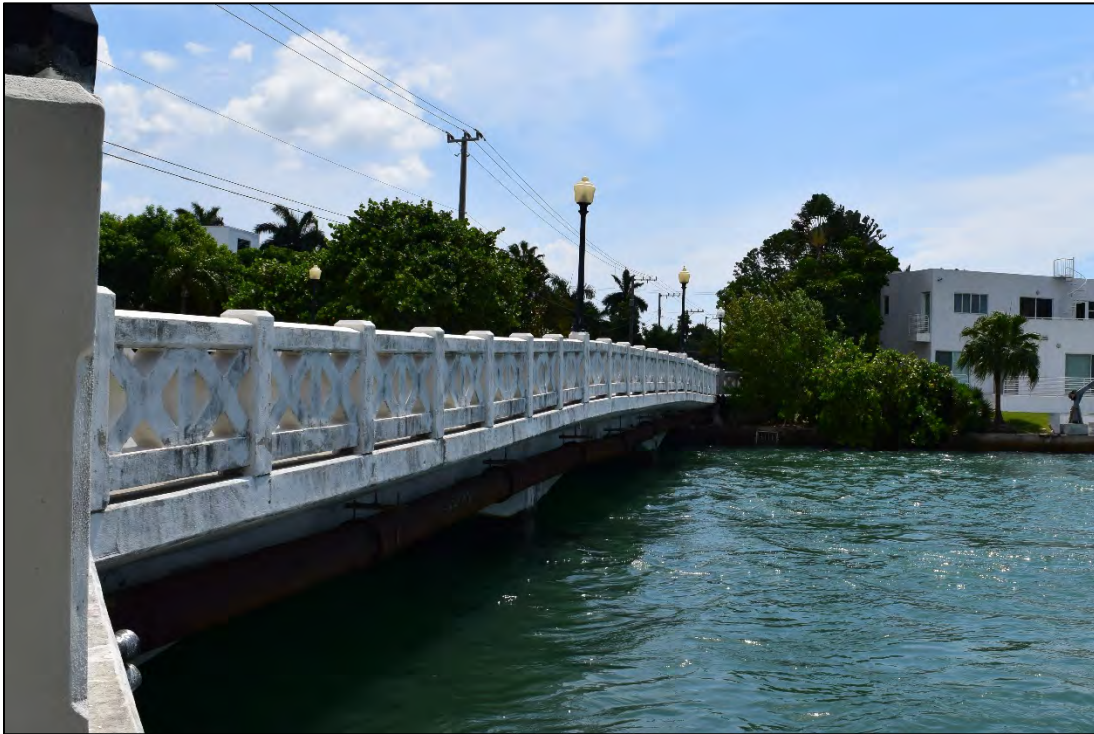
The Venetian Causeway Bridge 6 (8DA14378) is 160 ft. long with three fixed, tee-beam spans (Figure 1). It connects Di Lido Island to a small man-made landing to the west. The deck carries two lanes of vehicular traffic, one in each direction. Each bridge section is comprised of two 12-foot travel lanes with 4-foot shoulders that are used as bicycle lanes, and 4-foot wide sidewalks on each side.

Figure 1: Venetian Causeway Bridge 6 (8DA14378), Facing Northeast

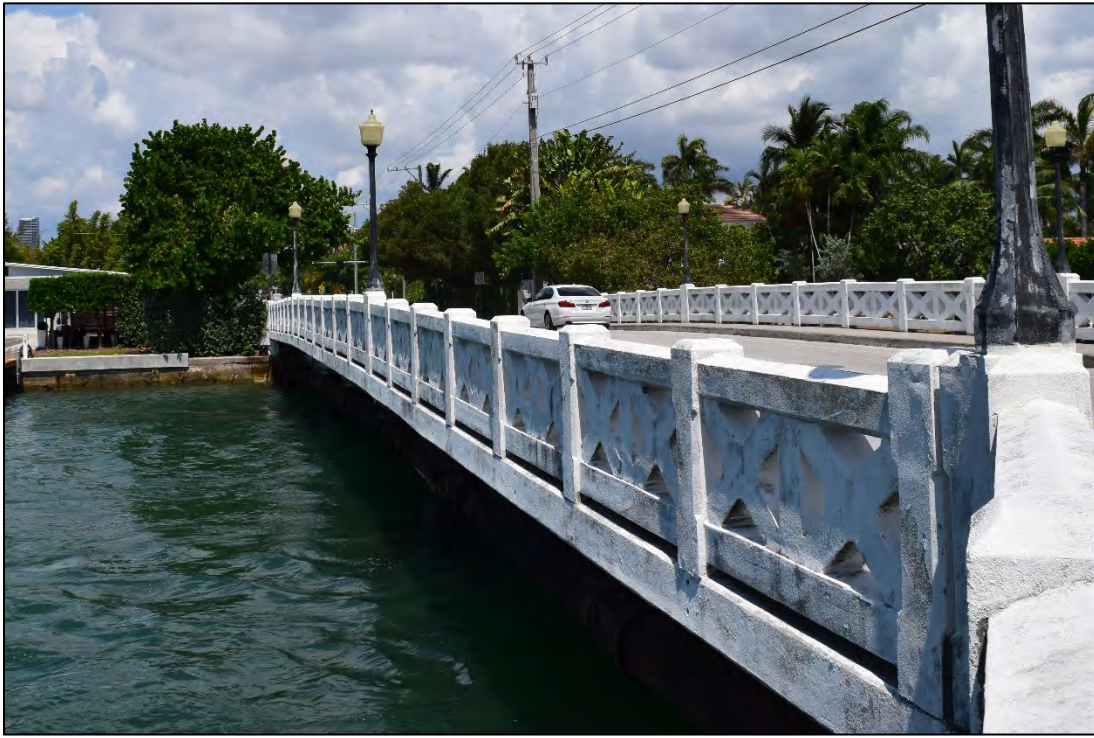
The Venetian Causeway Bridge 7 (8DA14379) is 160 ft. long with three fixed, tee-beam spans (Figure 1). It connects Di Lido Island to a small man-made landing to the east. The deck carries two lanes of vehicular traffic, one in each direction. Each bridge section is comprised of two 12-foot travel lanes with 4-foot shoulders that are used as bicycle lanes, and 4-foot wide sidewalks on each side.

Figure 1: Venetian Causeway Bridge 7 (8DA14379), Facing Northwest

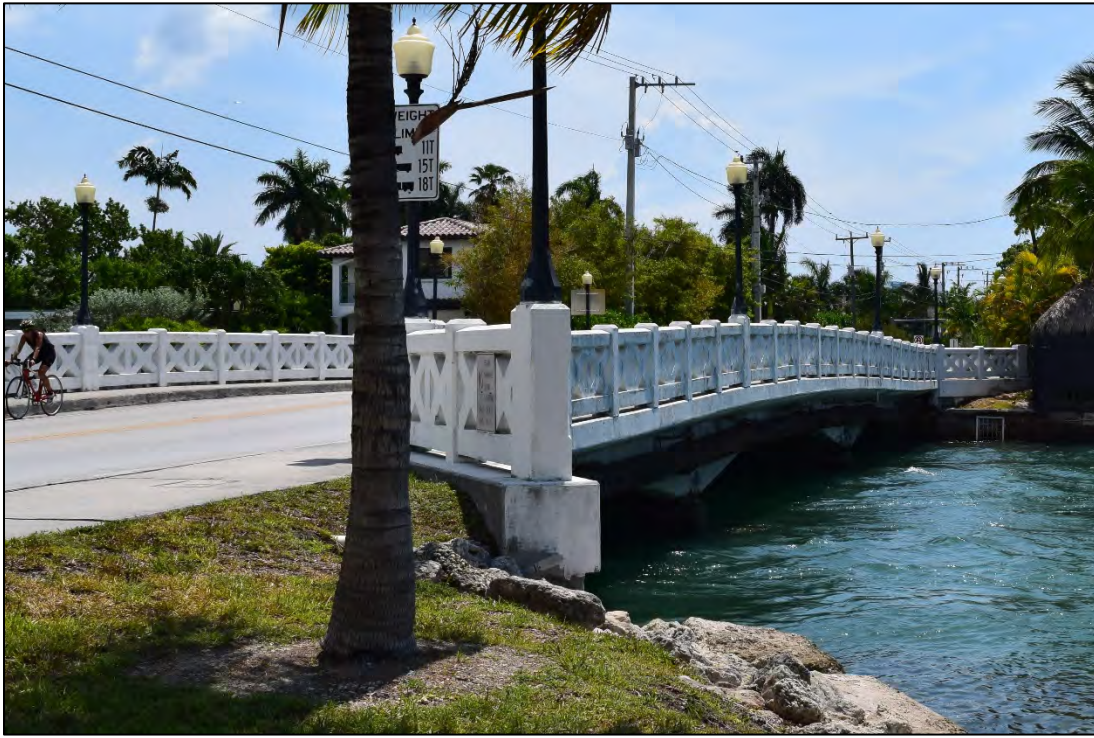
The Venetian Causeway Bridge 8 (8DA14380) is 160 ft. long with three fixed, tee-beam spans (Figure 1). It connects Rivo Alto Island to a small man-made landing to the west. The deck carries two lanes of vehicular traffic, one in each direction. Each bridge section is comprised of two 12-foot travel lanes with 4-foot shoulders that are used as bicycle lanes, and 4-foot wide sidewalks on each side.

Figure 1: Venetian Causeway Bridge 8 (8DA14380), Facing Northeast

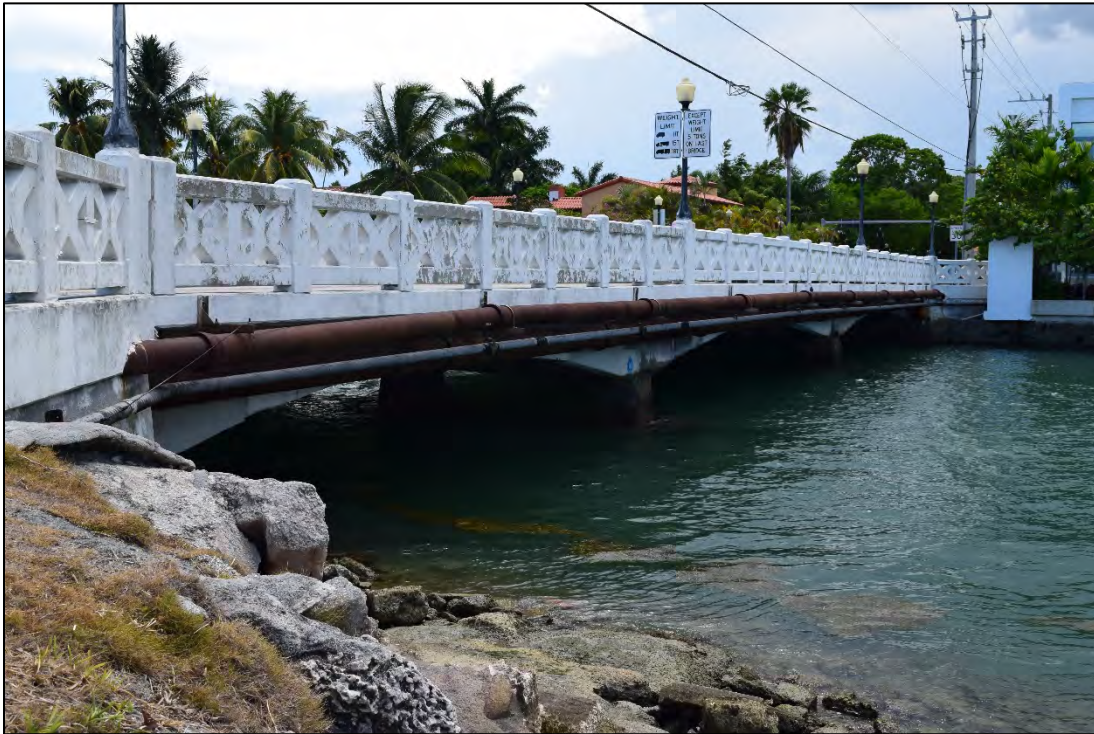
The Venetian Causeway Bridge 9 (8DA14381) is 154 ft. long with three fixed, tee-beam spans (Figure 1). It connects Rivo Alto Island to a small man-made landing to the east. The deck carries two lanes of vehicular traffic, one in each direction. Each bridge section is comprised of two 12-foot travel lanes with 4-foot shoulders that are used as bicycle lanes, and 4-foot wide sidewalks on each side.

Figure 1: Venetian Causeway Bridge 9 (8DA14381), Facing Southwest

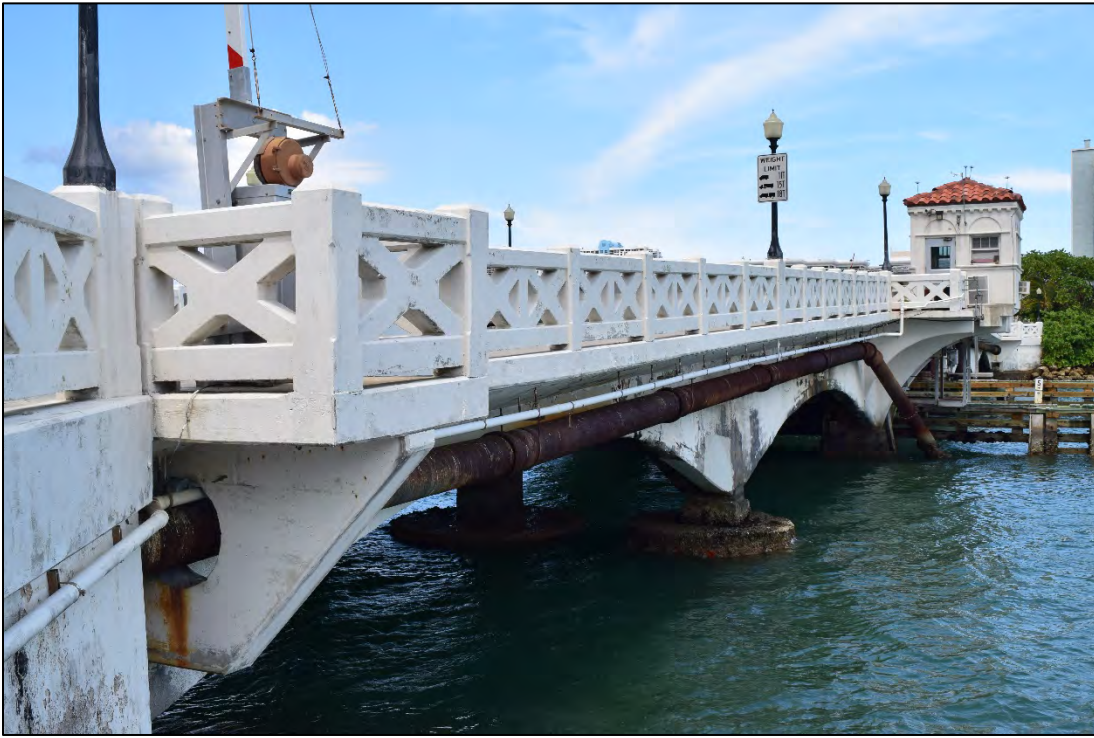
The Venetian Causeway Bridge 10 (8DA14382) is 302 ft. long with five spans including a movable bascule span over the navigation channel and four fixed approach spans (Figure 1). It connects two small man-made landings located between Belle Isle and Rivo Alto Island. The deck carries two lanes of vehicular traffic, one in each direction, as well as one bicycle lane in each direction with an alignment in the east/west direction.

Figure 1: Venetian Causeway Bridge 10 (8DA14382), Facing East

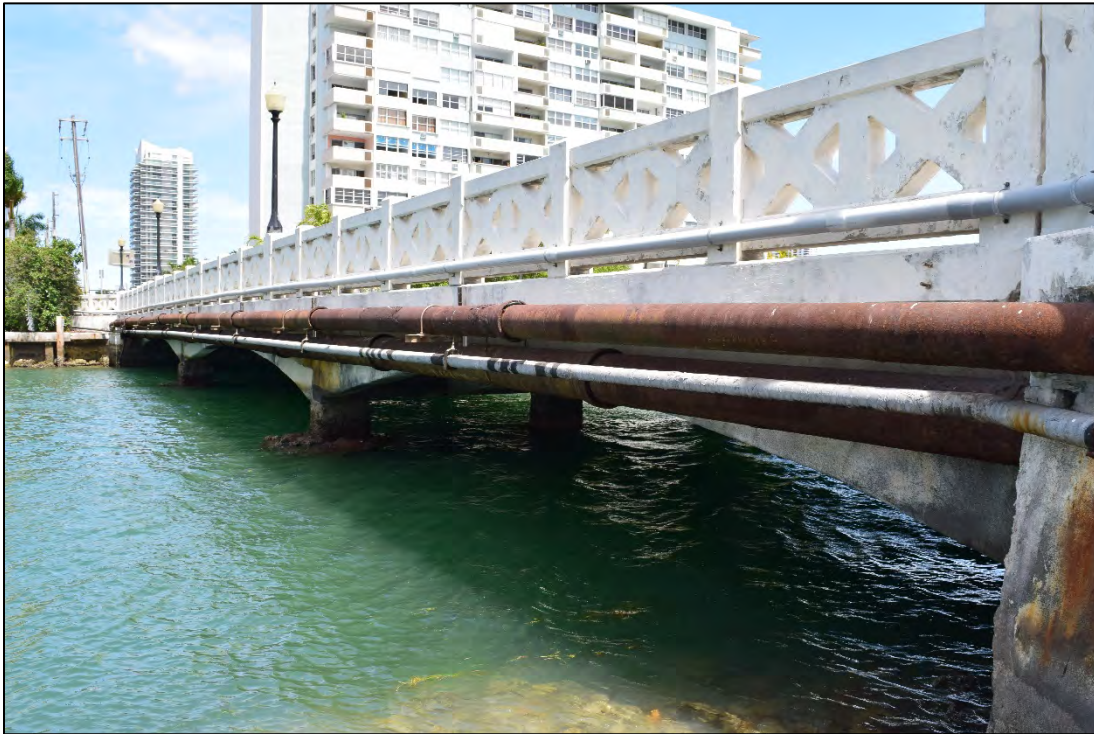
The Venetian Causeway Bridge 11 (8DA14383) is 154 ft. long with three fixed, tee-beam spans (Figure 1). It connects Belle Isle to a small man-made landing to the west. The deck carries two lanes of vehicular traffic, one in each direction. Each bridge section is comprised of two 12-foot travel lanes with 4-foot shoulders that are used as bicycle lanes, and 4-foot wide sidewalks on each side.

Figure 1: Venetian Causeway Bridge 11 (8DA14383), Facing Southeast

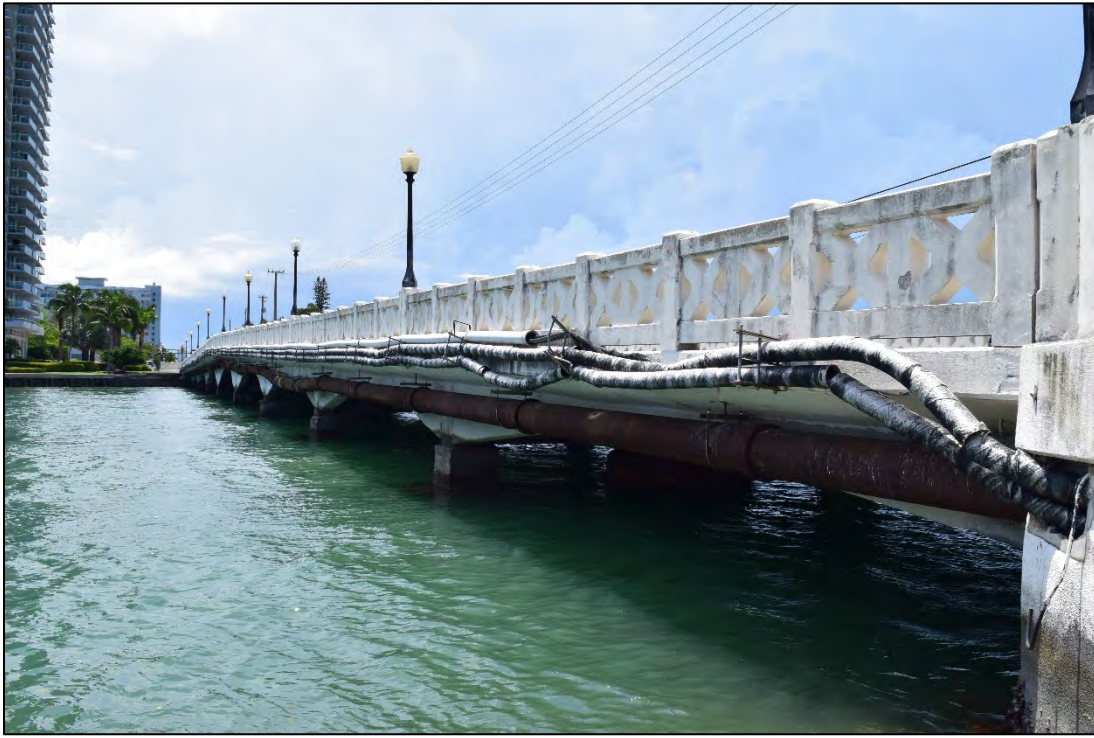
The Venetian Causeway Bridge 12 (8DA14384) is 460 ft. long with nine fixed, tee-beam spans (Figure 1). It connects Belle Isle to Miami Beach (Dade Boulevard). The deck carries two lanes of vehicular traffic, one in each direction. Each bridge section is comprised of two 12-foot travel lanes with 4-foot shoulders that are used as bicycle lanes, and 4-foot wide sidewalks on each side.

Figure 1: Venetian Causeway Bridge 12 (8DA14384), Facing Northwest

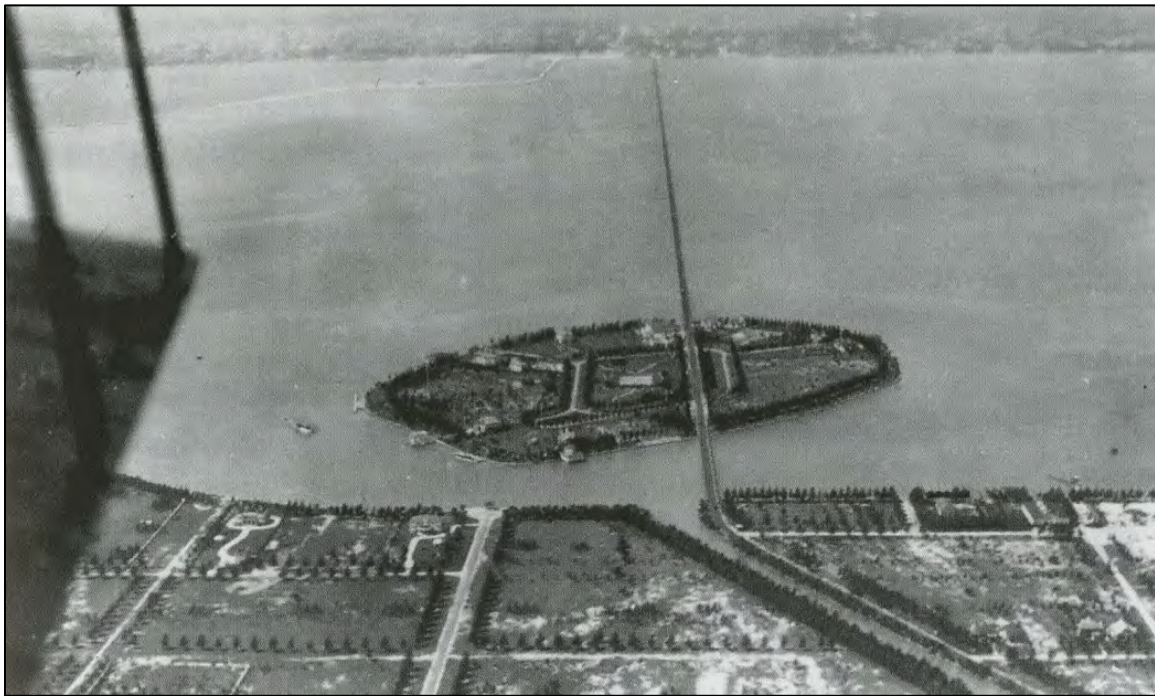
Belle Isle, the earliest of the islands, was largely shaped of dredge material excavated from the surrounding bay bottom during construction of the Collins Canal and Collins Bridge. The island was formed surrounding the eastern portion of the Collins Bridge. A plat map for the island was submitted in 1915 by the Biscayne Engineering Co., owned by W.E. Brown. Development of the island resulted from a partnership between F.C.B. Le Gro and John S. Collins (Figure 2). During the 1920s, several large estates were constructed on the island, including J.C. Penny's residence known as "White Haven" (City of Miami 1990).

Figure 2: 1920s Aerial View of Belle Isle and Collins Bridge
Courtesy State Archives of Florida, Florida Memory Collection

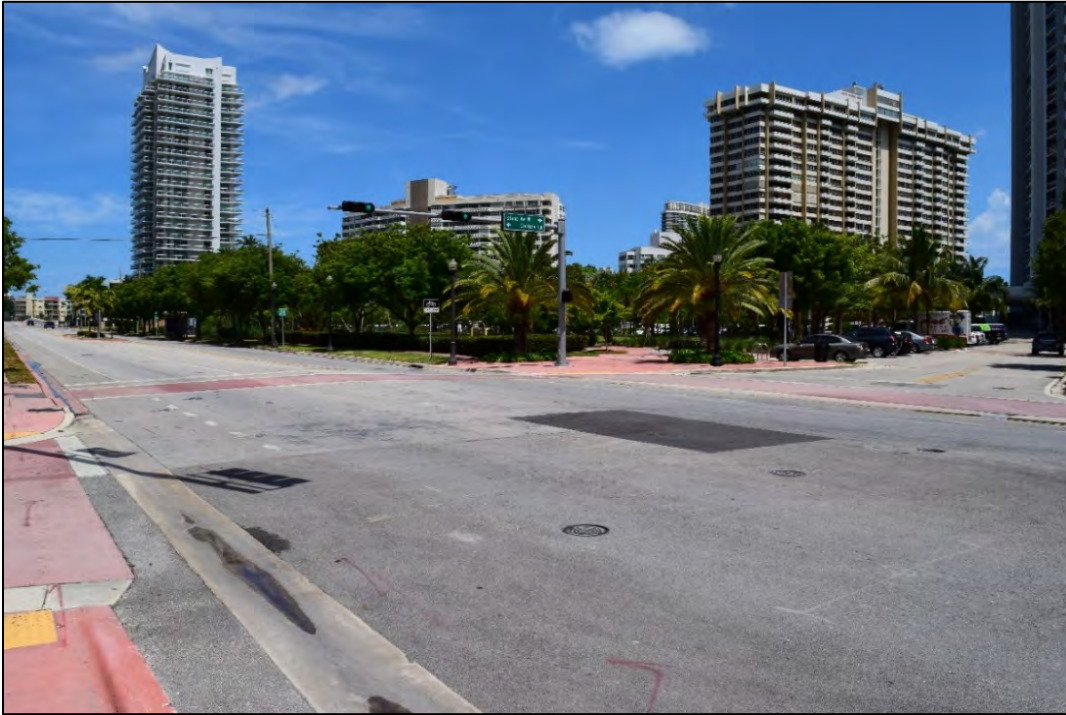
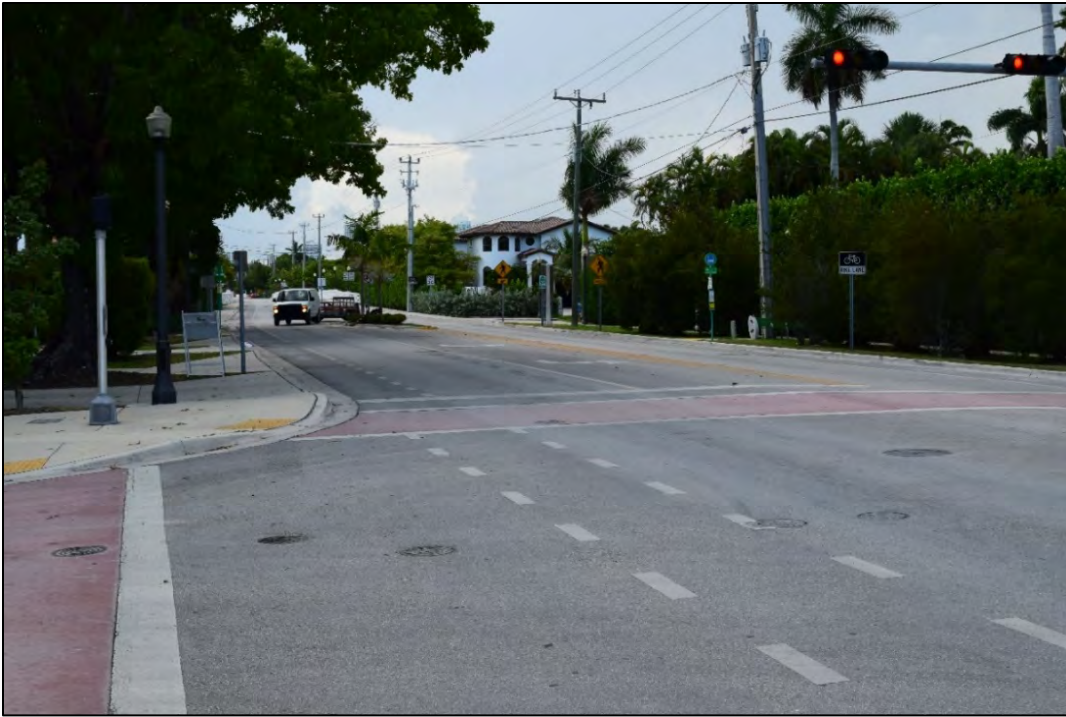
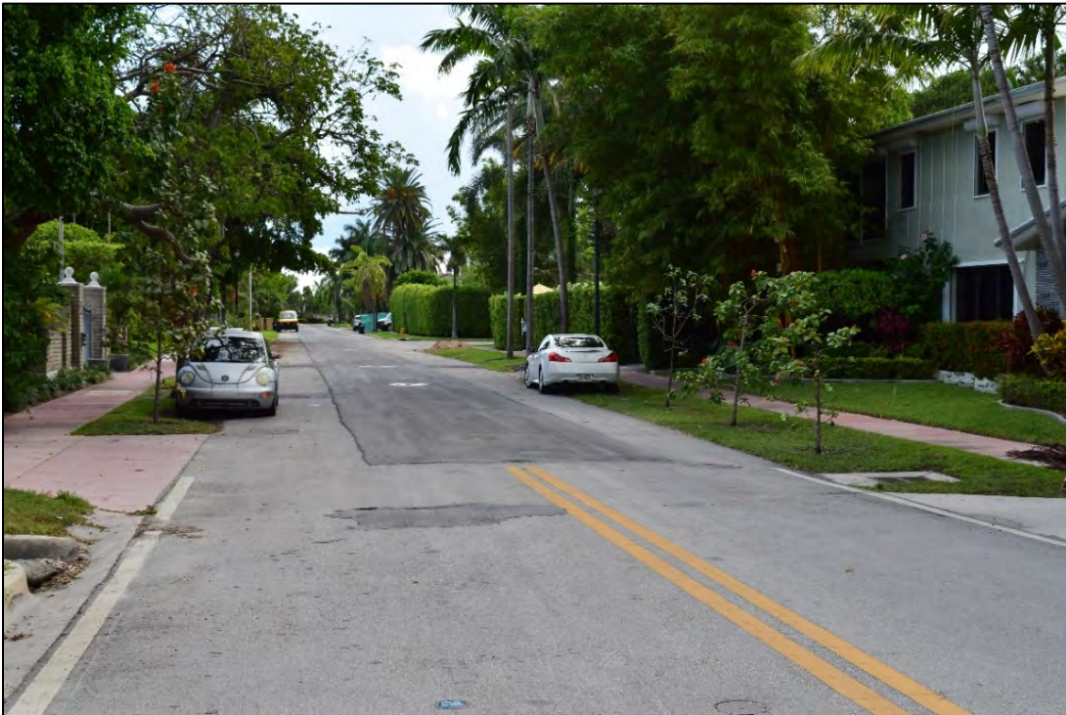
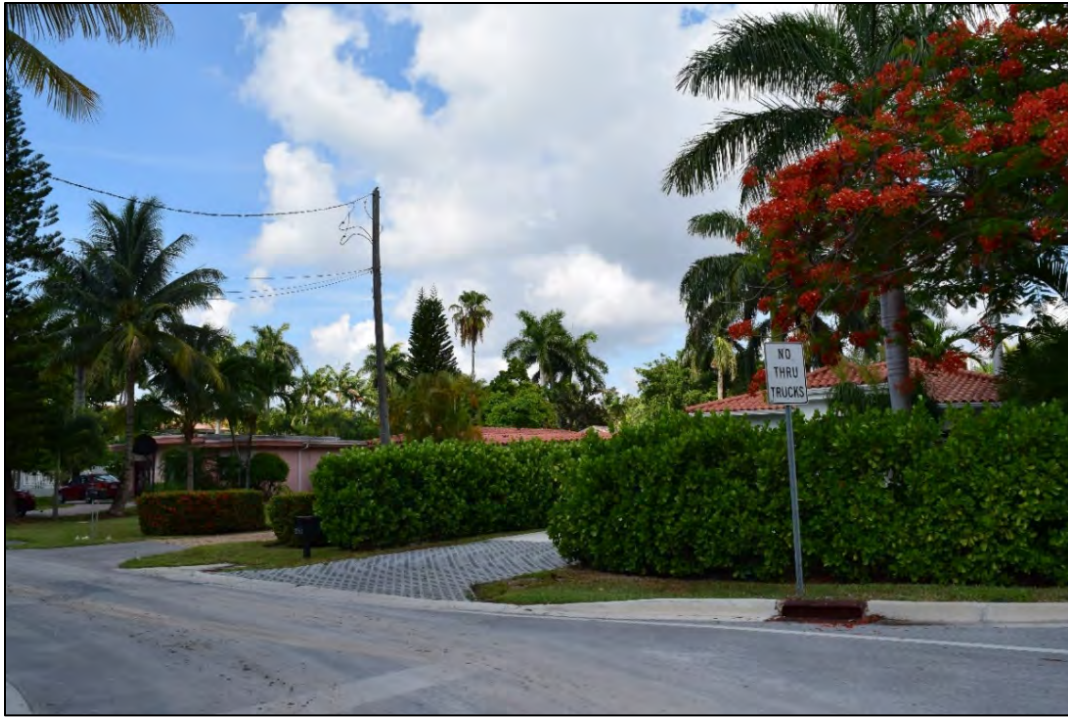
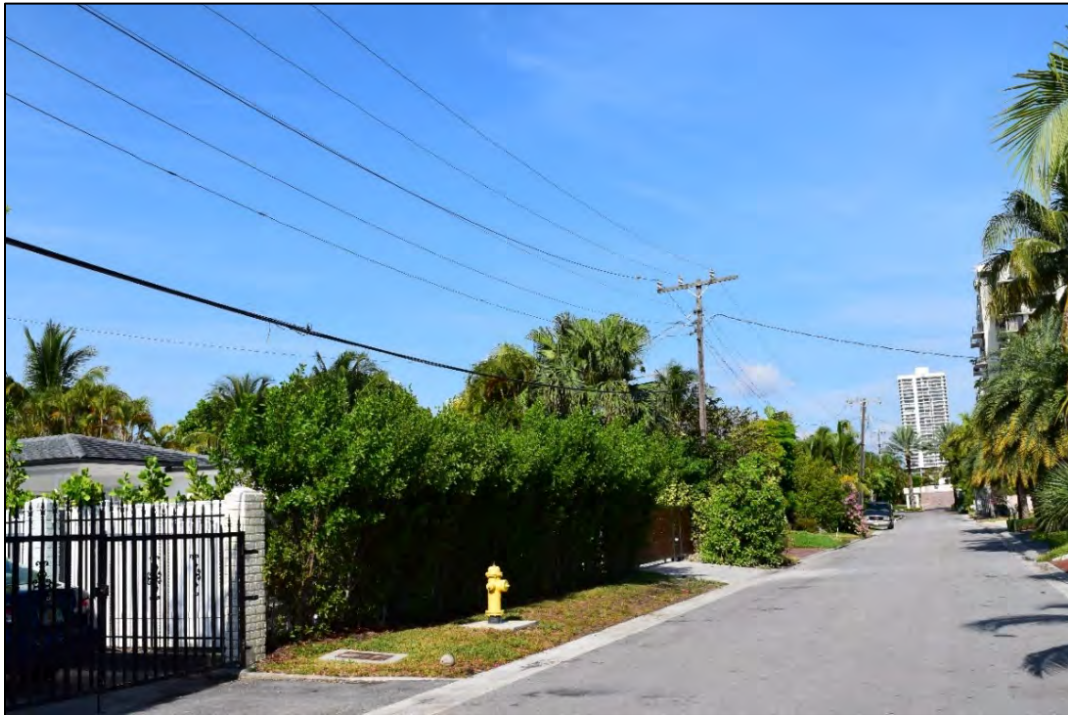
Based on current photographs of the streetscapes and comparison with descriptions of the original roadway and sidewalk widths, it appears that the roadways, curbing, sidewalks, landscaping, and lighting have all been updated since the time of construction (Figures 5-

9). According to the *Section 106 Documentation and Determination of Effects Venetian Causeway Streetscape Improvements Project* (FMSF Manuscript No. 16537) conducted by Janus Research in 2008, these elements no longer retain sufficient integrity to convey significance. Therefore, these elements do not contribute to the Venetian Islands Resource Group (8DA14395).

Figure 5: Streetscape View of Belle Isle, Facing Southeast

Figure 6: Streetscape View of Rivo Alto Island, Facing West

Figure 7: Streetscape View of Di Lido Island, Facing North

Figure 8: Streetscape View of San Marco Island, Facing Southwest

Figure 9: Streetscape View of Biscayne Island, Facing West

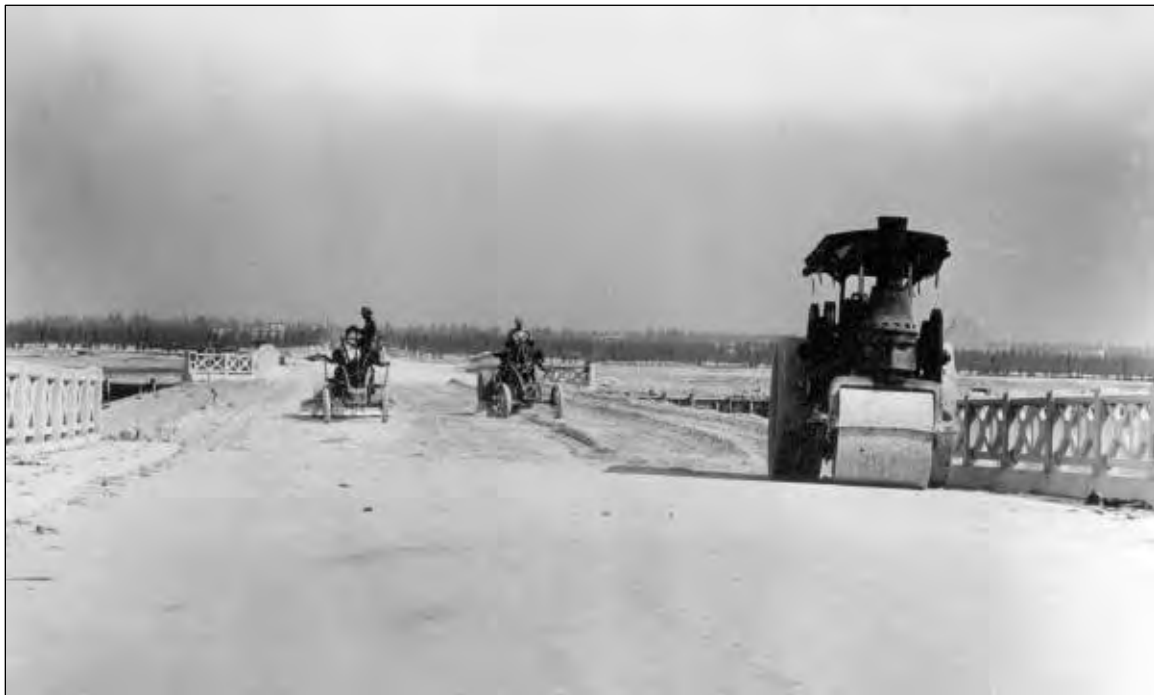
Beginning in 1925, the bridges and earthen causeways were constructed as the final phase in the development of the island communities (Figure 10). Harvey Stanley was responsible for the design of the bridges and the cost for the concrete structures was estimated at two-million dollars (Welcher 1989). The Raymond Concrete Pile Company of New York was selected as the building contractor and James M. Thompson served as superintendent. Plans for the new bridge included a combination of bridges and earthen causeway landings. The large islands would be connected using two bascule-span bridges, ten fixed-span bridges, and a series of earthen causeways. The bridges were completed in 1926, with a formal dedication occurring on February 28 of that year (Welcher 1989).

Figure 10: 1925 Photograph Showing Construction on the Venetian Causeway
Courtesy State Archives of Florida, Florida Memory Collection

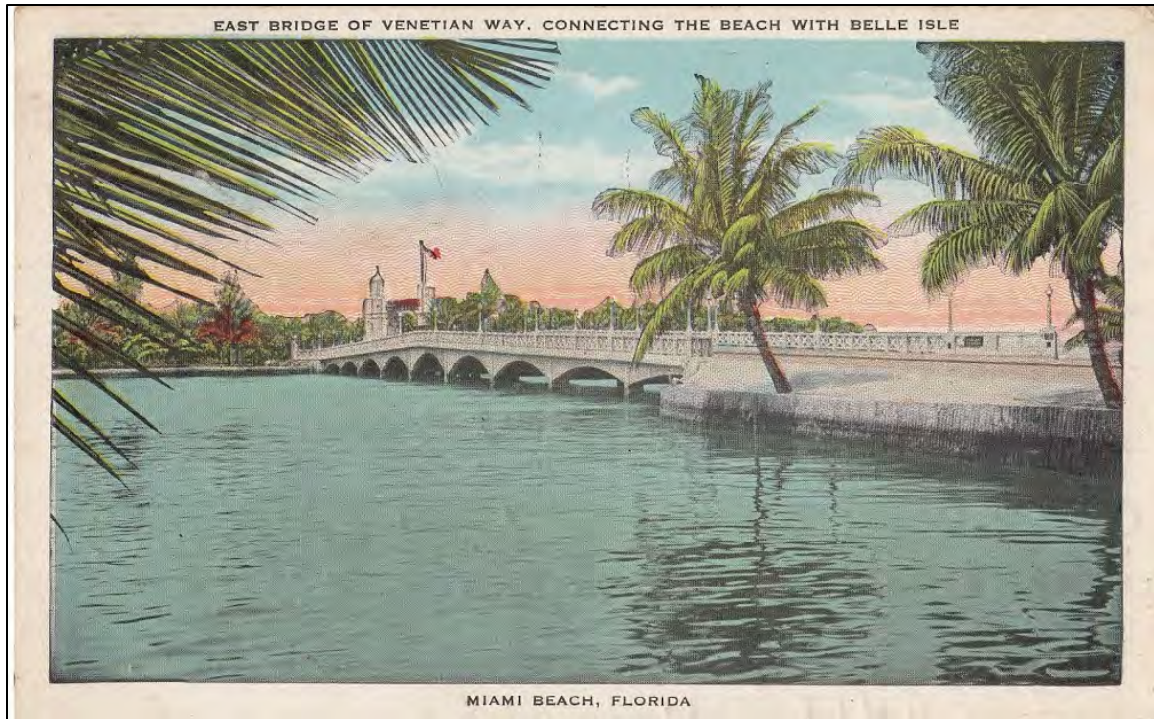
the bay from all of the bridges. A 1930s postcard shows the eastern-most bridge, Venetian Causeway Bridge 12 (8DA14384), as it originally appeared (Figure 12).

Figure 12: 1930s Postcard Depicting the Venetian Causeway Bridge 12 (8DA14384)
Courtesy Belle Isle Residents Association

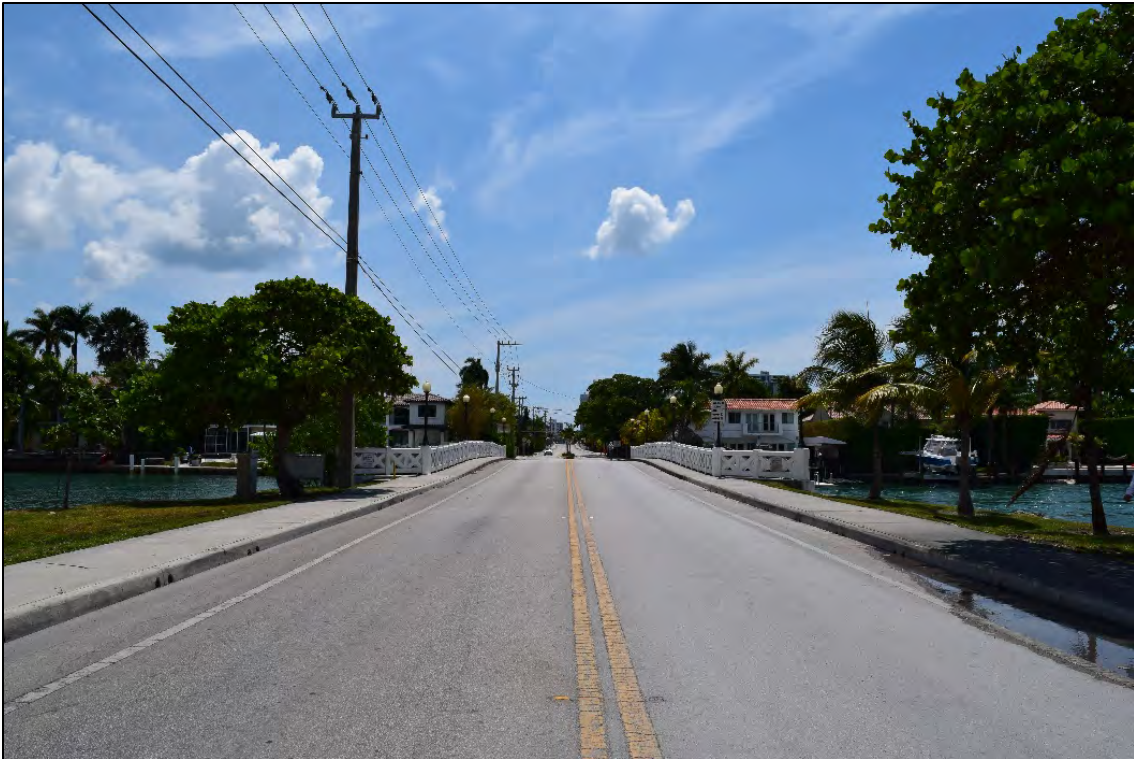
A total of five man-made earthen causeway landings are located between sections of fixed-span bridges (Figure 13). These small islands are constructed of residual dredge material and serve to connect fixed-span sections. The resulting configuration creates a combination of bridge and earthen causeway between large expanses of water. The landings allowed for shorter spans to be constructed between the large islands. The small islands were also intended to create small channels, which added to the “Venetian” feel of the islands.

Figure 13: View from Earthen Causeway Landing between Rivo Alto Island and Di Lido Island, Facing East

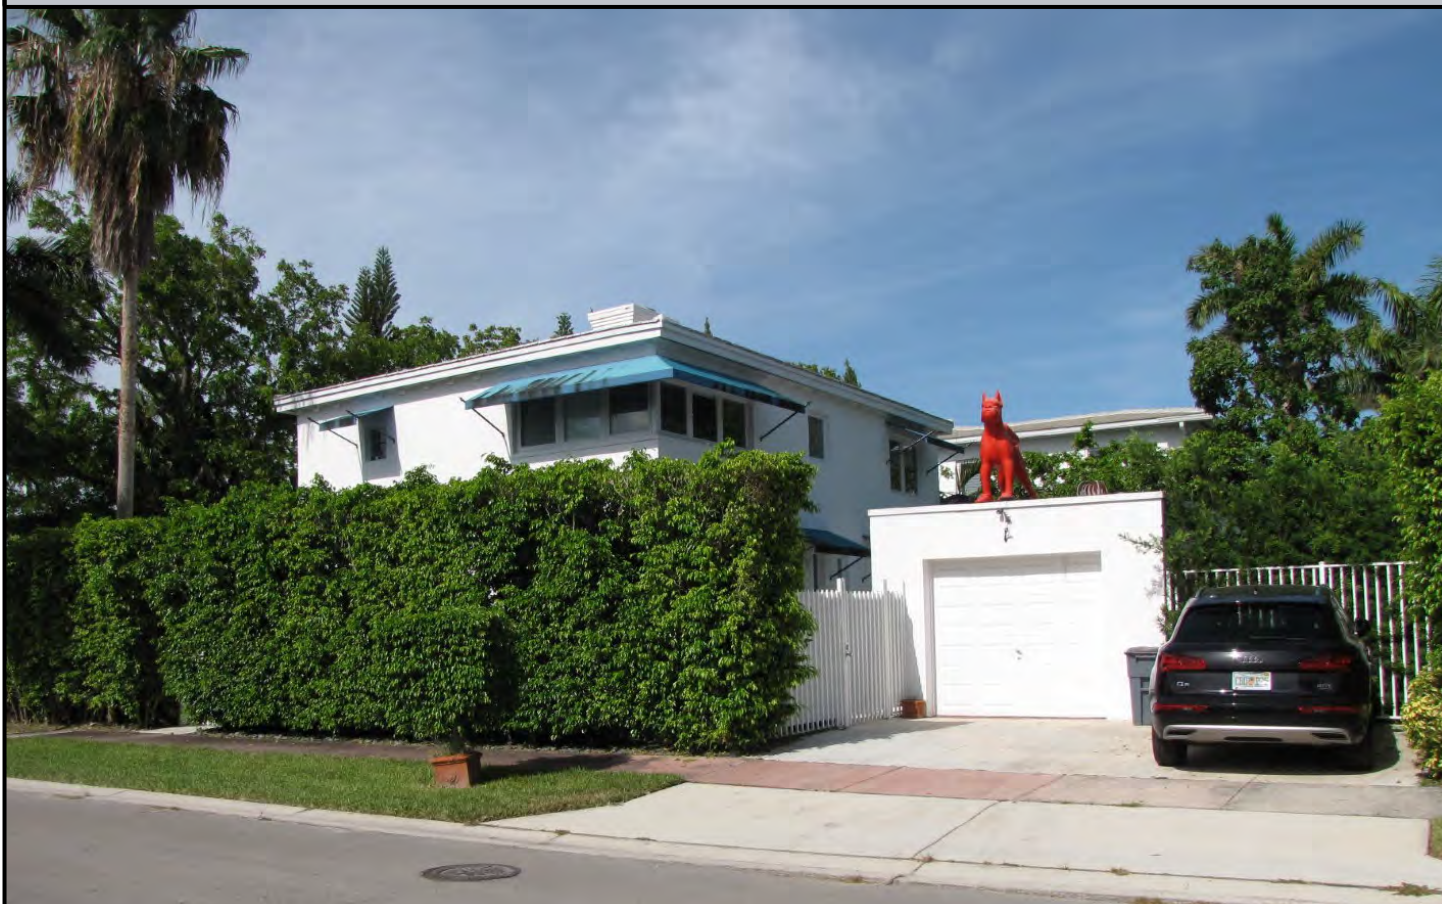
PHOTOGRAPH

Condition (overall resource condition): ☐ excellent ☒ good ☐ fair ☐ deteriorated ☐ ruinous

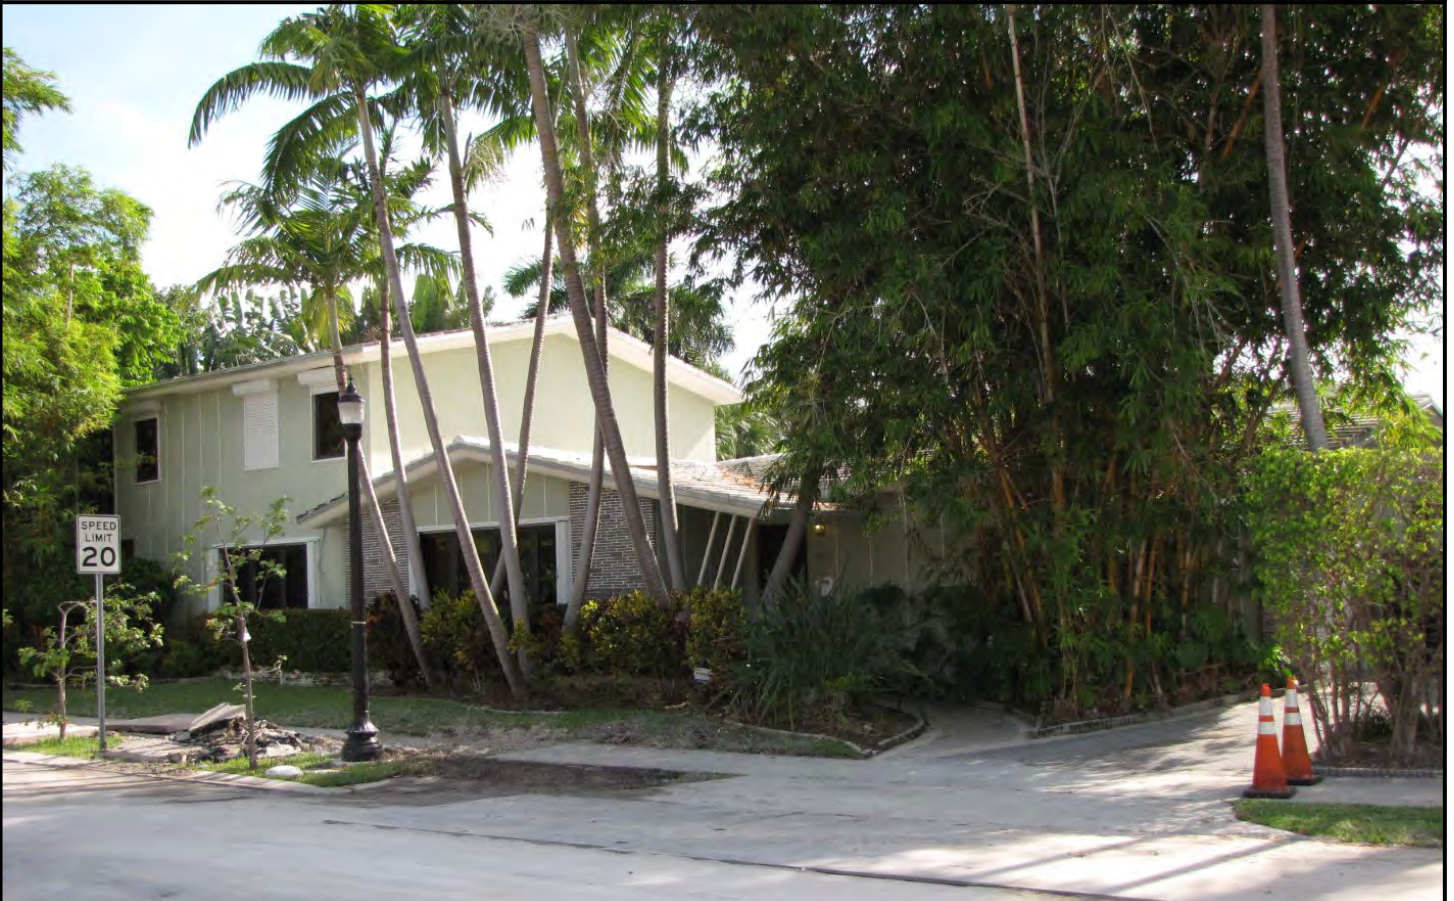
PHOTOGRAPH

Condition (overall resource condition): ☐ excellent ☒ good ☐ fair ☐ deteriorated ☐ ruinous
